Investigation of damages on reinforced concrete buildings caused by the 1990 Philippine-Luzon earthquake

ABSTRACT: The earthquake which occurred on Luzon island of the Philippines on July 16, 1990 caused great damage to many local buildings. The object of this paper is to investigate in detail the observed nature and the possible causes of damage to eight reinforced concrete buildings. The evaluation of the seismic capacity of these buildings are performed by applying the "Japanese Standard for Evaluation of Seismic Capacity of Existing Reinforced Concrete Buildings". It was found out that the presence of concrete hollow block walls greatly affected the seismic capacity of the buildings.

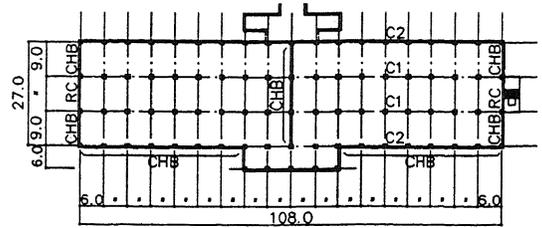
Fig. 1 Plan of building No. 1

Outline of the building : Figure 1 shows a rough plan of the building. Figure 2 shows a standard detail of section for the columns on the first floor. The building is a three-storey structure and was constructed in 1984. The floor and girders are prestressed. The building has 3 spans (@ 9.0 meters) in the transverse direction and 18 spans (@ 6.0 meters) in the longitudinal direction. The storey height is about 3.6 meters. The sectional area of each column is 46 cm square. The main reinforcement is 8-D32 and the hoop is D10-@300 for the side columns and 16-D32

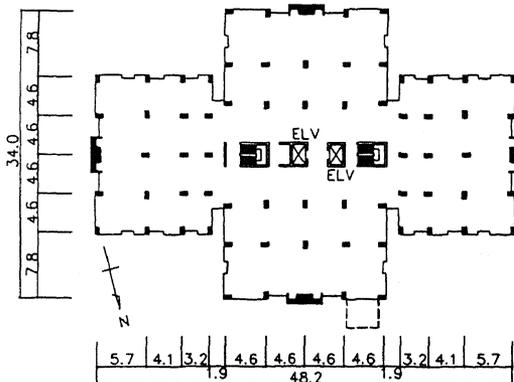
Fig.5 Plan of building No.2

Outline of the building : The building is a 10-story reinforced concrete condominium built on a southern slope. It was constructed in 1973. Figure 5 shows the typical floor plan of the building. The building is made up of three structures connected to each other with expansion joints. Found in the central part of the building is a reinforced concrete core wall, which provides spaces for elevators and staircases.

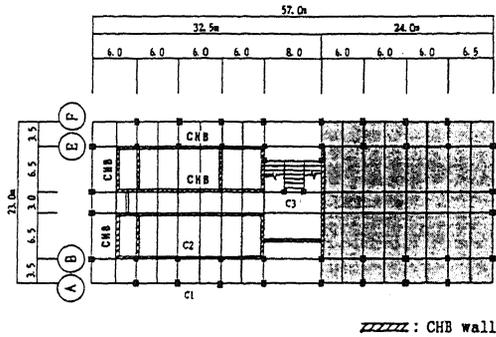
a) structural plan

Outline of the building : This is a two-story building with reinforced concrete column, and prestressed girders and floors. The building was constructed in 1987. It is 5 spans long in the longitudinal direction and is 3 spans long in the transverse direction. There is a 4 span-long extension in the longitudinal direction. It was still under construction and had concrete columns as high as the floor of the second storey when the earthquake occurred. Figure 8 shows a rough structural plan and a standard detail of section for the columns on the first floor. The central span in the transverse direction is 16 meters long, and prestressed girders were used (sectional area : 30 cm x 75 cm). The foundation consists of isolated footings with no tie beams. Short CHB walls with cased openings on top were found connecting the columns along rows B and E. In general, CHB walls were used as partitions. The roof was made of wooden truss covered with corrugated GI sheets.

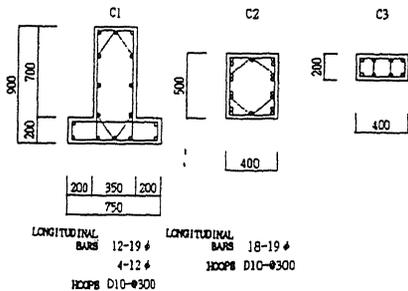
b) details of columns

in the reinforced concrete columns, which were transformed into short columns due to the presence of CHB walls in rows B and E, were the most noteworthy damage (see Figure 10). Many internal and external CHB walls collapsed and there were many cracks in them. It should be noted that no damage was caused to the girders and floors with long spans, to the columns at the second floor, neither to the extension of the existing building.

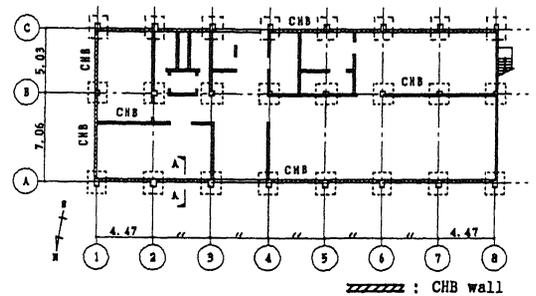
Fig.11 Structural plan of building No.8

Outline of the building : This is a two-story reinforced concrete building. Figure 11 shows the structural plan of the first floor of the building. Figure 12 shows the detail of section for the typical columns, girders and foundation beams. The height of the first floor is 3.4 meters. The roof is a wooden truss covered with corrugated GI sheets. The footing is an isolated footing with tie beams. The ground condition is satisfactory.

Condition of the damage : At a first glance the building does not appear to have been damaged by the earthquake except for the cracks in the scarcement around the building. It may be conjectured that the CHB walls with adequate numbers reinforcing bars minimized the impact of the earthquake.
