The Boca del Tocuyo earthquake of April 30, 1989 in Venezuela

Alfonso Malaver

Universidad Catolica Andres Bello, Caracas, Venezuela

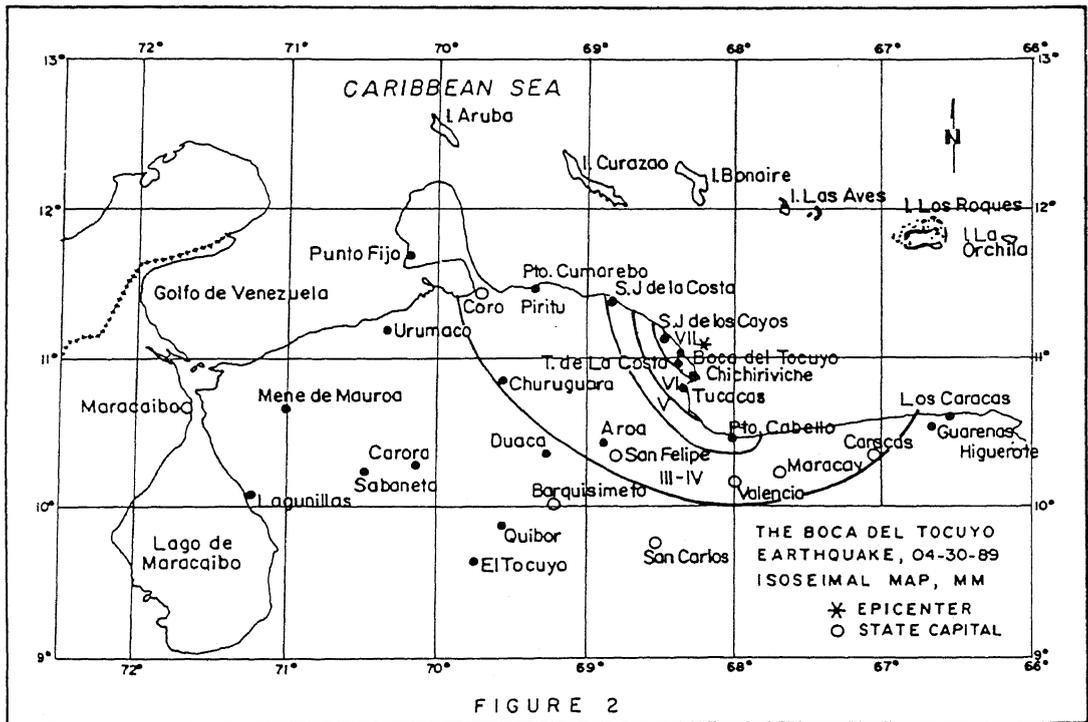
FIGURE 2

The intensity distribution, using Brazee's Modified Mercalli Scale (1978), is outlined in Figure 2, which shows that the highest intensity assigned was VII, for the towns of Boca del Tocuyo, San Juan de los Cayos, Chichiriviche and Tocuyo de la Costa (Falcón State). In the Caracas Metropolitan Area (Federal District), more than 150 km. from the epicenter, the

intensity was III. In the areas located near the Caribbean Sea and/or along the Tocuyo River in the towns of Boca del Tocuyo, Tocuyo de La Costa and Chichiriviche, liquefaction was found. Those specific sites were therefore assigned an intensity of IX on Brazeo's Modified Mercalli Scale (1978).
