Microtremor measurements in the disastrous areas by the 1990 Philippine earthquake

ABSTRACT: As members of the damage investigation team of Architectural Institute of Japan, we surveyed structural damage to buildings suffered from the Philippine Earthquake of 16 July 1990 at several disastrous areas in the northern Luzon Island: Baguio, Agoo, and others, from 20th to 30th of September 1990.

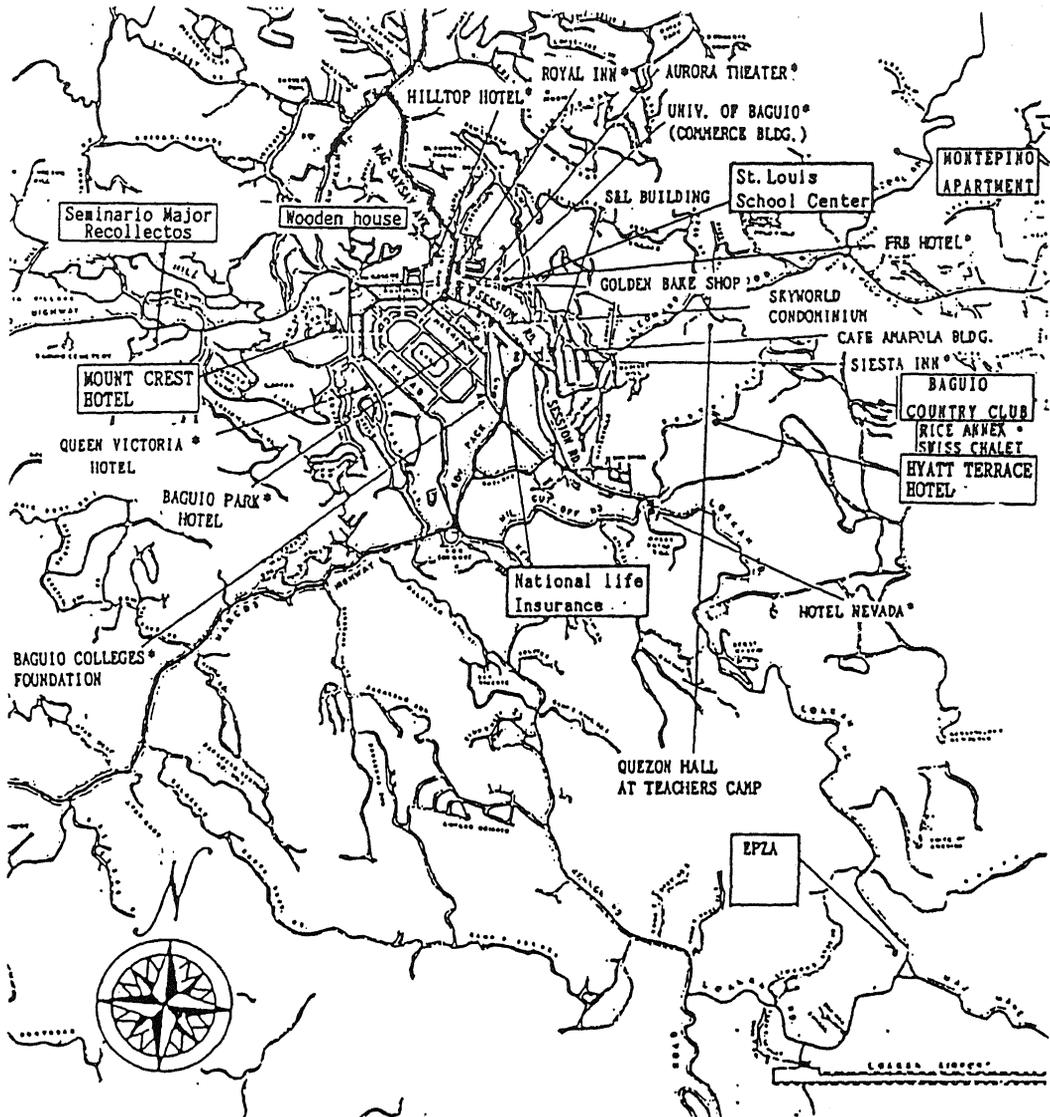
Figure 1. Location of damaged buildings & microtremor measurement sites in Baguio

Microtremor measurements were conducted on and around 7 structures in Baguio; Export Processing Zone Authority factories (EPZA), Baguio Country Club, Montepino Condominium, National Life Insurance Bldg. (NLI), St. Louis School Center, Two-story wooden house, and Seminario Major Recollectos. Figure 1 shows location of these buildings with other heavily damaged buildings not inspected at this time.

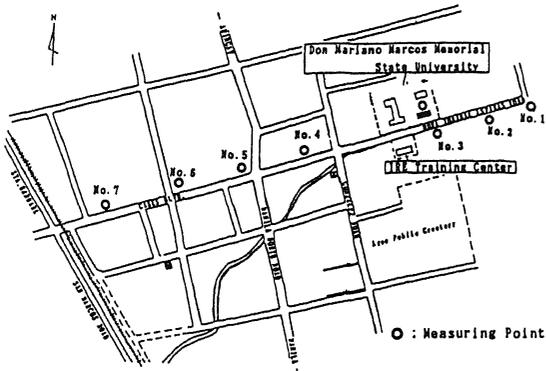
Figure 5. Location of microtremor measurements in Agoo

In Agoo, microtremor measurements were made on and around 3 buildings: Don Marcos Memorial State University (DMMSU) and International Rural Electrification Training Center (IRE). Further more, measurements on grounds were conducted along the road. Location of the measurement sites are shown in Figure 5.

We also took measurements at 7 sites on the ground along a east-west measurement line over than 2 km in length on the DONA TORIBIA ASPIRAS ROAD & CASES BLVD. (Fig. 5). The far-east site on the road was at the boundary between the east rock mountains and the flat land reaching to the sea. The far-west site was near the fields where sand-boils had been observed at the time of the earthquake was on the flat land. The center of the measurements line was the intersection of the national road; MANILA NORTH ROAD where the center of Agoo and there were some relatively large size structures near the intersection, and its vicinity was very noisy because of traffic. The observed waveform are shown in Figure 7 and spectra in Figure 8. Shapes of the wave forms and of the spectra were changed considerably between the east side (hill side) and west side (sea side) of the national road which ran from north to south; at the west side, predominant periods were as long as 0.8 sec., and there were no large structure. On the other hand, periods at the east side was about 0.4 sec..
