Engineering analysis of earthquake damage in catalogue-like form: Case-study of Eastern Kazakh earthquakes of 1990

A.S.Taubaev & E.T.Kenjebaev
KazNIISA, Alma-Ata, Kazakhstan, GUS

E.Hampe, H.-G.Schmidt & J.Schwarz
College for Architecture and Civil Engineering, Weimar, Germany

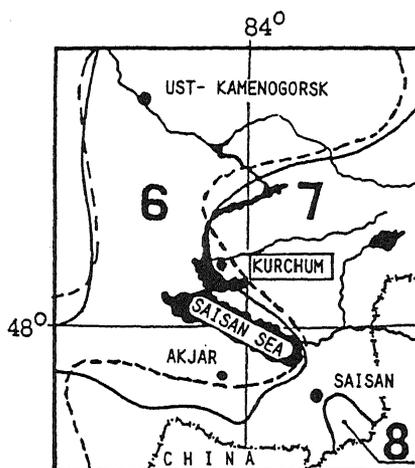
Figure 1. Parts of seismic maps according to the Soviet codes SNiP P-A.12-69 (—) and SNiP P-7-81 (---)

a seismic zone of an intensity 8°; after revision of the seismic map in 1978 the level of seismicity postulated for that region was reduced to an intensity of 7° (MSK). Similarly, the level of seismicity (in terms of intensity) of the town Kurchum was reduced from 7 to 6° (dashed line in Fig. 1).

The good performance of school No 1 can be explained by the regular plane (Fig. 8) and the antiseismic design for a reference intensity of 7° (MSK) according to the previous zoning map OSR-1969 (see Fig. 1).

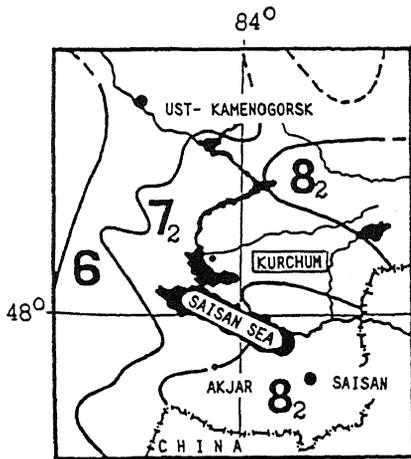
Figure 3. Zoning map of East Kazakhstan proposed after the earthquakes in 1990

the need of a correction of the currently proposed seismic zoning map (see actual version in Fig. 3).
