Damage assessment for two Icelandic earthquakes

Hjörtur Thráinsson

Engineering Research Institute, University of Iceland, Reykjavík, Iceland

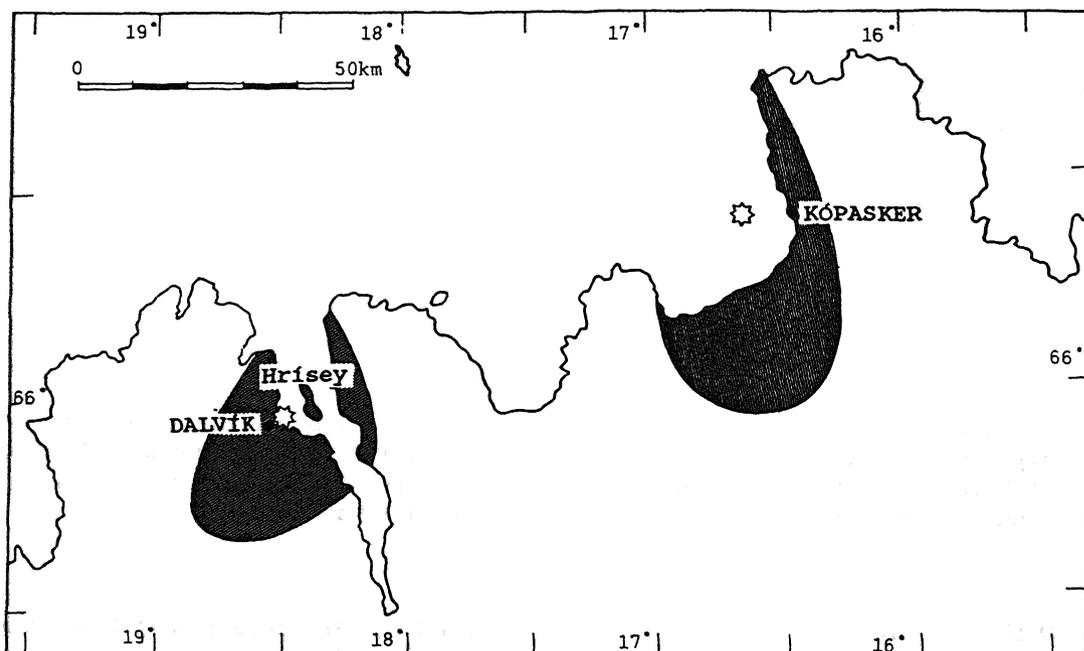
Figure 2. The epicenters of the earthquakes in this study (stars) and the areas where damage occurred to buildings (shaded).

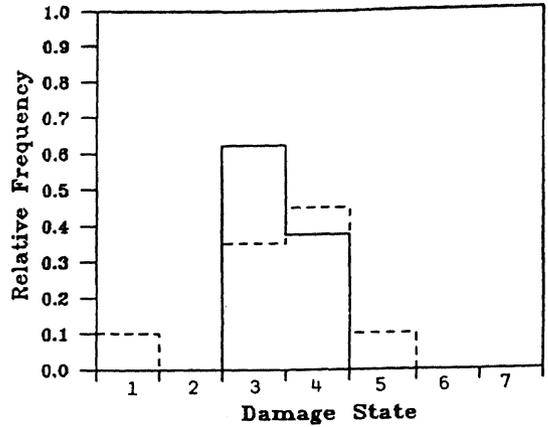
Figure 15. Relative frequencies of damage states. Wood frame buildings. MMI = IX. Solid: ATC-13; dashed: this study

It can be seen, that the observed damage in the two Icelandic earthquakes usually has a wider range than predicted by ATC-13, and the ATC-13 damage probability matrixes would consistently underestimate the number of buildings which sustained light or none damage. It should be noted that ATC's damage probability matrixes for earthquake engineering facility class number 9 (reinforced masonry shear wall without moment resisting frame, low rise) did not compare well with the Icelandic unreinforced concrete shear wall buildings.

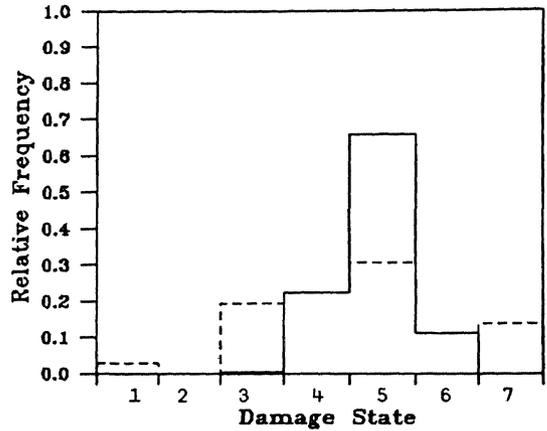
Figure 16. Relative frequencies of damage states. MMI = IX. Solid: ATC-13, URM, low rise; dashed: this study, concrete shear wall

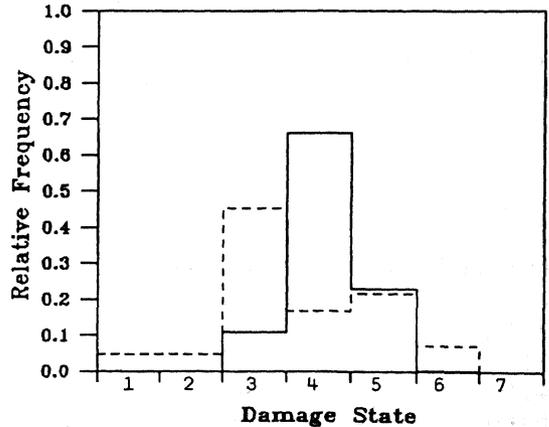
Figure 17. Relative frequencies of damage states. MMI = VIII. Solid: ATC-13, URM, low rise; dashed: this study, concrete shear wall

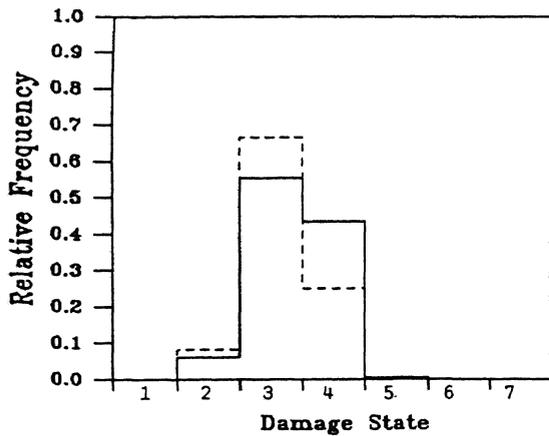
Figure 18. Relative frequencies of damage states. MMI = VII. Solid: ATC-13, URM, low rise; dashed: this study, concrete shear wall

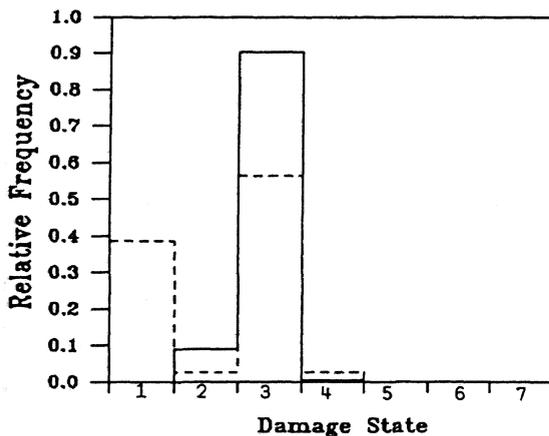
Figure 19. Relative frequencies of damage states. MMI = VI. Solid: ATC-13, URM, low rise; dashed: this study, concrete shear wall
