Earthquake damages and characteristics of microtremors at large-scale artificial housing sites

ABSTRACT: The detailed investigation by a house-to-house visit on the earthquake damages and the measurement of microtremors are carried out at two large-scale artificial housing sites. The extent of the earthquake damages corresponds to the soil condition of the fills at each housing site. The amplitudes of microtremors on the fill at damaged housing site are large compared to those at less damaged housing site. The largest cause for the serious damage of houses is insufficient compaction of the fill. Microtremor is worth using as the method of judgement for the damage potential in large-scale artificial housing sites.

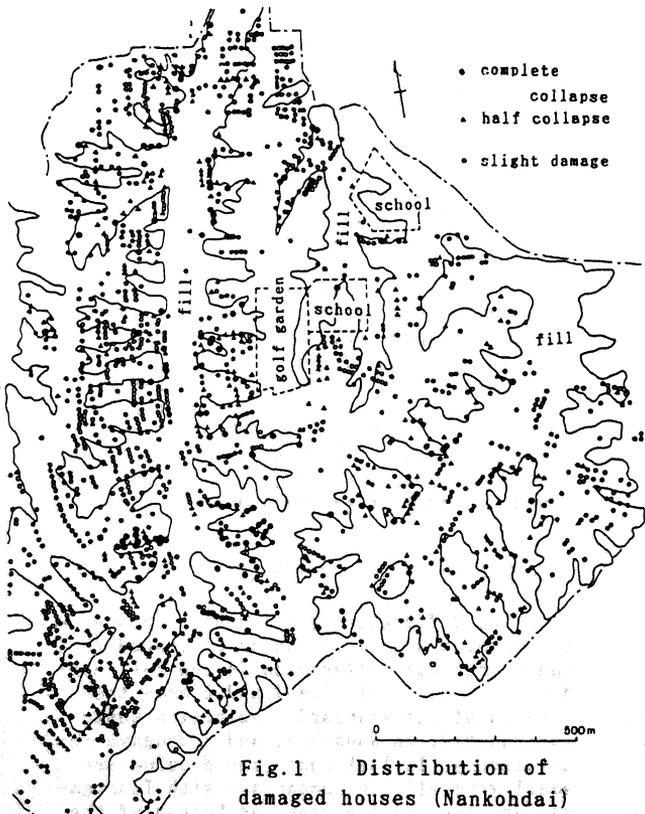
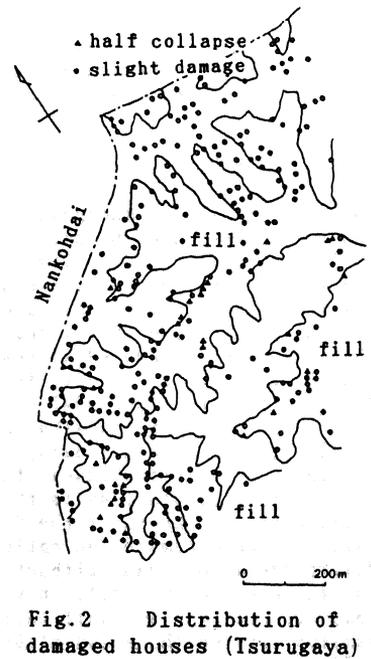
Fig. 3 Distribution of cracks (Nankohdai)

Fig.3 shows the locations of cracks at the

ground surface investigated in Nankohdai housing site. About ten years after since the earthquake occurred, this house-to-house visit investigation had been carried out. So it is possible that we overlooked some cracks. However, it is considered that the impressive cracks were not overlooked. The large cracks are located at the nearby boundaries between the earth cut and the fill, and are almost parallel to the boundary. It can be considered that these large cracks were caused by the slumping of the fill. The locations of heavy damages correspond nearly with the locations of large cracks. It is considered that the large majority of heavy damages were caused by these large cracks of ground.
