Post earthquake damage studies on the performance of buildings during Bihar (India)-Nepal earthquake on 21st August 1988

V.Thiruvengadam & J.C.Wason
 Central Public Works Department, New Delhi, India

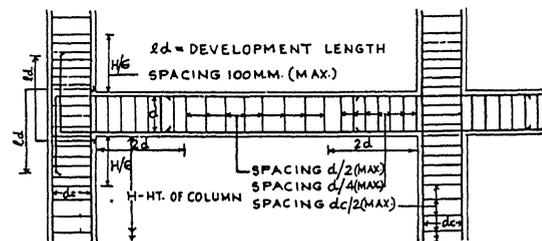
Figure 3. Ductility detailing of moment resisting frames

The building with stiff upper storey and flexible lower storey had undergone a heavy stress concentration due to the abrupt change in the storey stiffnesses. Large sway deflection has induced heavy moments and buckling of the columns due to P- Δ effects. The columns did not possess adequate ductility to withstand the large sway deflections and absorb the earthquake energy. This was evident from the absence of ductility detailing in the beams, columns and beam-column joints. Fig 3 indicates the code specified (2) ductility detailing of moment resisting frames.

While the main column reinforcement bars were adequate, closely spaced column ties were not provided to confine the concrete core and to prevent the buckling of the column bars. Due to the total absence of confining ties the vulnerable beam-column joints could not withstand the cyclic stresses induced by the earthquake. It was seen that the beam reinforcement had inadequate anchorage into the beam-column joints, with the result that the beams have not fully participated in resisting the earthquake forces and it could be seen that the beams have simply collapsed like rigid bodies.

The main lesson learnt from this building behaviour is the importance of ductility detailing. Also, the abrupt change in the storey stiffness has caused heavy stress concentration leading to the collapse of the building.

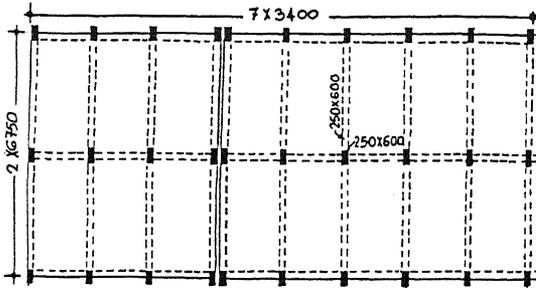
Figure 4. Typical floor plan of surgical ward.

This is a three storeyed reinforced concrete framed building with brick masonry filler walls Fig. 4. The building has a simple rectangular plan configuration and the long length of the building is divided with expansion/separation joints. Being an important hospital in the affected region, it has served to treat the victims of this earthquake.

The main earthquake induced distress in the building was the diagonal cracking of the brick masonry filler walls and their separation from the surrounding frame members. Such separation/cracking was severe in the first storey, less in the second storey and insignificant in the top storey. The pattern of cracking in the filler walls was along the mortar joints of the brick masonry and also at the frame-infill interface. Due to inadequate overall maintenance and seepage/dampness in the toilet areas, some of the RCC columns were in severely corroded condition. These corrosion affected members have further developed cracks during the earthquake shaking.

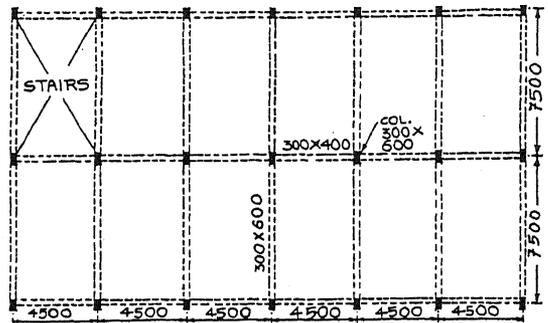
Figure 5. Typical floor plan of telecommunication building at Munger

The Telecommunication building, an essential service building which remained operational after the earthquake, is a three storeyed RCC framed building with moment resisting frames with brick masonry filler walls Fig. 5. The International Yogashram building is a seven storeyed RCC framed building with moment resisting frames with brick masonry filler walls and the tallest building in the affected region Fig.6.

The Telecommunication building had suffered no structural damage except separation and cracking of the non structural filler walls. There was no apparent damage to the RCC structural members. The Yogashram building had suffered practically no damage except few cracking of the brick masonry filler walls in the lower floors. Both the above buildings have shown a good performance under the earthquake primarily due to their regular building configuration and good structural system and arrangement. These are the cases of well designed and detailed buildings, the essential requirements in such high seismic zones.

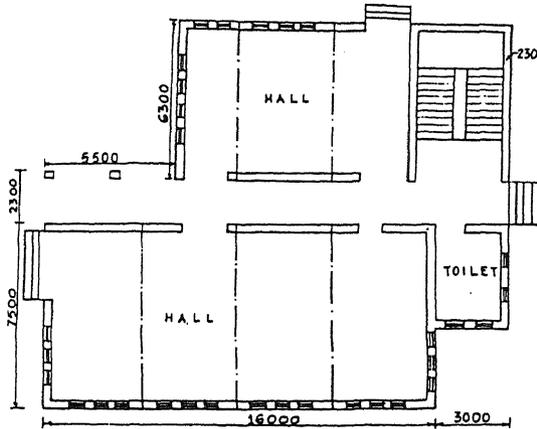
Figure 7. Ground Floor Plan of the Industrial Department building at Darbhanga.

This two storeyed load bearing brick masonry building with a wall thickness of 230mm had RCC beam and slab floor system. The bricks used were of average quality with a crushing strength of about 5N/mm², laid in 1:8 cement sand mortar. The building was of open type with large size halls of size 16m x 7.5m in both the storeys without any cross walls for lateral load resistance Fig. 7. The load bearing external walls had large number of window openings covering almost 70% of the wall area. A stiff staircase core was located at the end of the building providing unsymmetrical stiffening to the building. Although constructed only in 1987, no strengthening measures as per the codal provisions (fig. 8) were adopted.

The brick piers between the window openings had developed extensive shear cracks and particularly the end walls were more damaged (photo 2) and the openings over the doors have developed diagonal cracks upto the RCC floors.

The building had partly tilted. There were no apparent damage to the RCC beams and slabs of the floors. The overall damage was extensive and building was vacated after the earthquake.

The observed behaviour indicate that the building had been subjected to heavy torsion due to unsymmetrical stiffening effect of the stiff staircase portion. Due to this, the end walls were severely cracked and building had tilted. Adoption of such open type of brick masonry structures without any cross walls is undesirable from the earthquake point of view. This structure with large halls and large number of window openings should have been made as R.C.C. framed structure. The low strength of the cement mortar, poor quality construction, improper planning of window openings and non-adoption of strengthening measures were also responsible for the poor performance of this building.

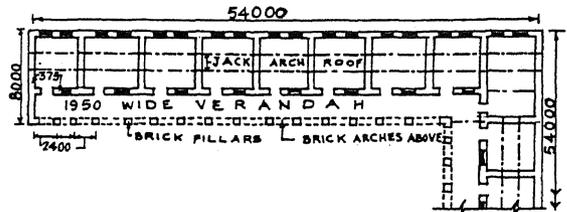
Figure 9. Madrasa building at Darbhanga.

These two buildings built in 1927 were made of 60cm thick brick masonry walls in lime mortar and with brick jack arch roofs with heavy lime concrete filling over the roofs. The Madrasa building at the Darbhanga town was a long L-shaped single storeyed building, each wing 54m long and 8m wide, with a 2m wide front corridor consisting of brick masonry arches supported over brick pillars (fig. 9).

The above buildings which had withstood the 1934 earthquake (magnitude 8.4), probably for their being strong and new at that time, are badly damaged due to this earthquake. The long front corridor portion of the Madrasa building in one of its wings had collapsed killing eight persons (Photo 3). The brick jack arch roofs had developed longitudinal cracks at their crown and partially collapsed in many portions of this building. The tie rods provided in the end panels of these arches which were in a corroded condition, had failed due to tension. As regards to old hostel building, one of the end of the building had collapsed (Photo 4) and other end had severely damaged. In the rooms, long and cross walls had developed vertical separation cracks and diagonal shear cracks. The jack arch roof panels had developed longitudinal cracks along their crown and collapsed in several portions.

The main reason for the damages of these buildings is their ageing with brick masonry losing their mortar strength due to prolonged weathering actions. The jack arch roofs collapsed as they could not withstand the tensile forces generated during earthquake. The masonry pillars supporting the corridor arches had collapsed due to shear failures. Heavy brick wall thicknesses and very thick lime concrete filling over the roofs had generated large inertial forces and the structure possessed no ductility and had very brittle failure. Another undesirable feature of the hostel building was its unduly long length causing large stresses under the conditions of differential ground vibrations. Similarly, the

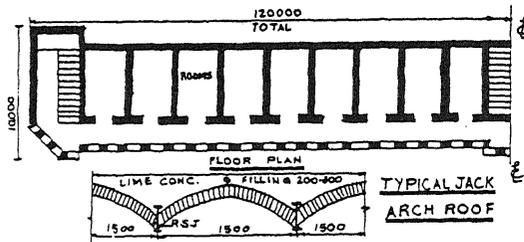
Figure 10. Old hostel building at Darbhanga medical college

The old hostel building at the medical college complex Fig. 10 is an unduly long (about 120 metres) two storeyed building. Both the buildings had no expansion/separation joints.
