Performance of R/C buildings in the 1985 Chile earthquake

R. Riddell

ABSTRACT: One of the most important features of the March 3, 1985 earthquake in central Chile was the performance of moderate-rise reinforced concrete buildings in the coastal city of Viña del Mar. Most of the buildings were designed with structural walls to resist both gravity and seismic loads. Strong ground motion occurred in Viña del Mar, but only a few buildings sustained serious structural damage. In this paper the general characteristics of the building inventory in the city are described, and the results and conclusions of detailed analyses of the three most severely damaged buildings -Acapulco, El Faro, and Hanga Roa- and two undamaged buildings -Torres del Sol and Torres de Miramar- are presented.

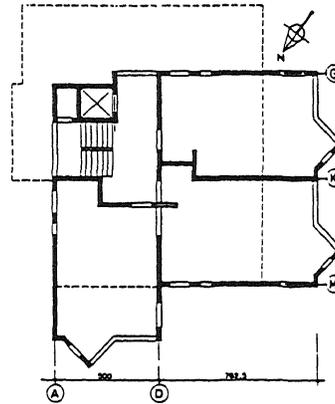
Figure 6. El Faro building. Typical story plan.

This was an eight-story one-basement building built in 1981. Materials specified for construction were: concrete cubic strength of 225 kg/cm^2 and steel yield stress of 4200 kg/cm^2 . The unsymmetrical arrangement of walls resulted in great eccentricity and significant torsional response. The typical floor plan is shown in Figure 6, where dashed lines delineate the basement plan. The building was severely damaged during the earthquake. There was no failure of the soil or the foundations. Damage concentrated in the first story: the wall along

Evaluation of individual members shows a lack of flexural reinforcement in several walls of the first story, including walls M and D, while concrete compression and shear are moderate. Results of the analysis and observed damage correlate well. Wood et al. (1991) investigated the behavior of this building and concluded that the building collapsed after the longitudinal reinforcement fractured in wall M in the first story; the brittle failure was related to underreinforcement, condition that was aggravated by the torsional response.

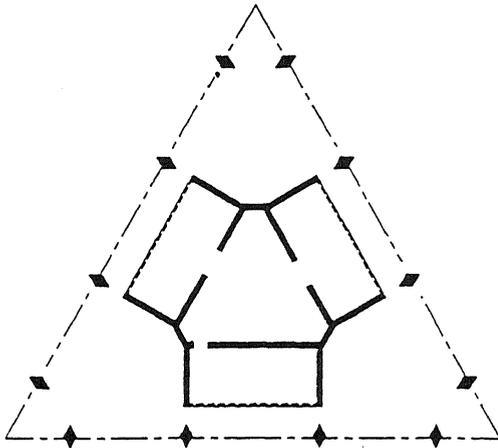
Figure 9. Floor plan of Torres de Miramar building, levels 1 and 2.

shows the plan of odd numbered floors from 3 up; even numbered floors differ to the previous in that door openings are in the opposite side of the core walls. No structural damage was observed in these buildings. The total cross sectional area of walls is 6.6% of the plan area in the most critical level (2nd floor). The calculated periods of vibrations, for a fixed-base model of the building, for the first three modes, were 1.19, 1.02, and 1.01 seconds; the first mode was a pure torsional mode as expected from the symmetry and the relatively low torsional stiffness of the building. By means of ambient vibration tests Midorikawa (1990) measured periods of 1.32, 1.07, and 1.06 seconds, which are in close agreement with the calculated ones. The maximum interstory drift, measured at the center of mass, was 0.07%, while peripheral displacements were 50% larger than at the mass center (accidental eccentricity was introduced by shifting the mass centers in 5% of the plan width).

The design base shear according to the Chilean code was $0.066W$. For the corresponding lateral loads strength requirements were satisfied in structural walls and columns, except in the first story columns near the middle of the sides where the demand was 5.3 and 8.7% larger than the capacity. However, soil structure interaction effects significantly influenced the dynamic characteristics of this buildings according to Wallace and Moehle (1989); they found that the translational period increased up to 43% when soil flexibility was considered in combination with intense ground motion. The elongation of the period resulted in about 45% reduction of the base overturning moment and about 25% reduction of the base shear, for response history analyses.

The calculated ultimate strength of the building to a triangular distribution of lateral load corresponded to a base shear of $0.18W$ for a flexural mode of failure associated to total plastification of the third level. The ultimate strength related to shear capacity corresponded to a base shear of $0.23W$; the weakest level was also the third. Considering a capacity of $0.18W$, 5% damping, and the inelastic response spectrum for the ground motion recorded in Viña del Mar, ductility requirements associated to a global ductility larger than 3 are inferred for this building, which should have manifested in terms of damage; however, if a 43% increase in period is considered, the ductility demands reduces to a global ductility of 1.5 which is more consistent with the observed behavior of building.

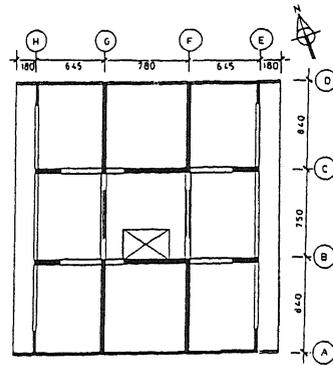
Figure 11. Floor plan of Torres del Sol building, levels 3 to 22.

This is a 22-story building with a penthouse and two basements that experienced only light structural damage during the earthquake. It was built in 1981-1982. The first three periods of vibration of 1.18, 1.17, and 0.79 correspond to uncoupled translational and rotational modes; the periods increase to 1.52, 1.42, and 0.85 respectively if a P3D model of the building is used. The building is almost symmetric in plan as shown in Figure 11. The structure is regular in height, except that it has a significant discontinuity in the second story of axes F and G as shown in Figure 12. The second story walls worked as deep beams coupling the walls below. These coupling beams exhibited incipient shear cracking after the earthquake, although they were not underdesigned.

The analysis shows that the reinforcing steel in the exterior walls in axes F-G at the basement and 1st-story levels exceed the allowable stress; these walls are subjected to flexure combined with axial tension for lateral earthquake loading. However, no damage could be seen in these walls even though they must have been driven within the inelastic range. Compression and shear stresses in concrete were in general quite low. Similar proportions to the Torres de Miramar buildings suggest that this building may have also experienced favorable soil-structure interaction effects. This condition, the low concrete stresses, and the symmetric configuration, may be possibly considered as beneficial factors justifying the good behavior of the building.
