# The repair and strengthening of the historic Stanford Memorial Church

C. D. Poland & E. M. Reis

*H.J. Degenkolb Associates, Engineers, San Francisco, Calif., USA*

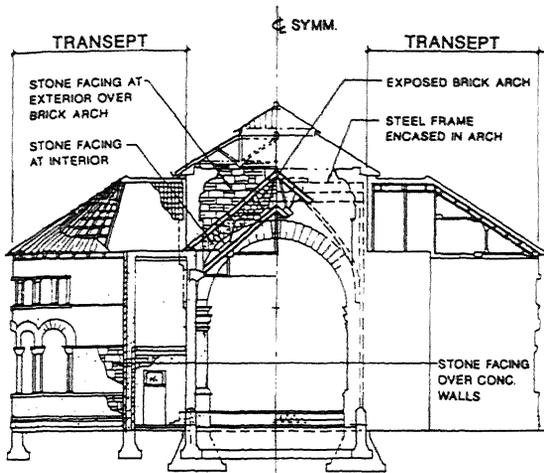
Figure 4: Elevation looking north.

When the church was rebuilt in 1913, the new concrete walls were poured up to the columns supporting brick crossing arches, with only nominal anchorage to the arches. The arches and the unreinforced walls they support rise above the wood roofs of the church without connection and are,

therefore, completely unbraced against out-of-plane movement. In the recent earthquake, the arches suffered damage due to perpendicular movement. In the north and west arches, movement was so severe that the bedding and pointing mortar of the voussoir stones was loosened, causing several of the stones to crack and slip down as much as two inches as shown in Figure 5. Many of the unanchored ashlar stones on the face of the arches popped over an inch out from the brick, and some crumbled to the floor.
