Observed effectiveness of minimal seismic strengthening of unreinforced masonry buildings

D. R. Bonneville & D. W. Cocks
H. J. Degenkolb Associates, Engineers, San Francisco, Calif., USA

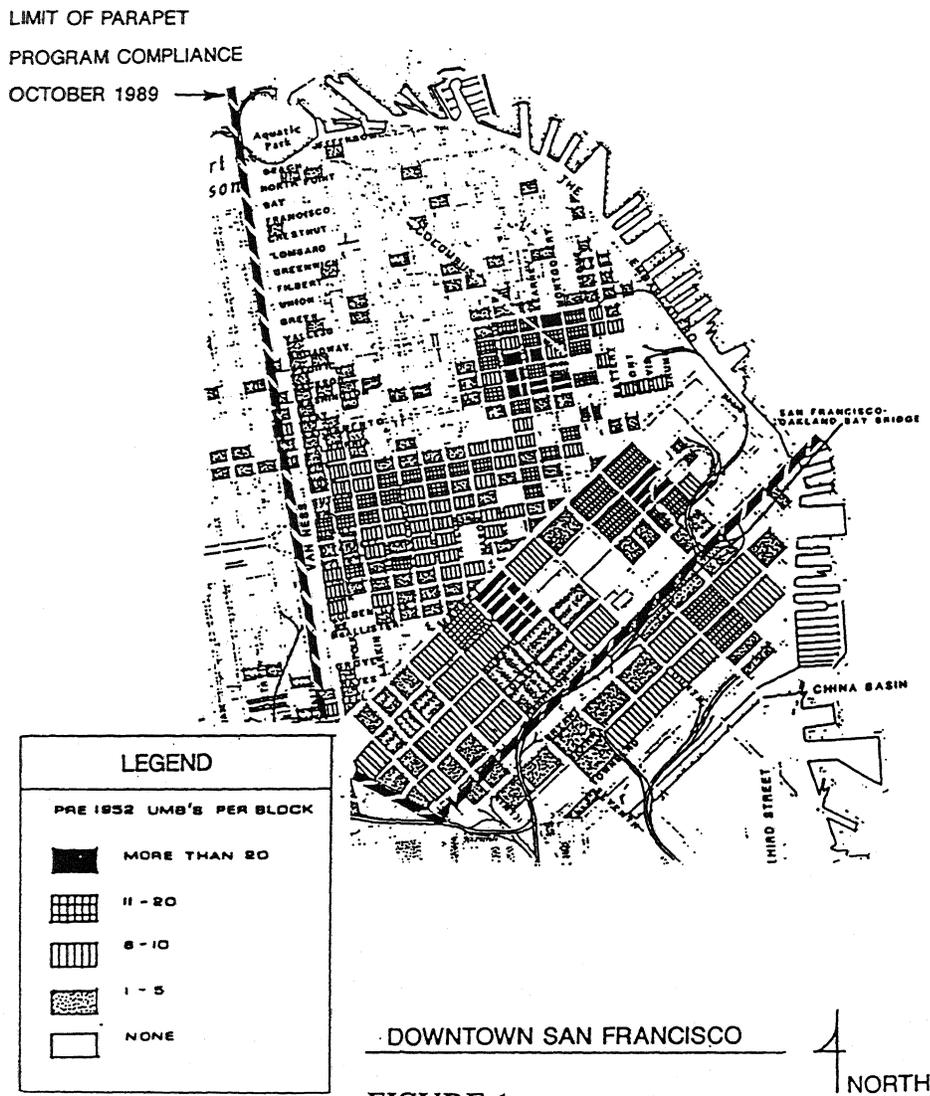
FIGURE 1

Figure 1 shows the a map of the downtown area of San Francisco in which most of the City's UMBs are located. Also outlined on the map is the zone in which the Parapet Safety Program had generally been enforced at the time of the earthquake. The buildings are located on sites ranging in soil quality from rock to bay mud. Figure 1 indicates that most of buildings are located within the area of the city that was in compliance with the parapet safety program at the time of the earthquake. However, because the program is limited in general to parapets that can fall onto streets, sidewalks or occupied spaces, and because City and State owned buildings have generally not been included

in the program, there were actually more UMBs subject to parapet (and upper wall) collapse than would be apparent from the map.
