# Dynamic behaviors of an earthquake-damaged viaduct before and after being mended

**ABSTRACT:** In Japan, Mizufuka first railway bridge, which is consisted of six single-story Gerber-type RC rigid frame viaducts, was heavily damaged by the Chibaken-Toho-Oki Earthquake having a magnitude of 6.7. The site, where this bridge is located, is steeply varied in the depth of bearing layer, and situated about 80 km away from the epicenter. A major damage to the viaducts was diagonal cracks that occurred in the upper part of the columns. The damaged viaducts were retrofitted by injection of epoxy resin into small cracks and making shear walls between columns transversely. Microtremor and earthquake observation were carried out in the states before and after the mend. The predominant frequency of the mended viaducts is higher than that of the damaged ones, and besides the response of the predominant frequency becomes dull. It is found that the shear strengths of the mended viaducts have increased.

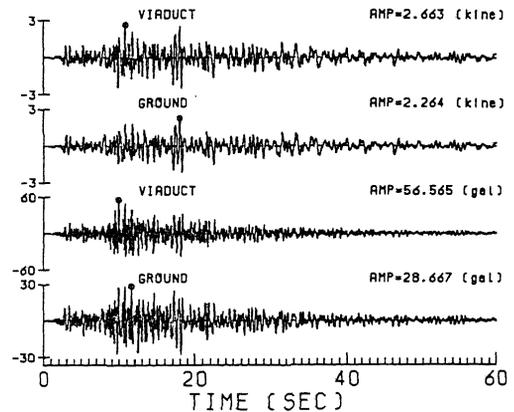
Figure 8. Recorded velocity and Acceleration time histories on the viaduct No.3 and the ground during event No.6 earthquake.

Figure 8 shows the time histories for the two velocities and acceleration time histories in the transverse direction of the mended viaduct No.3 and the ground under the viaduct recorded event No.6. The record event shows the peak velocities and acceleration 1.5 times to the ground in the transverse direc-

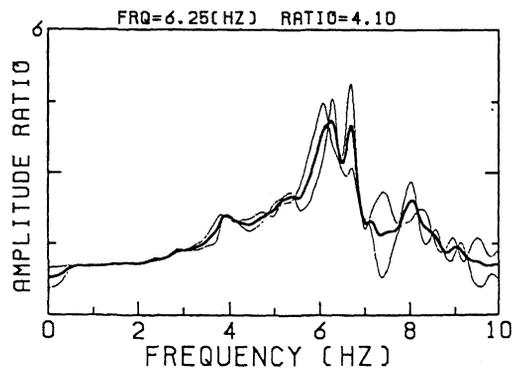
Figure 9. Transfer function between viaduct and ground in the transverse direction of viaduct No.2 due to two earthquakes event No.5 and No.6.

Figure 9 shows a mean value of two transfer functions of the velocity time histories between the ground and the viaduct in the transverse direction to the viaduct for the viaduct No.3 derived from the recorded event NO.5 and No.6 earthquakes. It is clearly seen that the predominant frequency of the transverse direction of the mended viaduct No.3 is approximately 6.0 Hz. This predominant frequency obtained from earthquake is in good agreement with that of microtremor.
