THE AMPLITUDE DEPENDENT DYNAMIC CHARACTERISTICS OF AN EXISTING BUILDING BEFORE AND AFTER SEISMIC RETROFIT

Masato MOTOSAKA¹, Takeshi SATO², Yuu YAMAMOTO³

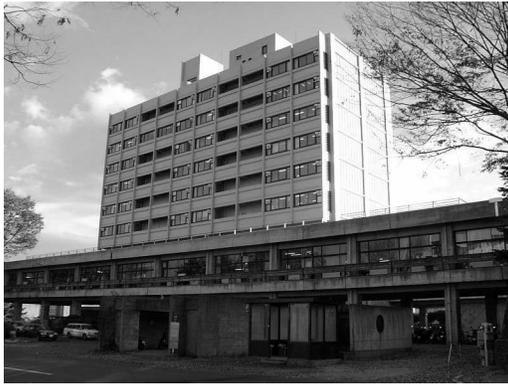
Photo 1 Overall view of the building from the north-west direction

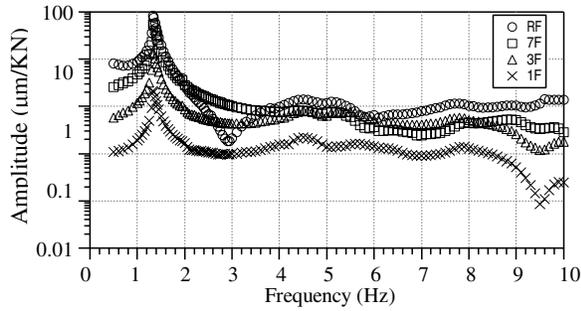
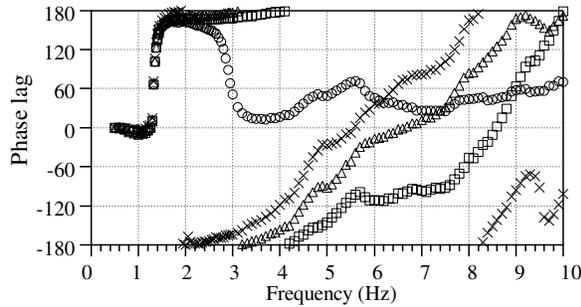
Fig.7 Resonance and phase lag curves for TR excitation

Fig.7 shows the resonance and the phase lag curves at the center of 4 floors for TR excitation of the test before the retrofit work. Fig.8 shows the comparison of the resonance curves for the tests before and after the retrofit work. Fig.8(a) is the resonance curves at the center of the roof slab for LN direction and Fig.8(b) is for the TR direction. The vertical axis shows the amplitudes for the unit excitation force, 1tonf. It is recognized that the resonant frequency becomes higher and the amplitude become smaller due to the strengthening in the both excitation directions. In the LN excitation, fundamental frequency changed from 1.40 Hz to 1.725Hz. The corresponding resonance modes are shown in Figs.9 (a) and (b) for the two tests. It is recognized that the torsional component is relatively large as shown in Fig.9(a) but becomes fairly small in Fig.9(b) due to the retrofit, installing the steel braces to depress the torsional motion. In the TR excitation the fundamental frequency changed from 1.325 Hz to 1.65 Hz. Note that the fundamental frequency for the LN excitation was 2.1 Hz just after the completion of the building, and 2.0 Hz for the TR excitation.

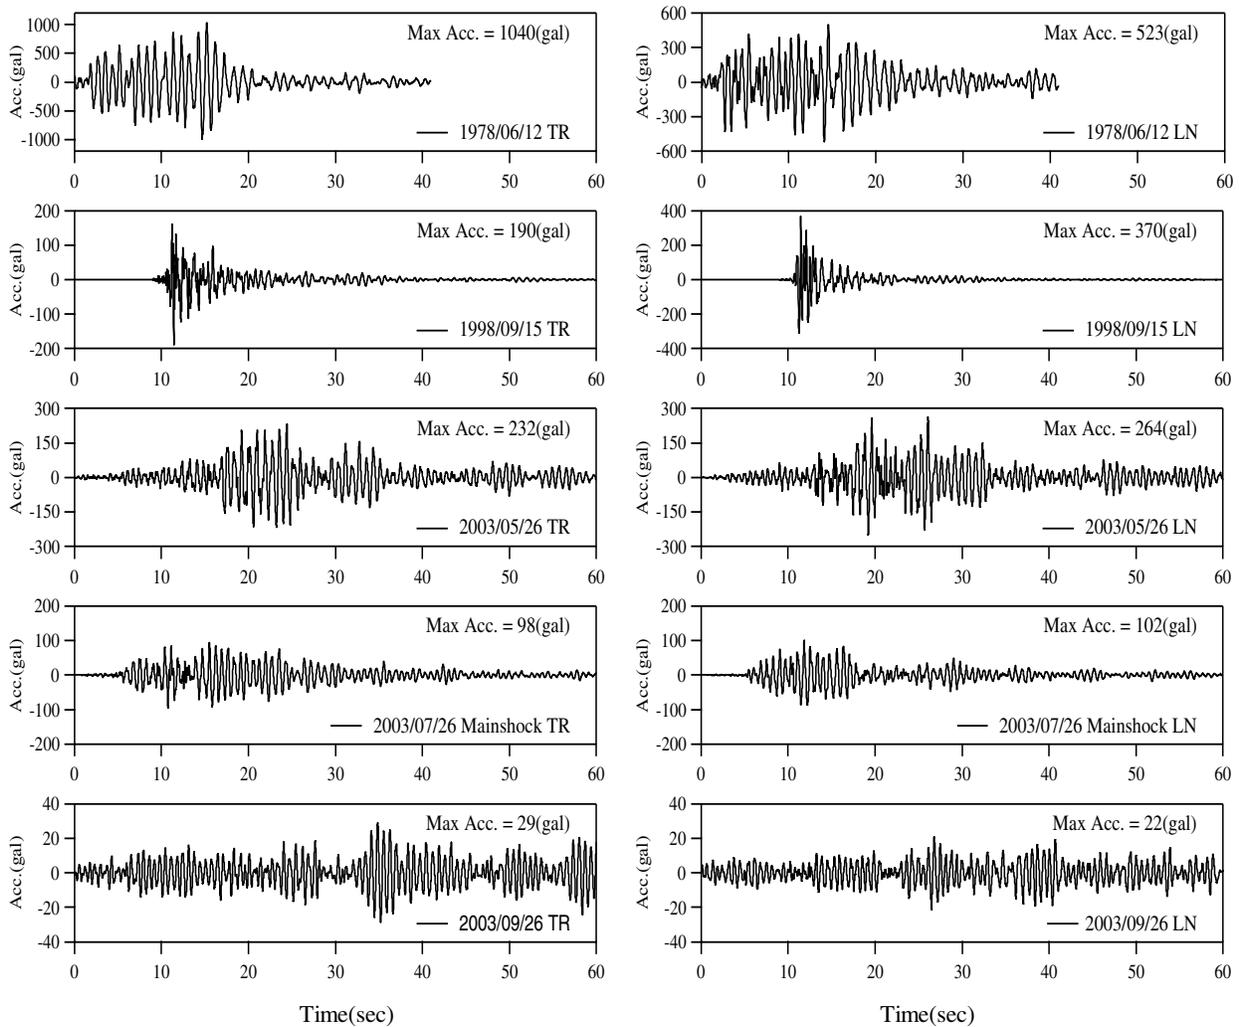
Fig.14 Some of the earthquake observation records obtained at the building

Earthquake observation records obtained at the building are shown in Fig.14 for some of the major records. The observation records for the 1970/9/12 earthquake, the 1978/2/20 earthquake as well as those for the 1978/6/12 earthquake are used for investigating the dynamic characteristics of the building in Term-1 (since completion until the 1978/6/12 Miyagi-ken Oki earthquake). The investigated records for Term-2 (after 1978 Miyagi-ken Oki earthquake but before retrofit work) are those for 10 earthquakes. The observation records were obtained for the 1998/9/15 Miyagi-ken Nanbu earthquake, a shallow inland earthquake. Those observations for Term-3 (after the retrofit work up to date) are about 50. After the retrofit work, the observation records were obtained for the 2003/5/26 Miyagi-ken Oki earthquake, the 2003/7/26 Northern Miyagi earthquake, and the 2003/9/26 Tokachi Oki earthquake.
