SEISMIC BEHAVIOR STUDY OF LIFELINES IN THE OCCIDENTAL **REGION OF MEXICO**

SUMMARY

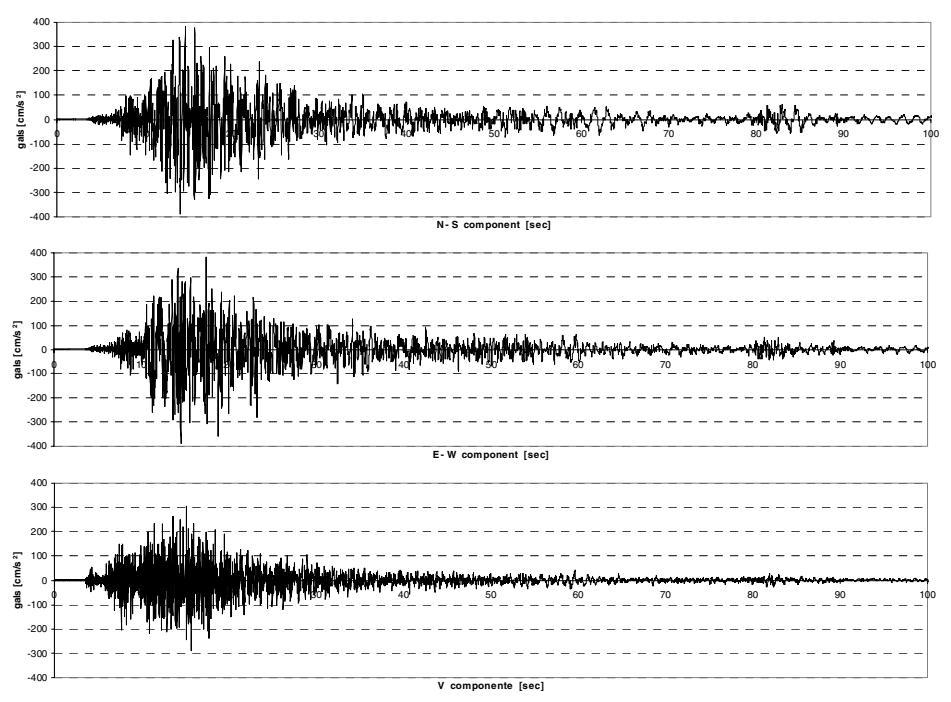
Probably the most severe earthquake thus far registered is the one of October 1995. The maximum accelerations registered were 0.394 g (N-S direction) and 0.395 g (E-W direction) and 0.309 g (vertical direction). The duration of the earthquake was of some 150 sec. Figure 13 shows the first 100 sec. The destructive power of this earthquake was evidenced by the damage inflicted in the region, especially in the Manzanillo Power Station, which included substation equipment failures, damage to the intake, liquefaction affecting turbogenerator pedestals and other foundations, as well as severe damage to secondary structures in the plant. The January 2003 earthquake had a duration of 90 sec, and the maximum accelerations were registered by the same accelerograph in the Manzanillo Power Station as 0.378 g (N-S), 0.266 g (E-W) and 0.192 g (vertical) as shown in Figure 14.

Figure 13. Acceleration components during the 1995 Manzanillo earthquake.

A comparison of these records shows that although the maximum accelerations registered for both events were almost the same, the other two components of the acceleration were substantially larger for the 1995 earthquake. With a larger energy liberated (8.0 vs 7.6 magnitudes) and a longer duration of the movement, this earthquake had a much larger destruction power.

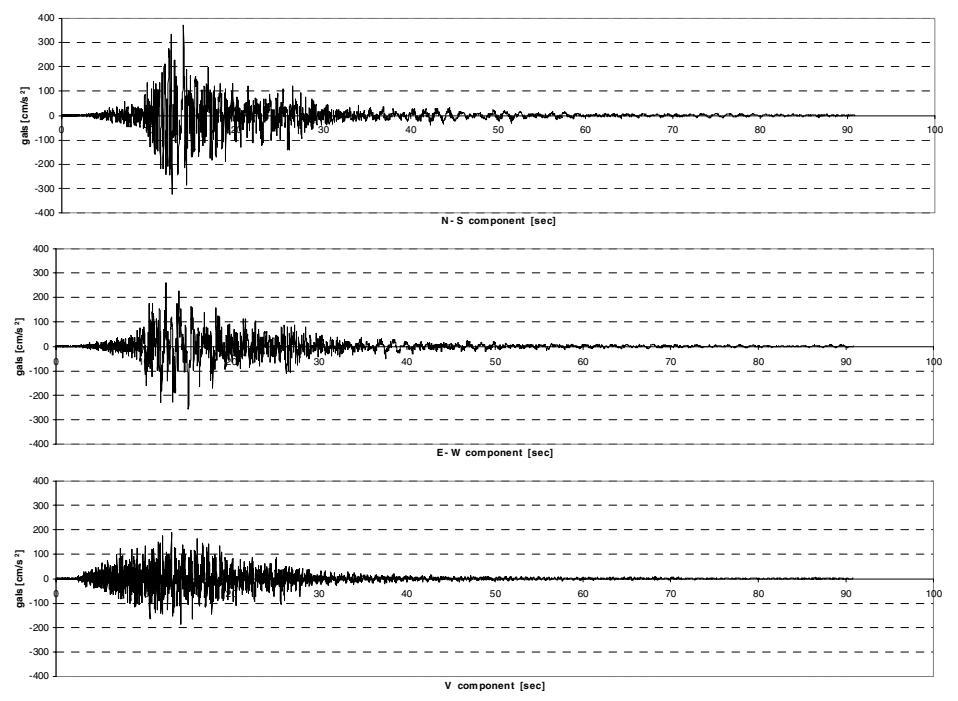
Figure 14. Acceleration components during the 2003 Tecoman earthquake.

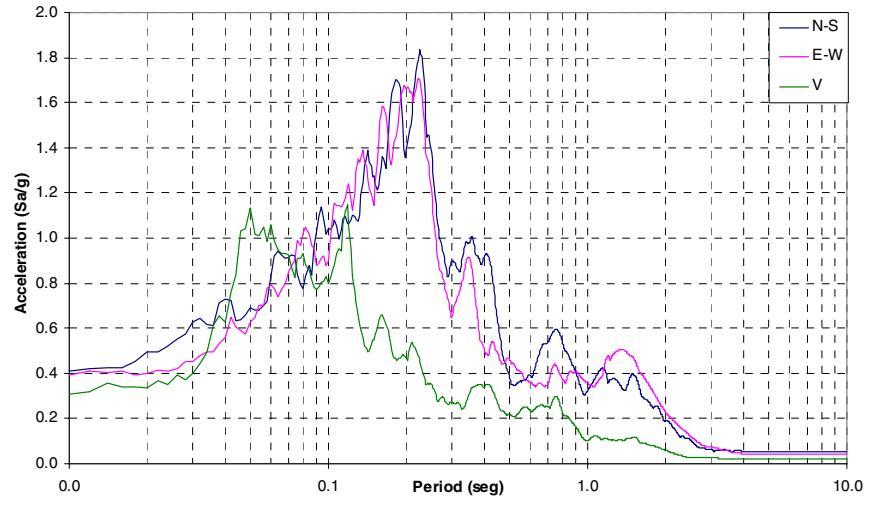
Furthermore, response spectra for both earthquakes were obtained. In Figure 15, response spectra for the 1995 event for 5% damping and for soft soil are shown. Maximum values of 1.83 g (N-S), 1.68 g (E-W) and 1.15 g (vertical) of spectral ordinates were obtained, corresponding to periods of 0.23 s, 0.23 s and 0.12 s, respectively. Figure 16 shows the response spectra for the 2003 earthquake, also for a damping factor of 5%. In this case the maximum values calculated are 1.52 g (N-S), 0.85 g (E-W) and 0.67 g (vertical), for periods of 0.13, 0.15 and 0.05 respectively. A comparison between Figures 15 and 16 shows that although there are significant differences between response spectra from both earthquakes, maximum values occur for periods between 0.1 g and 0.3 g, where substation equipment is vulnerable.

Figure 15. Site response spectra (5% damping) for the 1995 Manzanillo earthquake

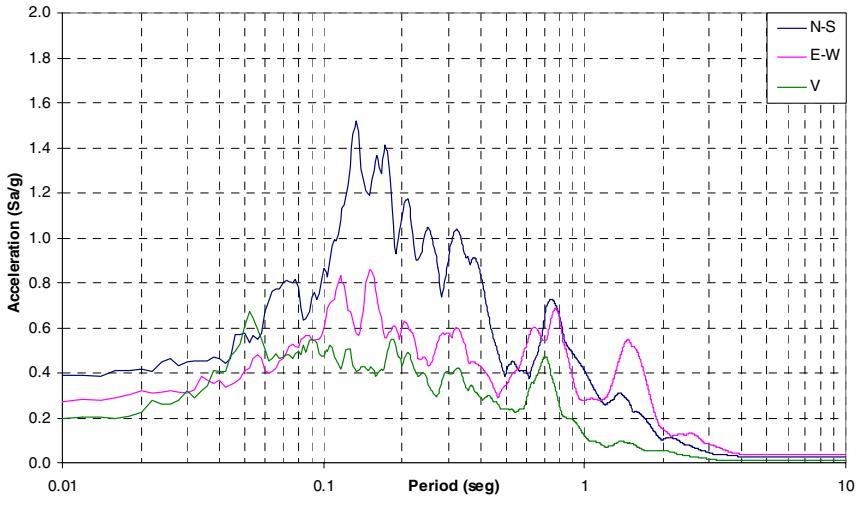
Figure 16. Site response spectra (5% damping) for the 2003 Tecoman earthquake.
