**AN EXPERIMENTAL STUDY ON THE COLLAPSING PROCESS OF
WOOD CONVENTIONAL HOUSES
-SHAKING TABLE TESTS OF REAL-SIZE MODELS-**

Mikio KOSHIHARA¹, Hiroshi ISODA², Chikahiro MINOWA³ and Isao SAKAMOTO⁴

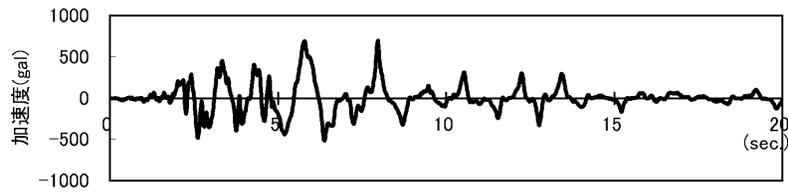
(1) Acceleration of Shaking Table

Fig.2 Damage of Test Houses

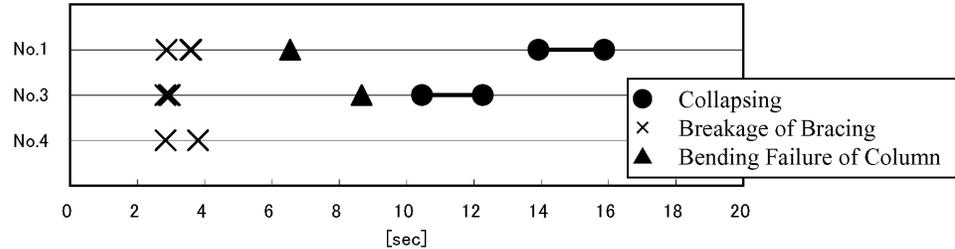
(2) Damage of Houses

Fig. 2 (2) shows the collapse start time and collapse complete time of each test with black circle (●). The collapse start time is defined as the time at which the deformation starts to go one direction regardless of movement of the shaking table. The collapse complete time is defined as the time at which the roof came in contact with the ground. For both No. 1 and No. 3, it took approximately two seconds from the start of collapse to the completion of collapse, and slowly collapsing process of wooden houses was observed.

The mark X in Fig. 2 (2) shows the time at which buckling and falling off occurred on three bracings (at the first story) located in the X direction. Eventually, all bracings of test houses lost its function because of falling or buckling. The figure shows that damages of all the bracings at the first story occurred near the first peak displacement (2.7 to 4.0 sec.) of input motion.

The mark, black triangle (▲), in Fig. 2 (2) shows the time at which the bending failure of intermediate column occurred at the upper portion, i.e., at the level of the bottom of the beam. It is considered that the bending failure of column head occurred near the time when the relative story displacement at the first story shown in Fig.2(3) exceeded 500mm (1/5.9 rad.). The through columns at the four corners did not break until collapse occurred.

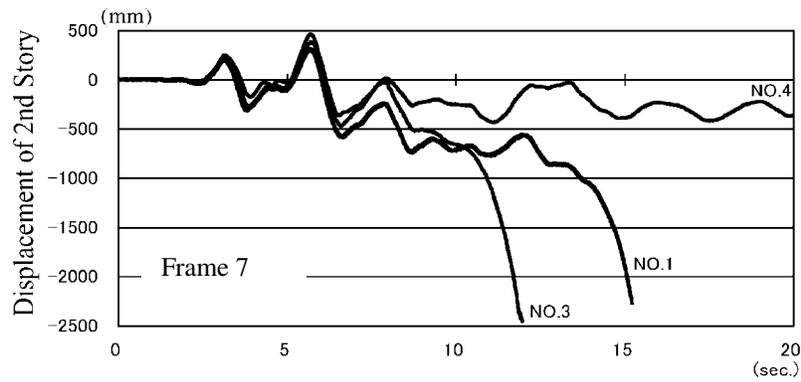
(3) Relative Story Displacement (Frame 7)

Fig. 2(3) shows the time histories of the relative story displacement in the X direction at the first story of collapsed houses (No.1 and No.3) and a not-collapsed house (No.4). Both houses show similar displacement history on the frame 1 and frame 7 until approximately six seconds. But they show different behavior on the frame 7 after the peak of 6.7 seconds. Although the displacement returned after that, the house No.3 did not return completely to the positive direction before the next peak. The deformation just before this is 500 mm (1/5.8 rad.).

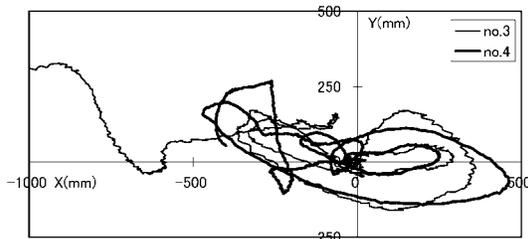
Fig.3 Trace of the 2nd Floor

The trace of the second floor is shown in Fig.3. The trace of the test house No.4 differs from that of the test house No.3 and the maximum displacement on the positive side is larger in No.4 than in No.3. Concerning the deformation on the negative side, the deformation in the Y direction toward the positive side is larger in No.4 than in No.3.
