SEISMIC VULNERABILITY OF SCHOOL BUILDINGS IN LIMA, PERU

Jorge MENESES-LOJA¹ and Zenón AGUILAR²

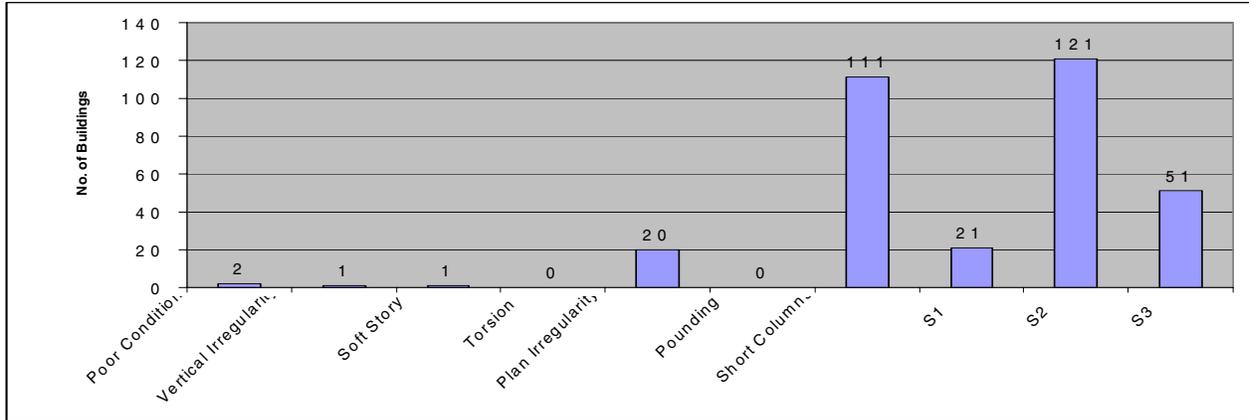
Fig. 11 Frequency of performance modification factors for C3 buildings

Figure 11 summarizes the findings of the visual assessment. Short columns, poor soil condition and plan irregularity are the most frequent features that adversely affect an acceptable seismic performance.

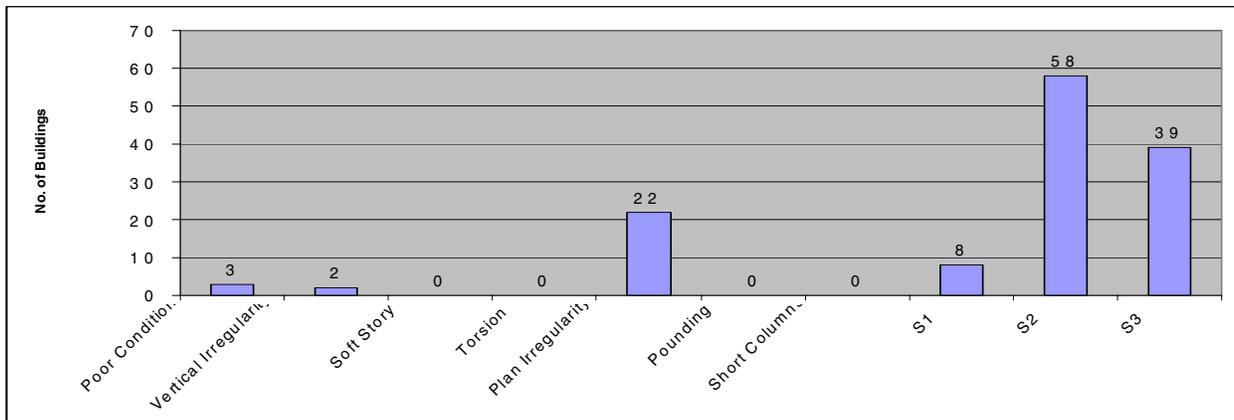
Fig. 13 Frequency of performance modification factors for CM buildings

Figure 13 condenses the results of the visual assessment. Poor soil conditions and plan irregularity are the most common features harming an acceptable seismic behavior.
