13th World Conference on Earthquake Engineering
Vancouver, B.C., Canada
August 1-6, 2004
Paper No. 2644

AN EXAMINATION OF DAMAGES OF REINFORCED CONCRETE CONSOLED BUILDINGS IN TURKEY DUE TO 17 AUGUST 1999 KOCAELI EARTHQUAKE

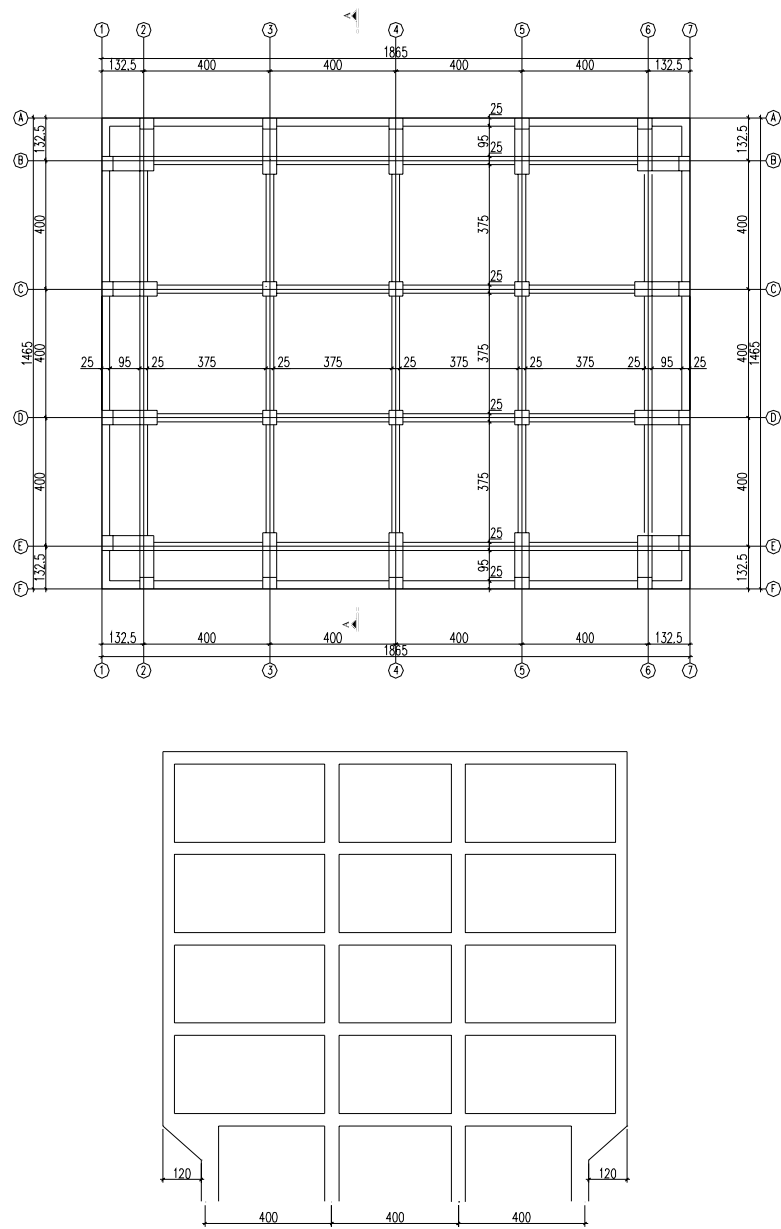
The building analyzed is a five-story reinforced concrete structure consisting of an orthogonal frame system [6]. The layout of the ground floor and the elevation of the building are shown in Figure 6. As it is shown in the plan and elevation of the building, the axes of the columns around the periphery of the building do not coincide with each other on the ground and first floors. The columns on the corner and on the perimeter in plan of these two floors are connected with corbels, which makes the structural system vertically irregular one. However, the inner columns of the building are continuous from the ground floor to the top floor. The story heights are *3.00m* and the slab thickness is *0.12m*. The cross section of the frame beams is *0.25m/0.60m* and the columns are *0.45m×0.45m* and *0.45m×0.55m* (ground floor), *0.45m×0.45m* and *0.35m×0.45m* (*1.st 2.nd* and *3.th* floors), *0.30m×0.30m* (*4.th* floor). The corbels have a height of *0.40m* and *1.50m* at the tip and at the connection points to column, respectively. The static and dynamic numerical analysis is carried out by using the SAP 2000 package and assuming linear elastic behavior. For the structural system, the modulus of elasticity is considered as $28 \times 10^6 \text{ kN/m}^2$. The structural system of the building is considered as space frames having shell elements representing floors. The columns are assumed to be fixed at base. Additionally, a separate analysis is done by assuming the elastic support at the base. In the case of elastic support the columns are assumed to be supported by square footings on the elastic springs representing the soil. A summary of the results of the analysis is presented below:

Figure 6 (a) Structural layout and (b) elevation of a building of five stories
