## **SPATIAL DISTRIBUTION OF PIPELINE DAMAGE IN DÜZCE CAUSED BY THE 1999 KOCAELI AND DÜZCE EARTHQUAKES**

**Iain TROMANS<sup>1</sup>, David MARLOW<sup>2</sup>, Julian BOMMER<sup>3</sup>**

### **SUMMARY**

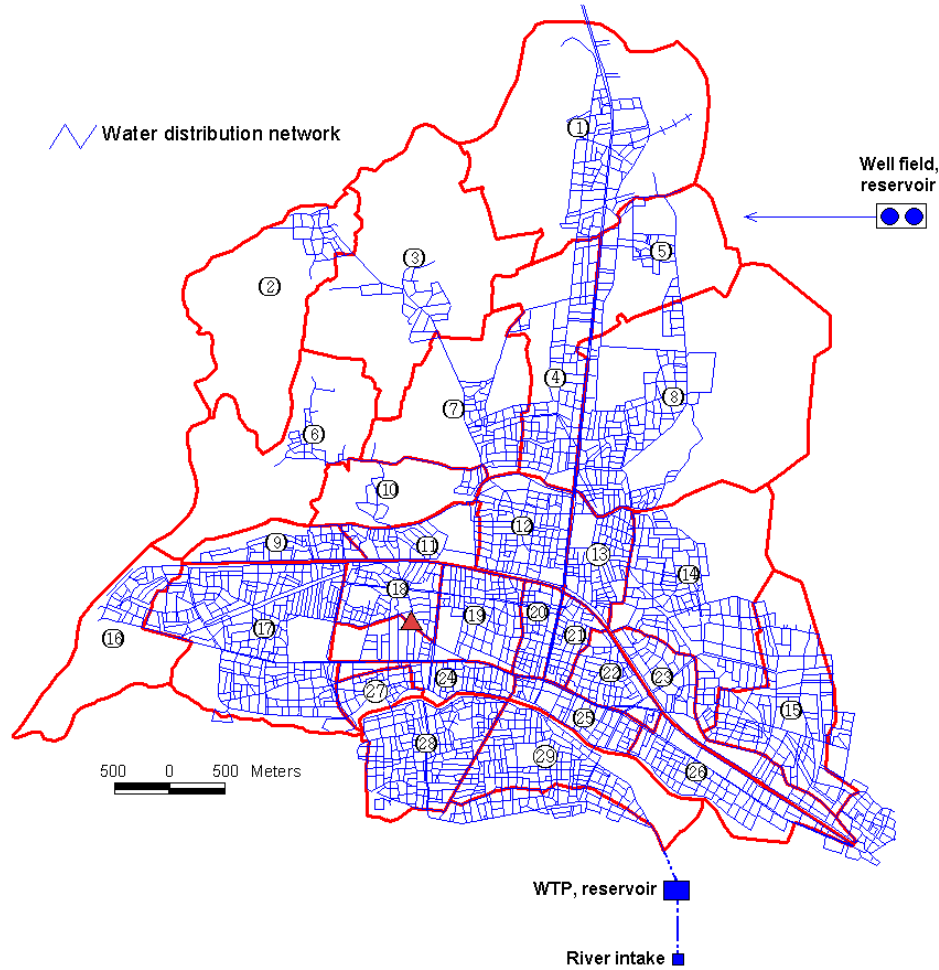
The full digitised network is illustrated in Figure 2. No distinction is made between different pipe materials or diameters as this information was not systematically available. However, it is known that most of the new network consists of PVC pipes with diameters between 100 and 200 mm. The old network is mainly CI (cast iron), with some AC (asbestos cement) pipes. A 600 mm diameter AC pipe conveys raw water from the main source, the River Ugur, to the water treatment plant which lies to the south of the town. A 1m diameter steel pipe then carries the treated water to the distribution network, joining the town in the Azmimilli District (district ID 29). Twin CI pipes, of diameter 125 mm, transport water from a well-field and reservoir to supplement the main river water supply; these pipes join the town in the north-east. Both main water sources are illustrated in Figure 2, although the precise connection point of the 125 mm CI pipes to the distribution network is not known.

**Figure 2 Düzce's water supply system, digitised from the 1:2000 scale maps of the Bank of the Provinces. District IDs are specified in Table 1. The red triangle shows the location of the DZC strong-motion station.**

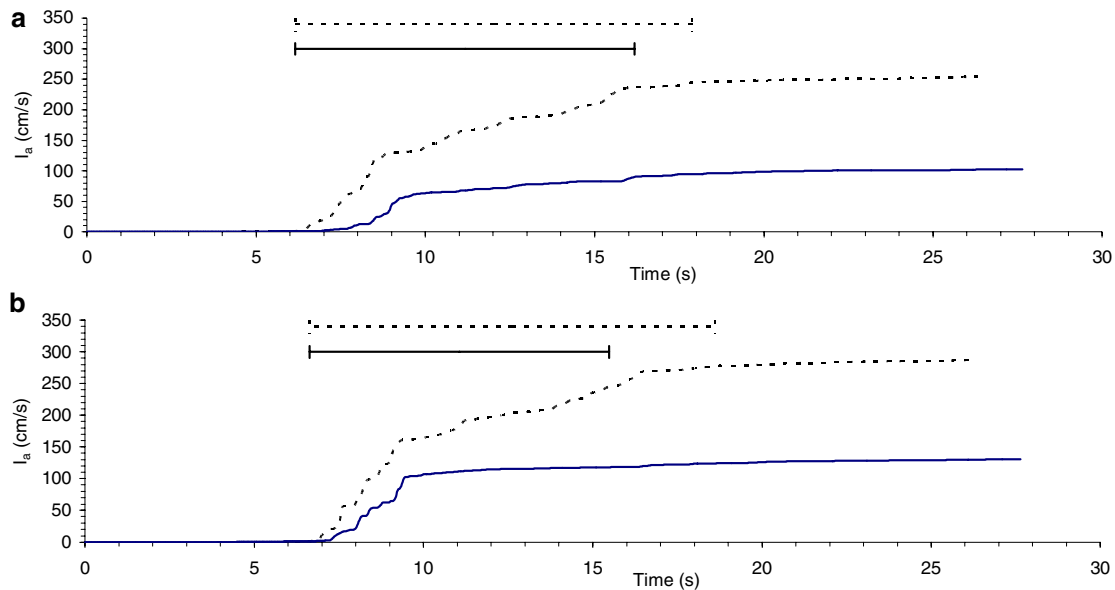
**Figure 5 Comparison between Husid plots for accelerograms recorded at DZC strong-motion station during the Kocaeli and Düzce earthquakes. Figure (a) shows NS components for both earthquakes. Figure (b) shows EW components for both earthquakes. Data from the Kocaeli earthquake is indicated with a solid line; data from the Düzce earthquake is indicated with a dashed line. For each Husid plot, the effective duration (Bommer [15]) is indicated.**

The rate of arrival of energy at DZC, as indicated by the gradient of the Husid plot, was also much higher during the Düzce earthquake, again indicating greater damage potential. Finally, longer duration of ground shaking during the Düzce earthquake (as indicated in Figure 5) is another factor likely to have contributed to greater damage levels. Energy-equivalent velocity spectra presented by Sucuoglu [16] also support the assertion that strong motion during the Düzce earthquake caused greater damage in Düzce than strong motion during the Kocaeli earthquake.

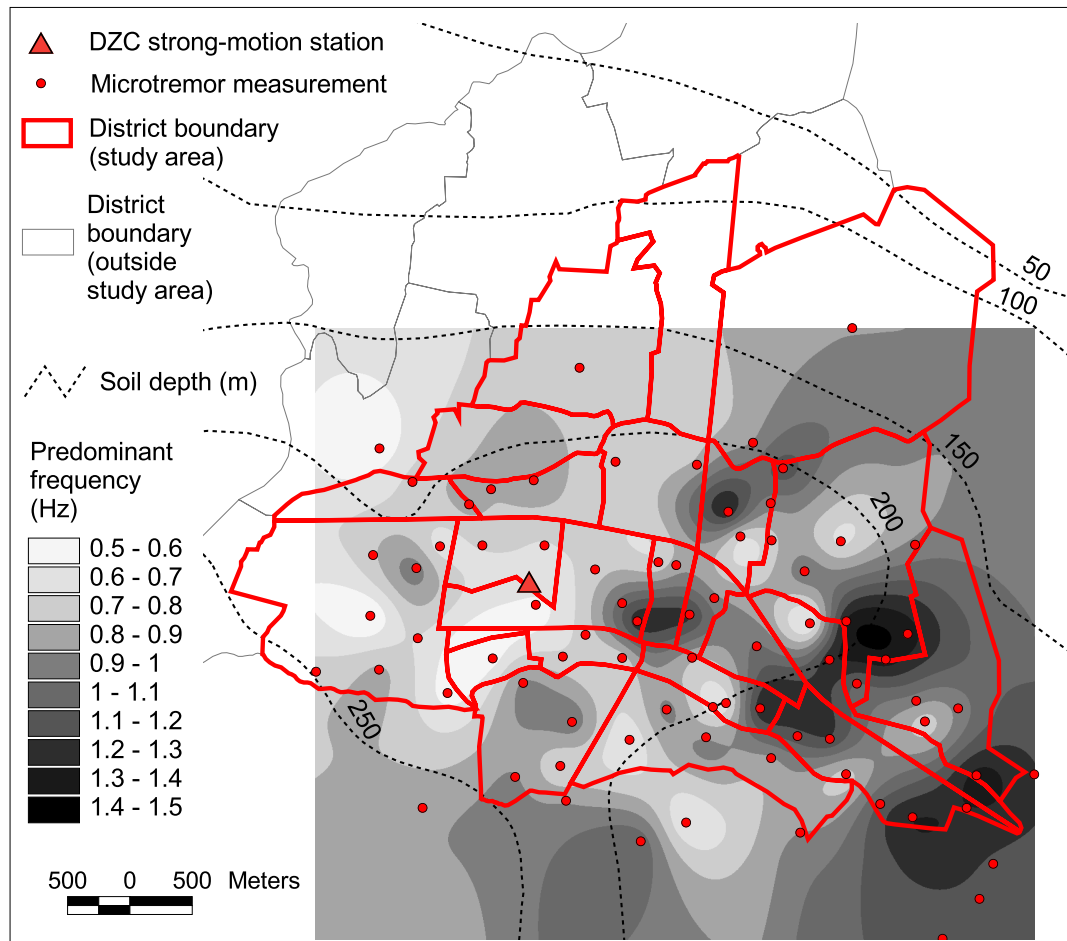
Figure 6 Contours of predominant frequency,  $f_p$  (Hz).

In order to help identify spatial trends in the  $f_p$  dataset, a parameter surface was defined extending over the whole study area. Interpolation between measurement locations was carried out within the GIS environment using the ArcView 3D Analyst Extension. A tension spline interpolation algorithm (based on a 5 m grid spacing, a weighting parameter of 20 and a fit to the nearest 6 grid points) was judged to give the best results, which are presented in Figure 6.

Contours of soil depth (surface-to-bedrock) have been superimposed on Figure 6. This information is from a geophysical investigation carried out by the Turkish General Directorate of Mineral Research and Exploration and Ankara University (MTA/AU [21]), as presented in Aydan [22]. There appears to be a general trend of increasing  $f_p$  from the western and central parts of the town towards the east and northeast. This observation is interpreted as the influence of soil depth on the ground response since a reduction in soil depth is generally expected to lead to an increase in  $f_p$ .
