BUILDING DAMAGE PATTERNS IN BINGOL-TURKEY AFTER THE MAY 1ST, 2003 EARTHQUAKE

Ahmet TURER¹, Ahmet YAKUT², Ugurhan AKYUZ³

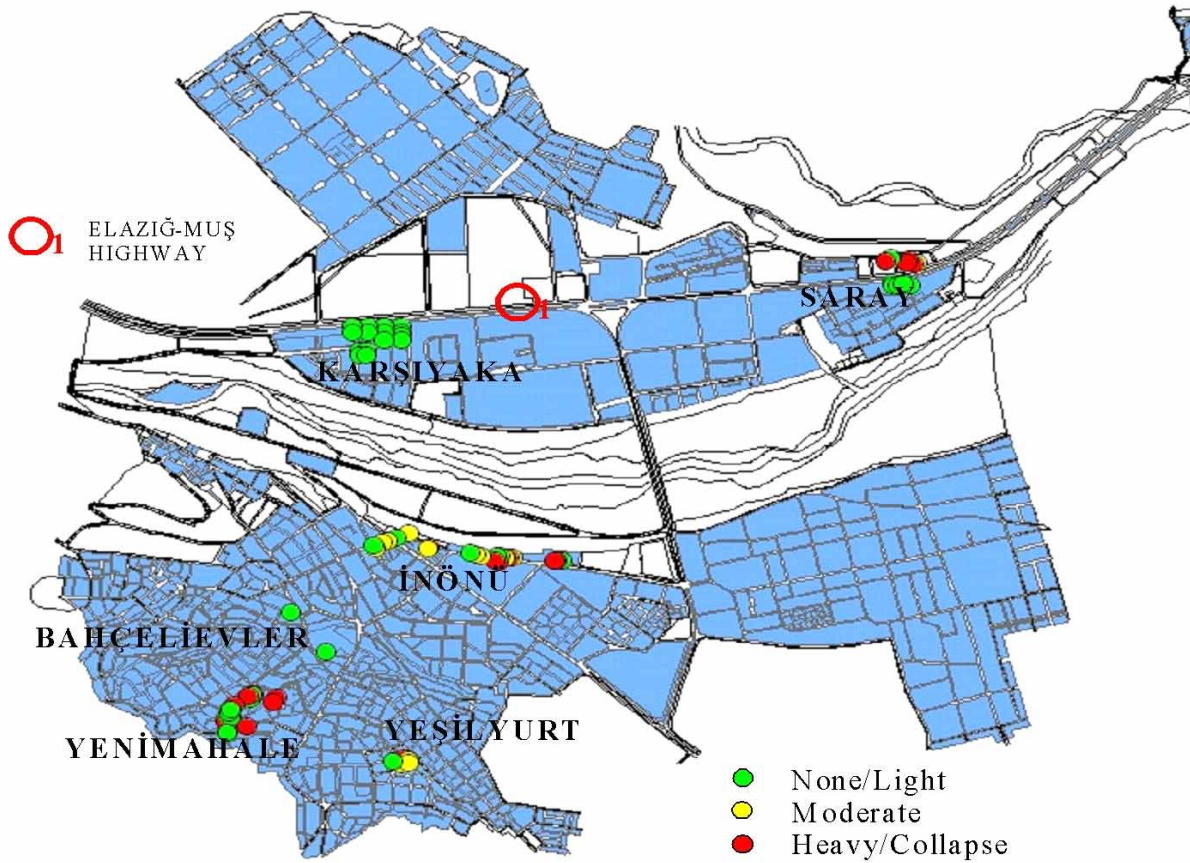
Among a large reinforced concrete building stock existed in Bingol area, a total of 57 residential buildings are randomly selected from major districts of the city. A group of adjacent buildings are investigated to capture a snapshot of the damage distribution in each one of the selected vicinities. Each building was assigned a damage degree based on the criteria mentioned earlier, and a quality classification of the materials was made by visual inspection whenever possible. Three levels of material quality were employed; poor, average and good. Nineteen buildings were judged heavily damaged/collapsed, 14 were assigned moderate damage and the remaining 24 were identified as either undamaged or lightly damaged. An overall summary that contains observed damage, structural system, number of floors, and apparent material quality of the surveyed residential R/C buildings is presented in Table 2. The geographic distribution of building locations and pertinent damage index values are shown in Figure 1.

Figure 1 Observed damage distribution plot on Bingol map

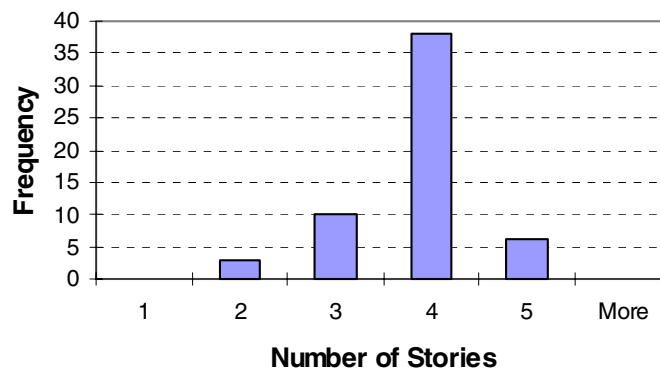
The majority of buildings surveyed comprised of four story reinforced concrete frame buildings as shown in Figure 2. The damage distribution among each building group shows that heavy damage percentage is the highest for 4 story buildings (Figure 3). The relationship between the damage level and material quality is also illustrated in Figure 4. Although a rough trend between damage and material quality is evident, the lack of quality assessment for the buildings that had collapsed or had no damage prevents us from making a general conclusion. Year of construction versus damage level assessment showed no direct relationship.

Figure 2 Distribution of buildings according to height

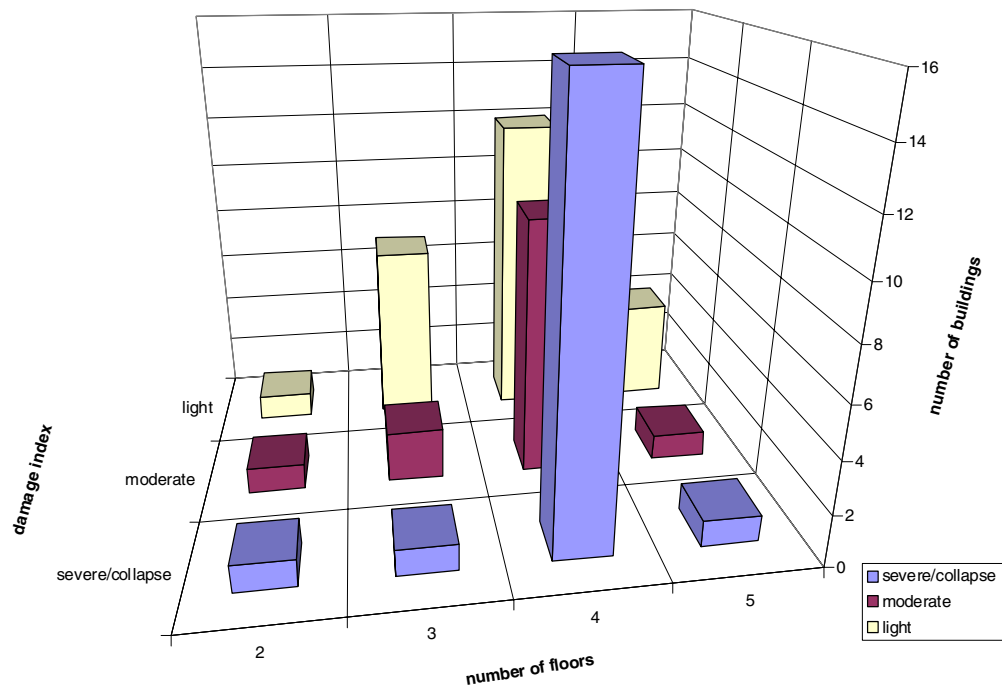
Figure 3 Observed damage versus number of floors matrix

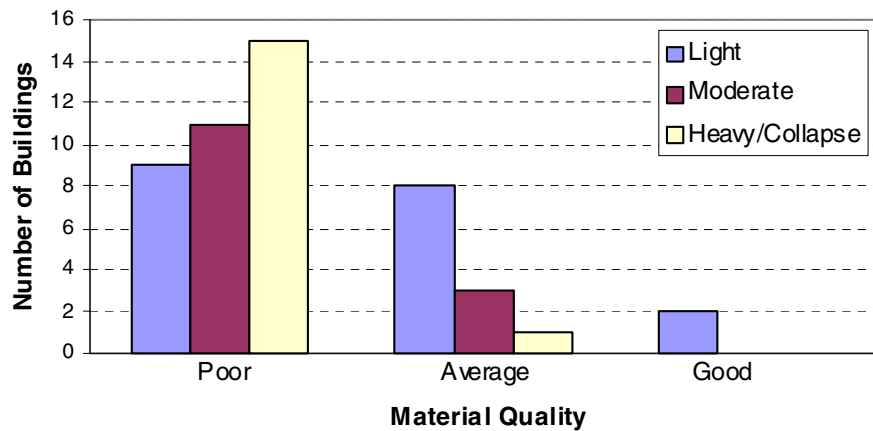
Figure 4 Observed damage versus material quality
