## SEISMIC PERFORMANCE OF ELECTRICAL SUBSTATIONS' EQUIPMENTS IN IRAN'S RECENT EARTHQUAKES

### ABSTRACT:

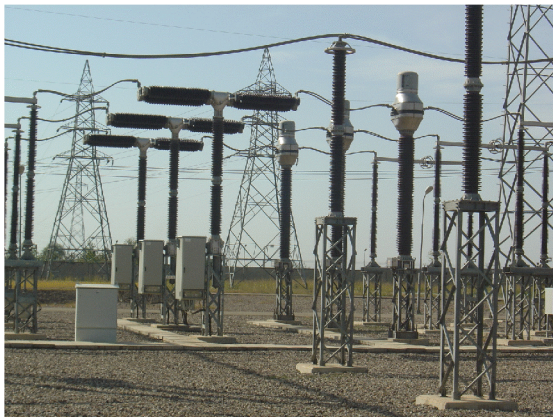
Figure 16: Equipments in Ali Abad substation

The safe equipments of this substation are shown in figure 16. Another 230 kV substation in the affected area was Gorgan substation. Due to the small amount of PGA all the equipments in this station were safe and no damages were reported. Figure 17 shows the equipments of this substation.
