A COMPARATIVE SEISMIC PERFORMANCE ASSESSMENT AND REHABILITATION OF EXISTING SCHOOL BUILDINGS

A. Yakut¹, Y. Tonguç² and P. Gülkan¹

ABSTRACT :

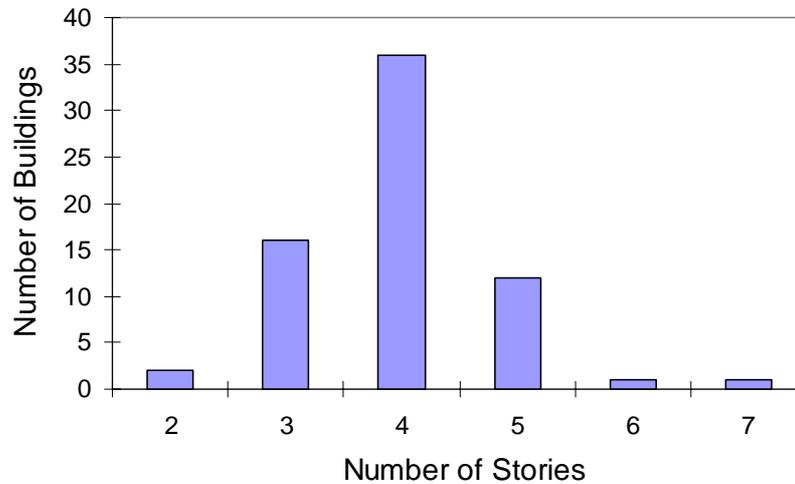
Figure 2 Distribution of number of stories

Sixty eight reinforced concrete school buildings were investigated in this study. Figure 2 presents building statistics with respect to the number of stories. Majority of buildings had 3-5 stories dominated by 4 stories. Fifty eight buildings were located in the second highest seismic zone of Turkey, the remaining ten being in the highest zone according to the current seismic zone map. As indicated earlier, at least three core samples per floor were taken to determine the building specific concrete compressive strength to be used in the assessment. Distribution of concrete compressive strength shown in Figure 3 reveals that the concrete compressive strength was generally between 8-16 MPa with an average value of approximately 11 MPa. It is worth noting that the current code requires a minimum of 20 MPa for the design of buildings. From visual inspection, it has been observed that generally plain bars having characteristic yield strength of nearly 200MPa were used.

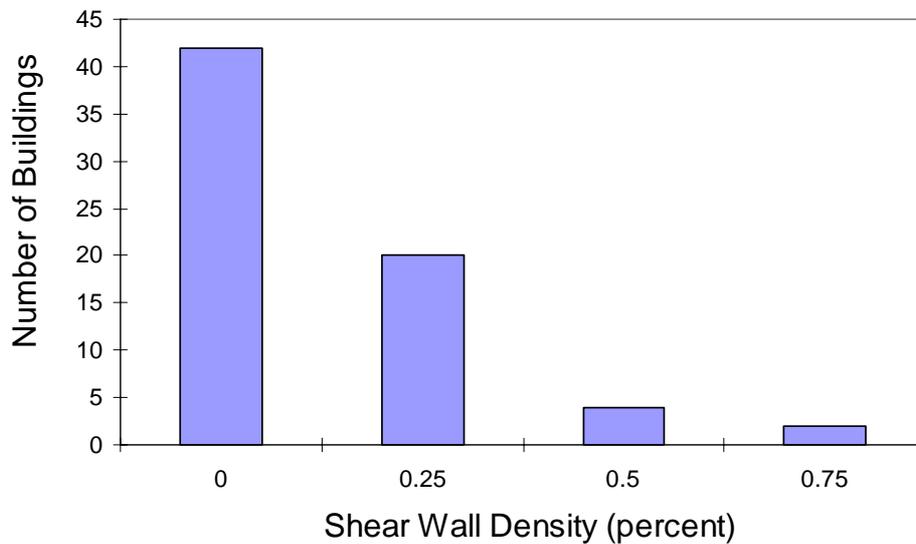
Figure 4 Shear wall density of the buildings

The structural system of all buildings studied was made of reinforced concrete with varying percentage of the column and shear wall area. Since the density of shear walls in a given principal direction is believed to have a prominent role in the seismic performance of the buildings (Gulkan and Sozen, 1999; Yakut, 2004), the histogram showing shear wall densities were obtained as presented in Figure 4. The shear wall densities obtained here represent the minimum value of the shear wall area divided by the total floor area above the ground floor level corresponding to the two principal directions of the building. It is not surprising to observe that most of the buildings have no shear walls.

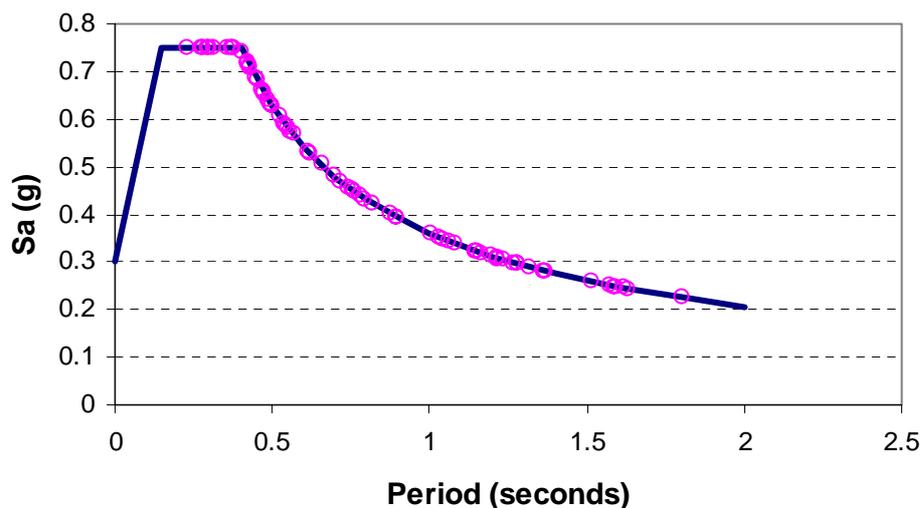
Figure 5 Response spectrum and periods of the buildings

The response spectrum given in the Turkish seismic code (TEC, 2007) corresponding to seismic zone 2 is shown in Figure 5 along with the predominant periods of the buildings evaluated. As evidenced in this figure, most of the buildings fall into the constant velocity region of the spectrum.
