PERFORMANCE OF MASONRY AND CONCRETE BUILDINGS DURING M7.8 GORKHA (NEPAL) EARTHQUAKE OF APRIL 25, 2015

D. C. Rai⁽¹⁾, V. Singhal⁽²⁾, S. Bhushan Raj⁽³⁾ and S. Lalit Sagar⁽⁴⁾

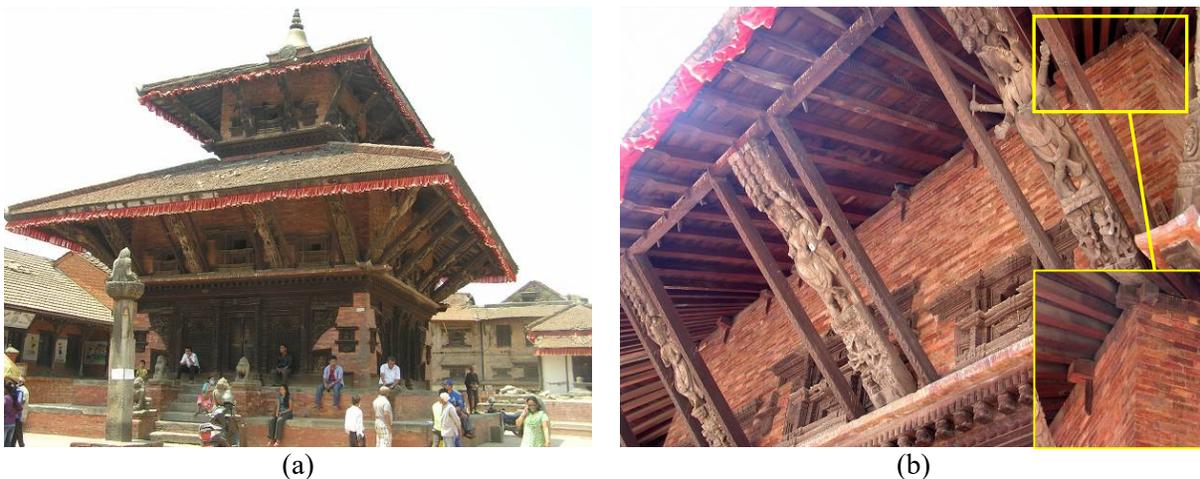
continuous timber bands at each storey levels. In addition, in the *dega* temples, wide timber bands were provided on the top of openings which act as lintels for carrying the loads from the upper storeys (Fig. 9a). The roof was connected to the walls by means of wooden pegs which enhance the box action of the building (Fig. 9b). The sloping/ overhanging timber roof was supported by aesthetically carved timber struts which also act as structural members enhancing the rigidity of the floor/roof (Fig. 9b). However, it seems that this knowledge of earthquake resistant features was somehow lost during the last few decades leading to the poor seismic performance of the URM buildings. The lack of earthquake resistant features in these masonry structures could also be due to high cost and non-availability of structural timber in Himalayan regions. The use of material other than timber, such as precast RC and steel members, for confining masonry should be investigated for wider application [15].

Fig. 9 – Good construction practice in URM buildings of Bhaktapur Durbar Square: (a) provision of wide timber bands over the top of openings, and (b) connection of floor/roof and walls using timber struts and wooden pegs
