## ANALYSIS OF THE SEISMIC PERFORMANCE OF A STRENGTHENED PAGODA TEMPLE DURING GORKHA EARTHQUAKE

### **Abstract**

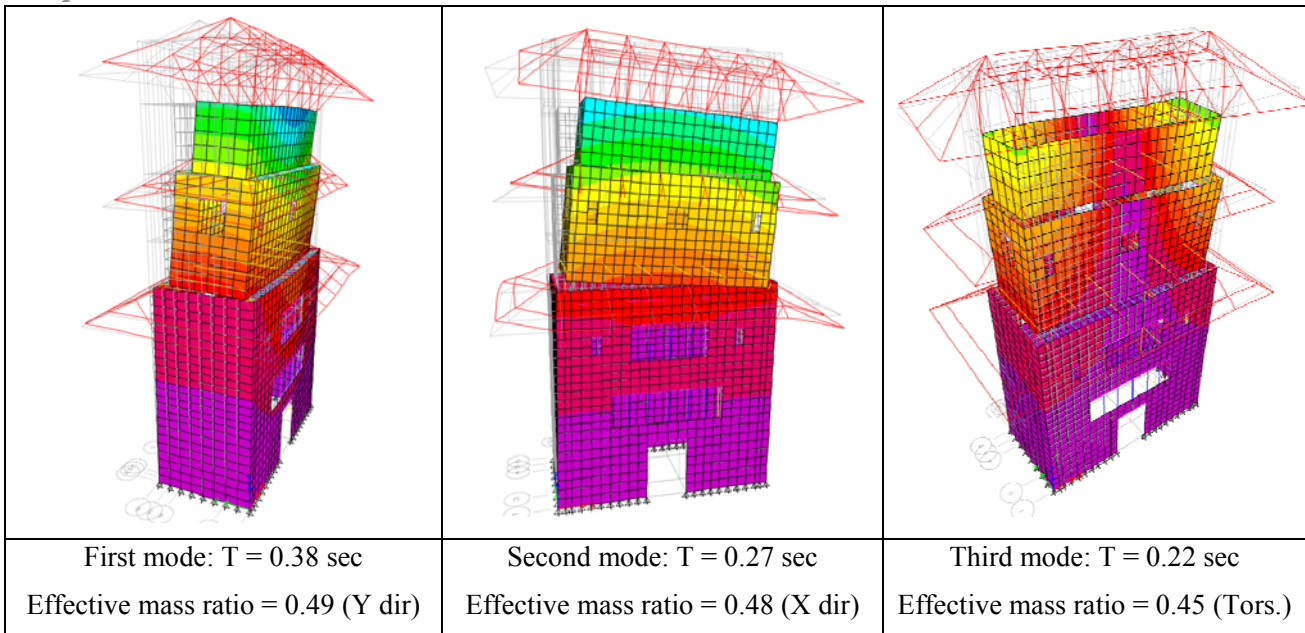
Fig. 8 – Modal analysis: mode shapes and frequencies.

The comparison between models with and without strengthening interventions shows that the variations in the natural frequencies are negligible. Wood bracing, indeed, does not modify the dynamic behavior of the temple, as mode shapes and frequencies are substantially determined by the wall mass and stiffness properties.

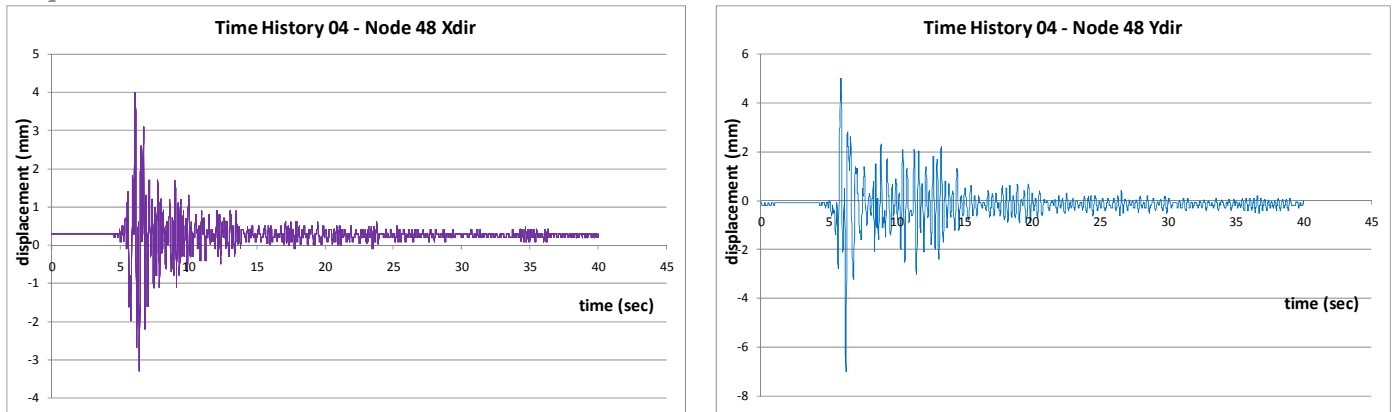
Fig. 10 – Displacements at the top of the building in the horizontal directions.

Stress distributions generated by the 2015 earthquake (see Fig. 9) can be compared to the working stress values proposed by Shakya for brick masonry [15]. Maximum compression stresses (S22) are much higher than the limit values, but are located at corners of walls and openings, while at other locations maximum values are less than 1.0 MPa. Maximum horizontal displacements are 4.0 mm in the X direction and 6.9 mm in the Y direction at the top of upper walls.

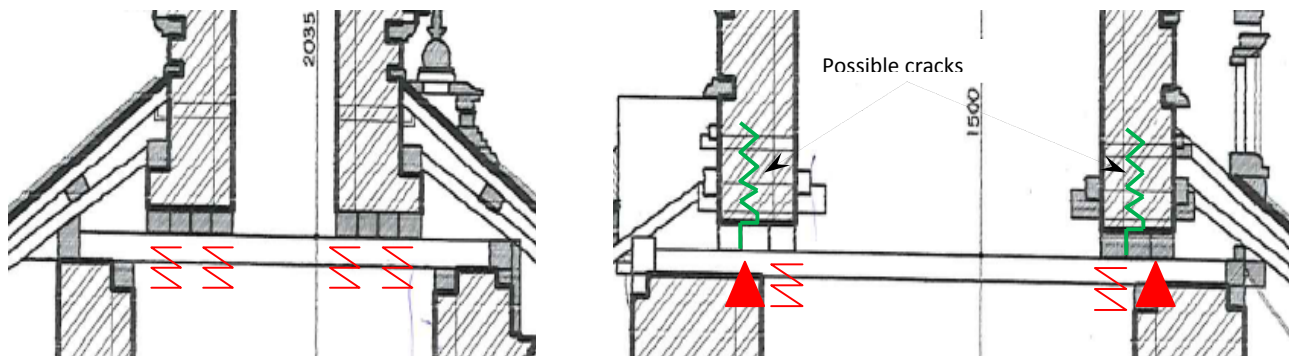
After identifying typical structural details, the analysis of limit equilibrium conditions for specific structural components could be meaningfully applied also to Nepalese pagoda temples. In this case, a major problem is clearly related to misaligned walls, supported by elements with different vertical rigidity (Fig. 12), i.e., the bottom wall and the timber beams. Different rigidities in the wall support system would lead to the development of a local failure mechanism specific of this structural typology, not previously analyzed.

Fig. 12 – Different support conditions for masonry walls, at different levels, and the corresponding schematic interpretation (in red).
