Seismic Response of a Historical Unreinforced Masonry Building Damaged in the 2014 South Napa Earthquake

Several unreinforced masonry buildings damaged during the 2014 South Napa earthquake, California, USA, were investigated after the earthquake. The numerical analyses conducted on a representative example are presented in this paper. The building is the Sam Kee laundry building, the oldest stone commercial building in Napa, built in 1875. The geometry of the building was accurately captured by a laser scanner. Using this geometry information and material data available in literature for similar buildings, a finite element model of the building was developed according to the equivalent frame approach and was subjected to nonlinear time history analyses. The investigated building was closely located to a strong motion station on Main Street, Napa, California. This record was used as seismic excitation input to the numerical model. Results of the conducted analyses accurately predicted the observed damage in the building which consisted of shear cracks and shear damage in the south and north walls and failure of piers from the east wall. Analysis results are used to describe the re

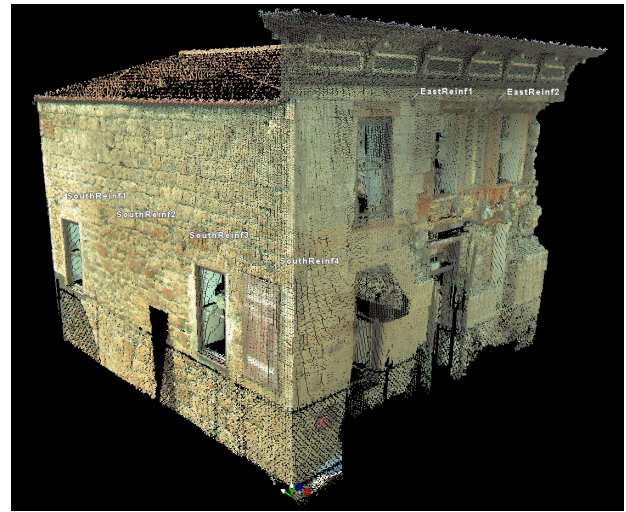
b) Anchorages of tie rods detected from laser scanning point cloud

The conditions of the building in 1972 and right before the 2014 South Napa earthquake are presented in Fig. 1. The building was restored in the past and the masonry and grout materials used in these restorations differed from the original ones. The difference in the material used for the restorations is easily noticeable from the difference of colors in the photographs of Figs. 1a and b. To reinforce the building, the following measures were introduced in the past restorations: 1) two tie rods in the east-west direction with anchor plates right below the roof level and 2) four tie rods in the north-south direction at the first floor ceiling level as marked in Fig. 2a and as identified in the point cloud in Fig. 2b.

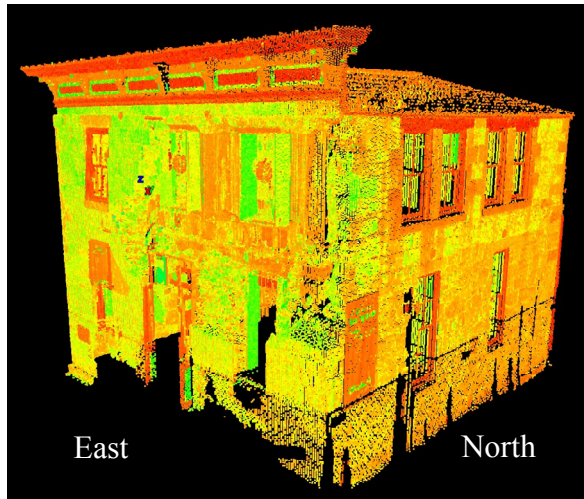
a) Point cloud

application [2] and the final point cloud is presented in Fig. 4a. The failure surfaces of the masonry walls are shown in Fig. 4b and the corresponding dislocations of the bricks are presented in Figs. 4c and d. The plots were generated in Matlab [3] and they present color contour maps of distances from a vertical plane (Deviations in North and East are positive).

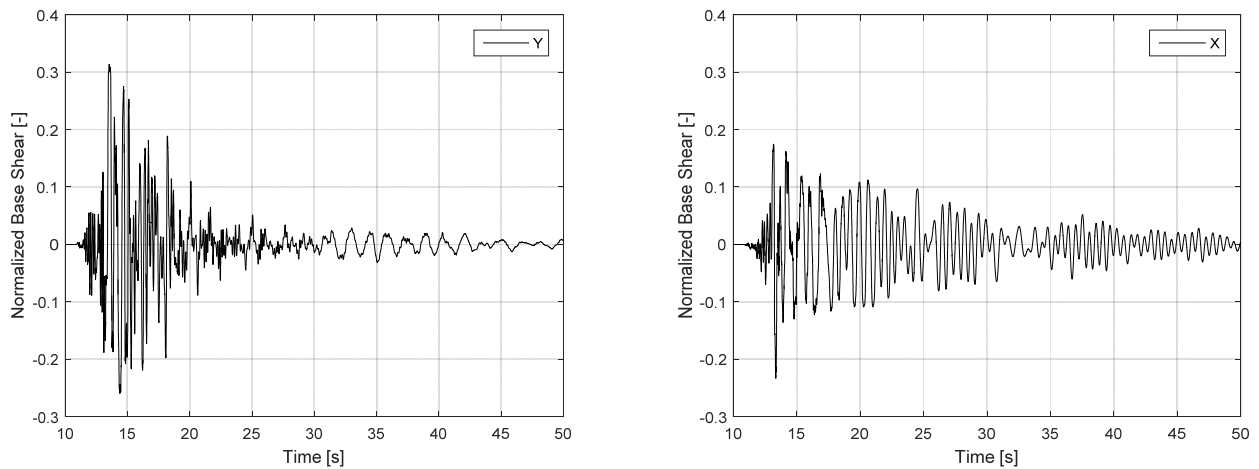
Fig. 8 – Time history of normalized base shear force in the two orthogonal directions of the building

Time histories of base shear forces in the x and y directions of the building normalized by the weight are plotted in Fig. 8. It is observed that the spectral accelerations corresponding to the natural periods of the building in Fig. 7 are larger than the peak normalized base shears in Fig. 8, indicating that the base shear capacity of the building is reached in both directions. As expected, the base shear capacity in the y direction is higher than that in the x

direction (about $0.31/0.23 \approx 1.35$ times higher, refer to Fig. 8), mainly due to the large number of openings including doors in the x direction and the existence of mostly solid walls in the y direction. Global force-displacement relationships of the four walls, (north and south) in the y direction and (east and west) in the x direction, are plotted in Fig. 9. Differences in the response between south and north walls indicate the existence of torsion which is mainly caused by the stiffness differences of these two walls having different number of openings (6 windows in the north wall compared to only 2 windows in the south wall). It is observed that the stiffer south wall is subjected to larger forces in the elastic range of response, but is subjected to smaller drifts because of its higher strength. Both the east and west walls show degraded response consistent with the observed damage after the 2014 South Napa earthquake. The reason of having degraded response in the east and west walls along the x direction, while having more stable response in the north and south walls along the y direction, can be briefly explained by the demand to capacity ratios ($1.15/0.23 = 5$ in the x direction, which is much higher than that in the y direction, namely $0.59/0.31 = 1.9$).

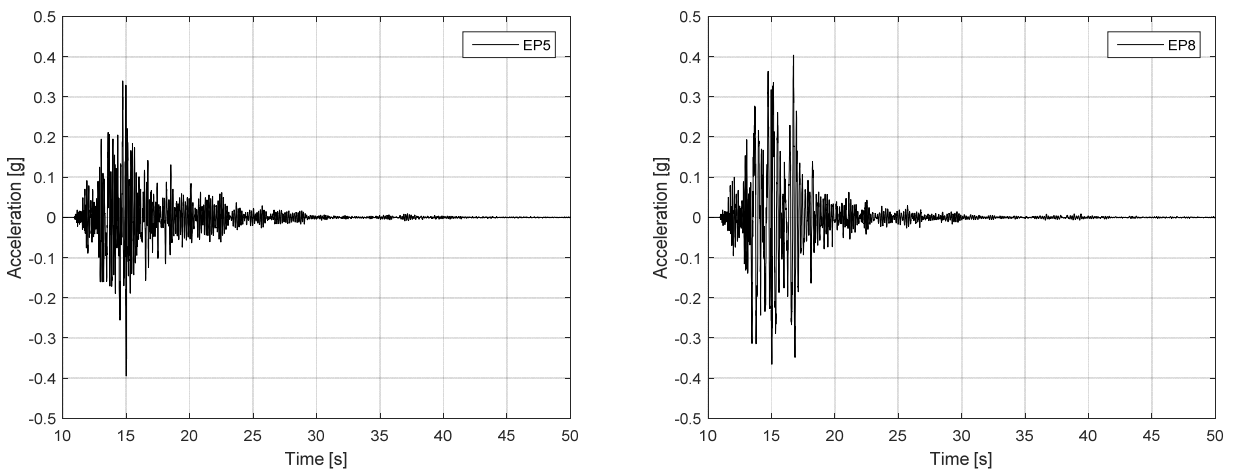
Fig. 11 – Out-of-plane (y direction) accelerations experienced by EP5 and EP8

As observed in Figs. 2 and 4, the piers EP7 and EP8 failed during the 2014 South Napa earthquake. The in-plane force-displacement relationships shown in Fig. 10 indicate that the strength of these piers has been reduced considerably and the response is significantly degraded, which explain the reason of these collapses. To investigate the reason of having EP8 collapsed, while EP5 on the other corner remaining intact, the out-of-plane accelerations that these two piers experienced are compared in Fig. 11, from which it is observed that these accelerations have similar amplitudes. Not plotted here, the interstory drifts in the out-of-plane direction (i.e. along y direction) are also similar. On the other hand, from Fig. 12, the displacements in the out-of-plane direction (i.e. along the y direction) are about 60% larger (corresponding to a ratio of $2.8/1.8 = 1.6$ based on the peak values from Fig. 12) in the N-E (i.e. near EP8, refer to Fig. 4) corner than that in the S-E corner (i.e. near EP5, refer to Fig. 4) of the East wall. This observation together with a larger number of out-of-plane deformation cycles and larger residual deformation somewhat explain the reason why the damage was observed in EP8 but not in EP5.

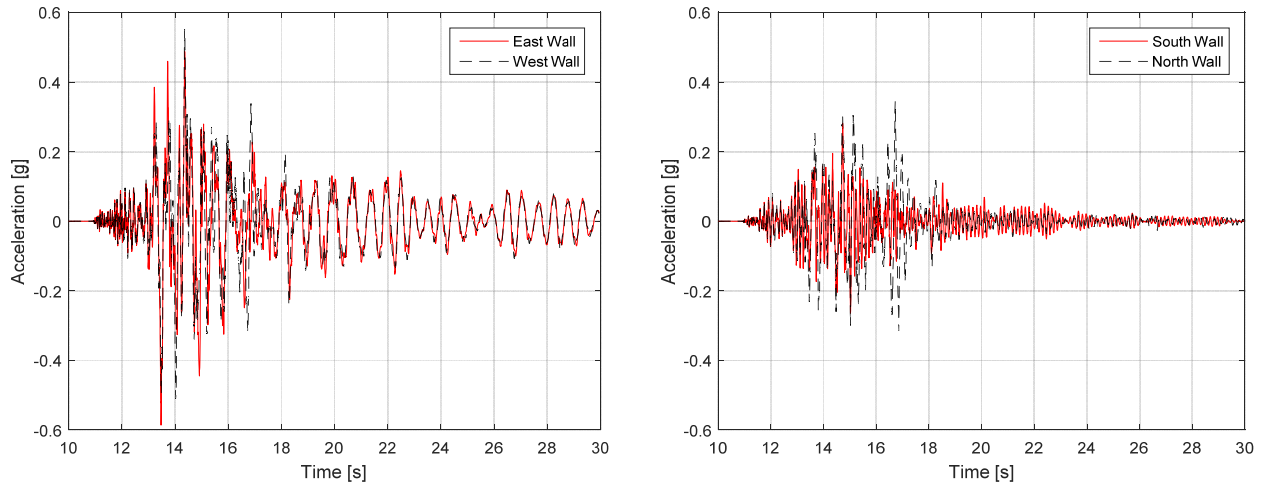
Fig. 14 – Time histories of first floor accelerations

Finally, the acceleration time histories on the first floor along the four walls are plotted in Fig. 14, where differences between the accelerations on the north and south sides and between those on the east and west sides indicate the presence of torsion. These accelerations are large enough to lead to nonstructural content damage, such as falling of wine bottles or other sales items in the store, which would have not only led to economic losses but also injuries, had the earthquake occurred during day time.
