## Performance of Fire Sprinkler Systems in the 2014 South Napa Earthquake: Computational Modeling with Validation by Laser Scans

S. Takhirov<sup>(1)</sup>, K.M. Mosalam<sup>(2)</sup>, F. Cakir<sup>(3)</sup>, S. Günay<sup>(4)</sup>

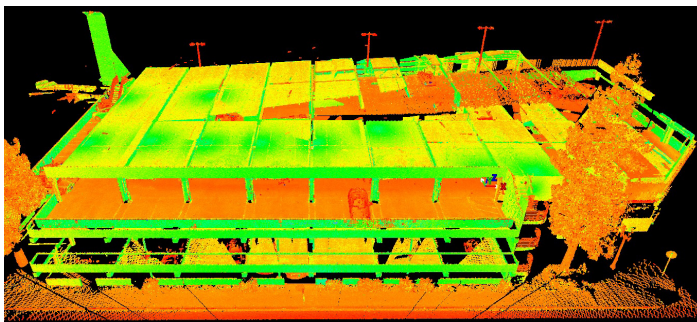
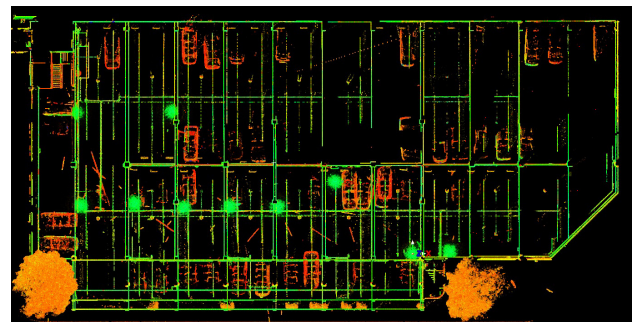
Fig. 4 – Stitched point clouds of the parking structure and damaged fire sprinkler system

The damaged condition of the piping system on the third floor of the parking structure was scanned from thirteen stations. A terrestrial laser scanner, namely Scan Station C10 from Leica Geosystems, was utilized. The point clouds were stitched in the Cyclone application [5] and the final point cloud is presented in Fig. 4a.

A plan view of the point cloud showing details of the piping system is presented in Fig. 4b. A zoomed in portion of the point cloud is shown in Fig. 5. The point cloud is colored based on real colors of the system captured by a still imaging camera built into the scanner. It shows residual displacements of the piping system that can be clearly estimated by the exposed amount of unpainted part of the pipes that used to be hidden by bracket of a hanger rod. The superposed ellipses show the bracket locations and the double headed arrows show directivity of the motion. All details of the piping system were captured and documented by the laser scanner including: (1) location of each pipe in space including residual deformations, if any, (2) the diameter of the pipe, (3) the location of the hanger rod in space, (4) the diameter and length of the rod, (5) the residual displacements along the longitudinal axis of the pipe, ... etc. Some of the examples of subsequent measurements from the point cloud

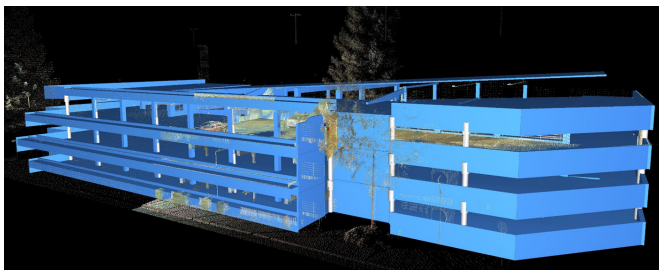
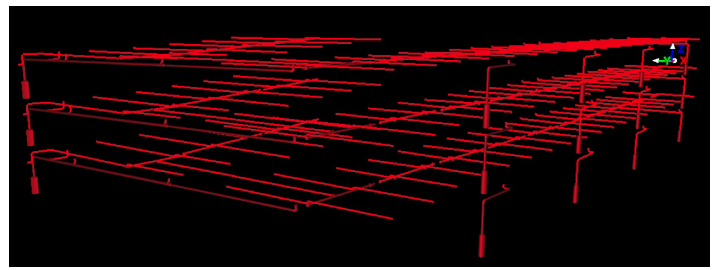
Fig. 8 – Model of the structure and piping system

The point cloud was used to model the building and the piping system itself as presented in Fig. 8. The Cyclone application [5] was used to convert the point cloud into solids. A zoomed view of the model of the building integrated with fire sprinkler system is presented in Figs. 8 and 9. This solid model was imported into ANSYS [6] to generate the finite element models of both the building and the piping system.

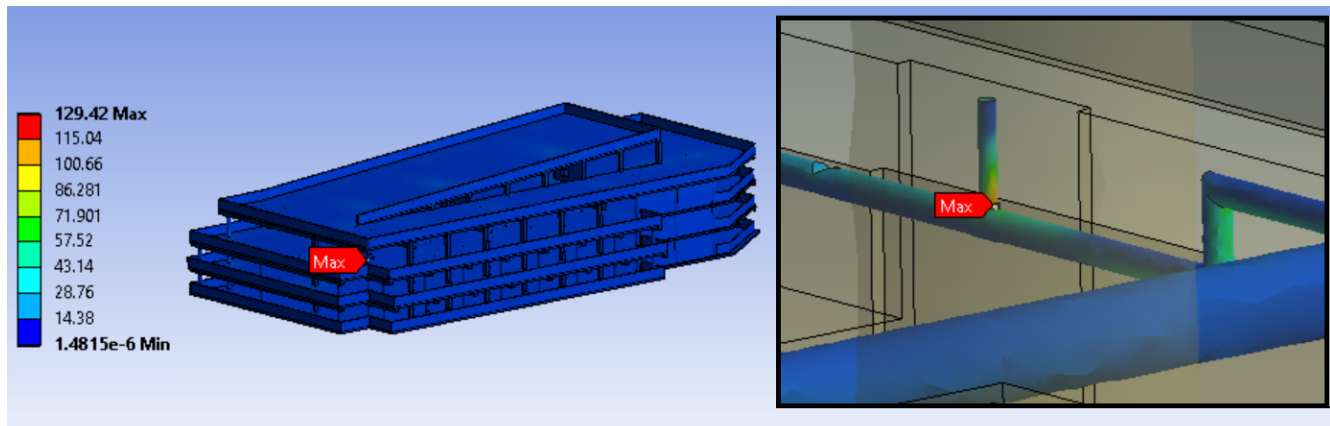
Fig 15 – Maximum principal stresses from the gravity load analysis (MPa)

Self-weight of the structure is an important parameter for the structural and nonstructural behavior. Therefore, static analysis due to self-weight is first performed using the computational model. The analysis indicated a maximum principal stress (tension) of 129.42 MPa, which occurred at the connection section between the hanger rods and the steel pipes and the transition zone from the steel pipes to the reinforced concrete structure (Fig. 15). Furthermore, the minimum principal stress (compression) is determined to be 114.68 MPa above the lower section of the hanger rods (Fig. 16). The maximum displacement at the center of the fourth floor slab is about 15.15 mm and the maximum displacement of the steel pipes is 13.94 mm (Fig. 17).

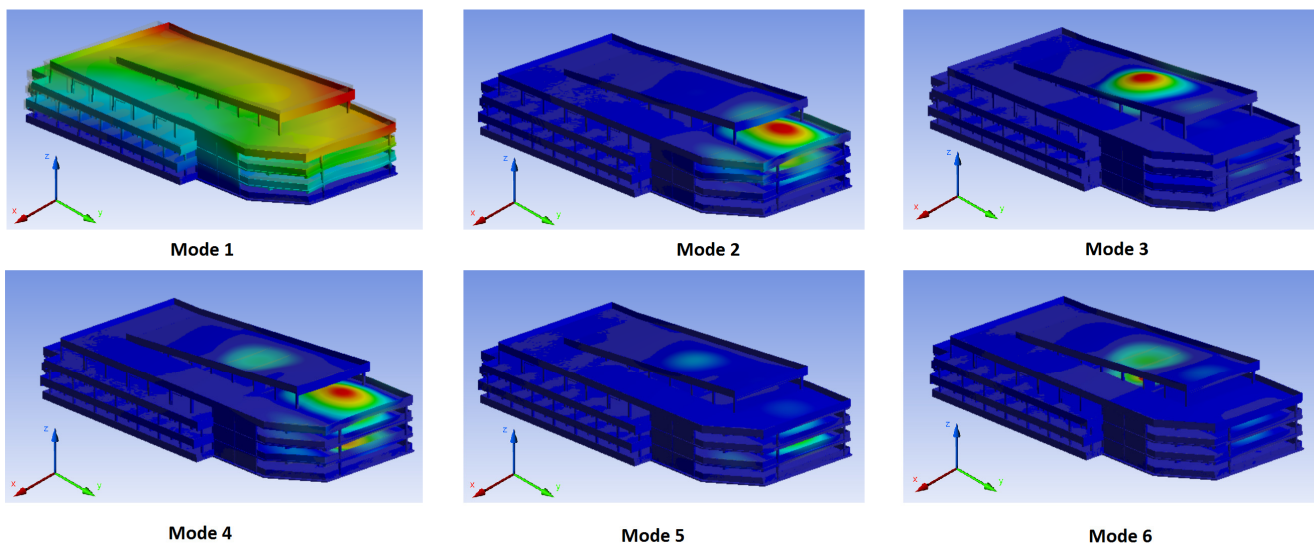
Fig. 18 – First six mode shapes of the parking structure

The modal analysis is primarily used for quantifying the dynamic characteristics of the structure. The first six mode shapes are shown in Fig. 18 with the corresponding first six periods of vibration listed in Table 1. Modal analysis indicate that the torsional mode occurs in the first mode with  $T=0.28$  sec. It is observed that modes 2 to 6 are localized at specific parts of the slabs, indicating corresponding potential dynamic response, which can affect the investigated piping systems. According to modal analysis results obtained, vertical slab vibration in Z direction is observed in modes 2-6.
