ANALYSIS OF STEEL TANKS IN CHILE SUBDUCTION EARTHQUAKES

P. Pineda⁽¹⁾, G. R. Saragoni⁽²⁾

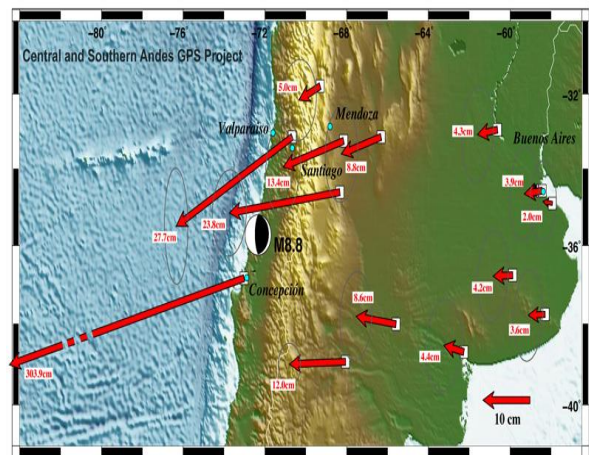
Figure 4. GPS coseismic horizontal displacement after 2010 El Maule earthquake showing 303.9 centimeters at the coast of Concepción, close to ENAP Refinery. [https://www.soest.hawaii.edu/soest_web/soest.news_chile_feb2010_eq.htm].

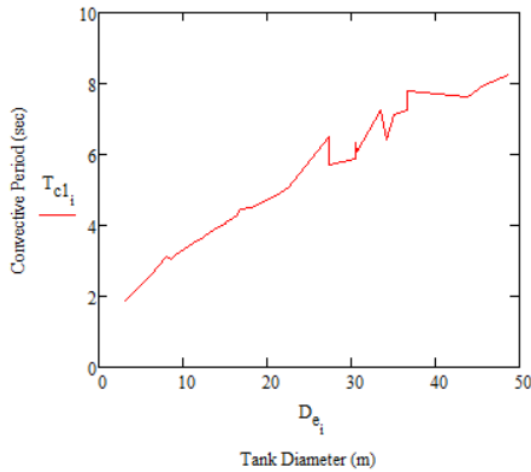
Figure 13. Convective Periods for studied tanks, 1985 Chile Earthquake. T_{c1} : convective period calculated for studied tanks, in seconds.

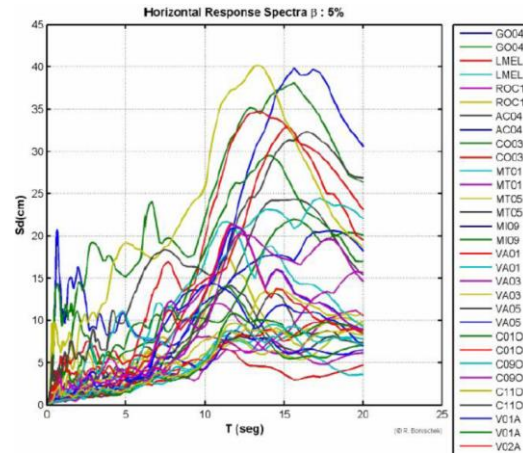
Figure 14. Horizontal displacement response spectra, subductive interplate Chile earthquake, 2015 Illapel ($M_w=8.4$). Boroschek [25].

It should be noted that displacement registers shown by displacement spectra in Figure 14 refer to vibratory motions, whereas the formula (1) and the sloshing of Figure 16 shows an inertial behavior in the mentioned coseismic direction. Considering this formula, anchors of tanks will be required in some cases despite API 650-E recommendation in order to avoid damage in bottom plates as well as piping, in addition to reducing the risk of buckling of shell. The sliding also produce seismic forces not consider in API650-E and other design codes for unanchored tanks. It must keep in mind that the small sliding has produced failure in bottom plates. Table 3 indicate sliding (S) of tanks in coast areas of subduction earthquakes. In 2007 Tocopilla Chile earthquake, the tank located on acid plant in Mejillones city, was detected a horizontal sliding between 80 to 100mm in the perpendicular direction of the coast and corresponding to convergence direction of subducted Nazca plate. According to the orientation the tank indicated in Figure 15 in perpendicular direction to the coastline besides the buckling of shell showing in Figure 6, explains the influence of the earthquake directivity. For the 2010 Chile earthquake Figure 10 shows that the tanks are oriented in direction N-S, on the other hand, Figure 16 shows that the central tank had slosh in W-E direction perpendicular to the coastline, similar to the above mentioned case for the earthquake 2007, confirming the influence of the coseismic directivity of the subductive Chilean earthquake. This effect is incident on the seismic response of tanks with a predominant the convective mass. In both cases the tanks were self-anchored, so it is important to consider a possible horizontal sliding in future earthquakes for tanks located in subductive zones near of asperities and assess the application of the equation (1). Figure 17 shows some tanks located in a gas plant in San Vicente port, tank on the west side on Figure 18 had an inclination of a one-degree perpendicular to the coastline, confirming once again that Chilean coast earthquakes dominated the directivity in the direction of subduction. The tank was built in 1968, it had height dimensions of 11.6m in diameter and 12 meters, and was full during the 2010 Chile earthquake.
