## STUDY ON DAMAGE AND SEISMIC PERFORMANCE OF TIMBER BUILDINGS DAMAGED DURING THE RECENT LARGE EARTHQUAKES IN JAPAN

T. Tsuchimoto<sup>(1)</sup>, N. Kawai<sup>(2)</sup>, T. Nakagawa<sup>(3)</sup>

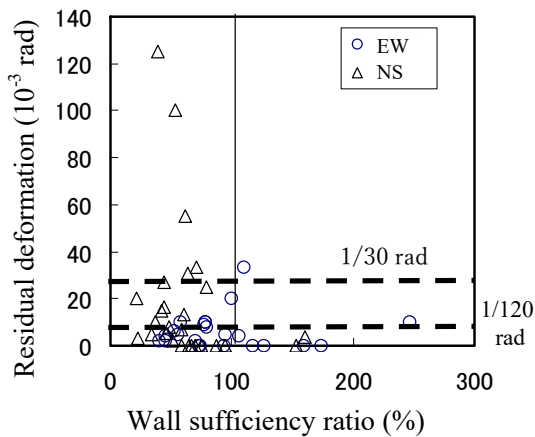
(a) 2000 West Tottori Earthquake

In 2000 West Tottori Earthquake (a), the wood house with wall sufficiency ratio of about 100 % or more has never suffered the damage with residual deformation of about 1/120 rad or more. Here, the sear deformation

of 1/120 rad is the allowable story deformation of Japanese building code for timber constructions. In Noto Peninsula Earthquake (c) and Chuetsu Offshore Earthquake, these are in the same tendency except for a few plots. The arrowed plots in (d) is the timber construction shown in Photo 3 (b) and has the reason why many books make the seismic force unexpectedly large because of the change of usage from hospital to library.

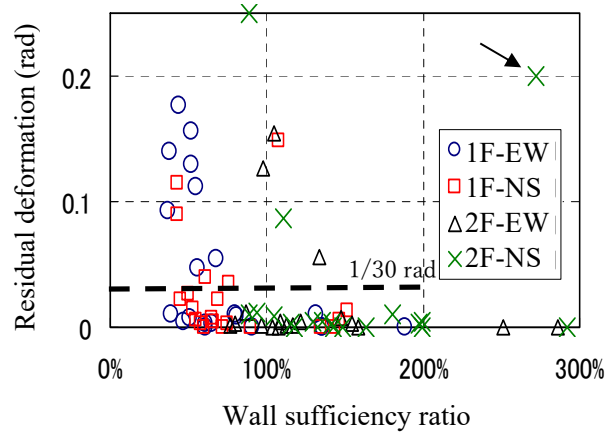
(b) 2004 Niigata Chuetsu Earthquake

On the other hand, in 2004 Niigata Chuetsu Earthquake (b), several wood houses with the wall sufficiency ratio of about 100 % or more suffered the damage with the residual deformation of about 1/10 rad or more. It is the reason why the seismic intensity of 2004 Niigata Chuetsu Earthquake was 7 and stronger than the other three earthquakes. However, the arrowed plots in (b) is the wood house shown in Photo 5 (a) and has the reason as mentioned in the section of 3.5.

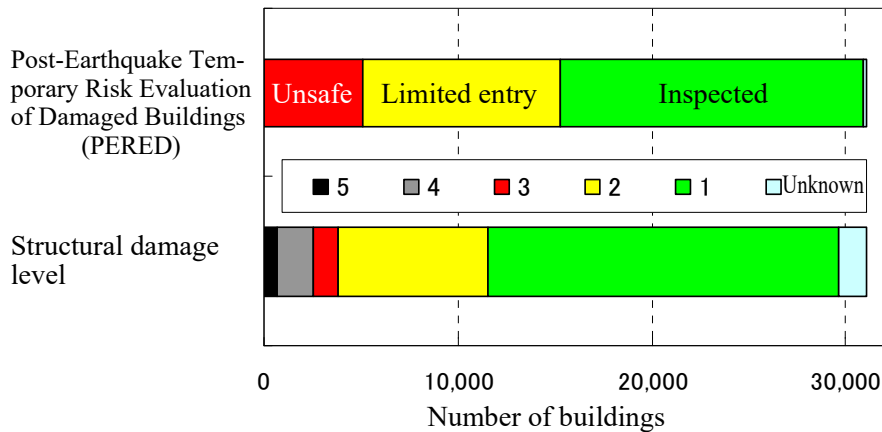
Fig. 3 – Results of post-earthquake temporary risk evaluation of damaged buildings and structural damage level

The results of PERED due to 2004 Niigata Chuetsu Earthquake for over 30,000 buildings were obtained and analyzed. The only informations of the structural damage were picked up form the results. And, the structural damage levels were defined as shown in Table 2. The results of PERED and the classified strucral damage level were compared and shown in Fig. 3. It is considered that the “Unsafe” of PERED were classified to the structural level 5-2.

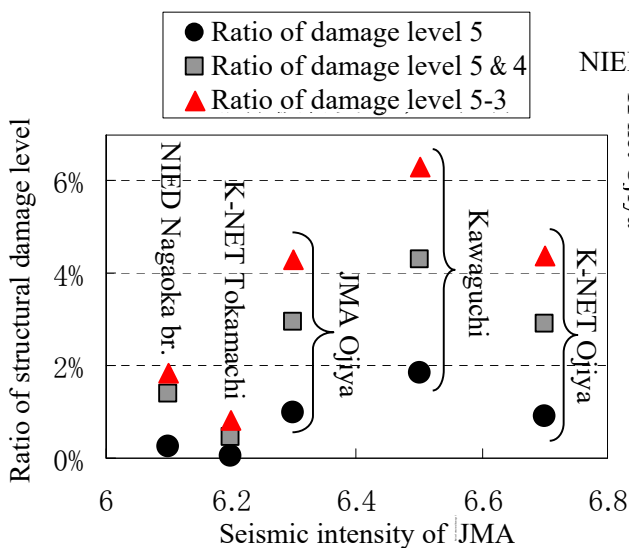
Fig. 4 – Relationships between the seismic intensity and the ratios of the structural damage.

Next, the datum within 1 km from the point of the strong-motion seismograph were picked up and analyzed. The structural damage level and the several parameters of the recorded seismic wave were compared together. At first, the ratios of the damage level to all datum within 1 km were compared with the seismic intensity calculated from the recorded wave, as shown in Fig. 4. However, the ratio and the seismic intensity didn't have significant correlation. Second, the ratios were compared with the maximum acceleration recorded in the seismic wave, as shown in Fig. 5. The ratio didn't always become larger with the rising of the acceleration. Finally, the ratios were compared with the maximum velocity recorded in the seismic wave, as shown in Fig. 6. The ratio became larger with the rising up of the velocity. In other words, as the earthquake that the large velocity was observed or as the area where the large velocity was observed, the seismic damage to wood houses became heavy.

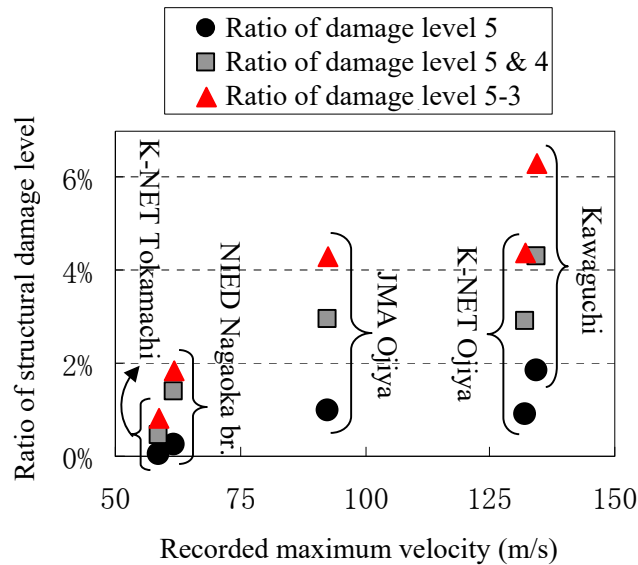
Fig. 6 – Relationships between the recorded maximum velocity and the ratios of the structural damage.

- The structural damage ratio of wood houses was not higher in the area where the higher seismic intensity or acceleration was recorded. However, the ratio was higher in the area where the higher velocity was recorded. as the earthquake that the large velocity was observed or as the area where the large velocity was observed, the seismic damage to wood houses became heavy.
