MUISNE, ECUADOR 2016: ONCE AND AGAIN RELEARNING ABOUT THE ROLE OF THE MISCALLED "NON-STRUCTURAL" MASONRY WALLS

A. Urich⁽¹⁾

Abstract

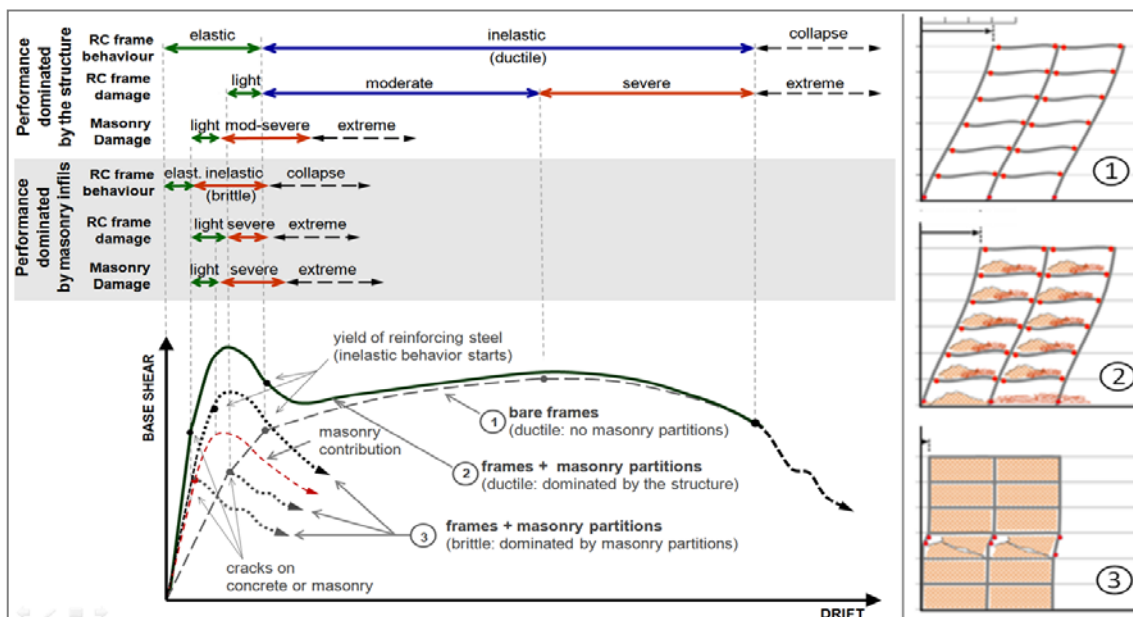
Fig. 11 force-displacement curves inferred from damages

The force-displacement curves inferred from the described symptoms are summarized in Fig. 11 above; more details are presented in a complete recognition report [30]. It shows the huge influence that masonry partitions may have on the overall capacity of the buildings, affecting the stiffness, so the natural period, the deformation capacity, the ductility, the stress distribution between structural members and those that were not supposed to be structural, etc. the figure also shows the relationship between different deformation states to damage levels in both, structural members and masonry partitions.
