CASE HISTORIES OF GEOTECHNICAL ENGINEERING DAMAGE FROM THE 2016 M_W 6.0, M_W 6.2, and M_W 7.0 KUMAMOTO EARTHQUAKES

The authors conducted two surveys in the devastated areas: one during April 16-17, and the other during May 11-14, 2016 as part of the GEER team efforts to document the effects of the earthquakes (GEER Report, 2016). Five major case histories were identified as a part of the GEER reconnaissance. This report summarizes this earthquake sequence and these case histories.

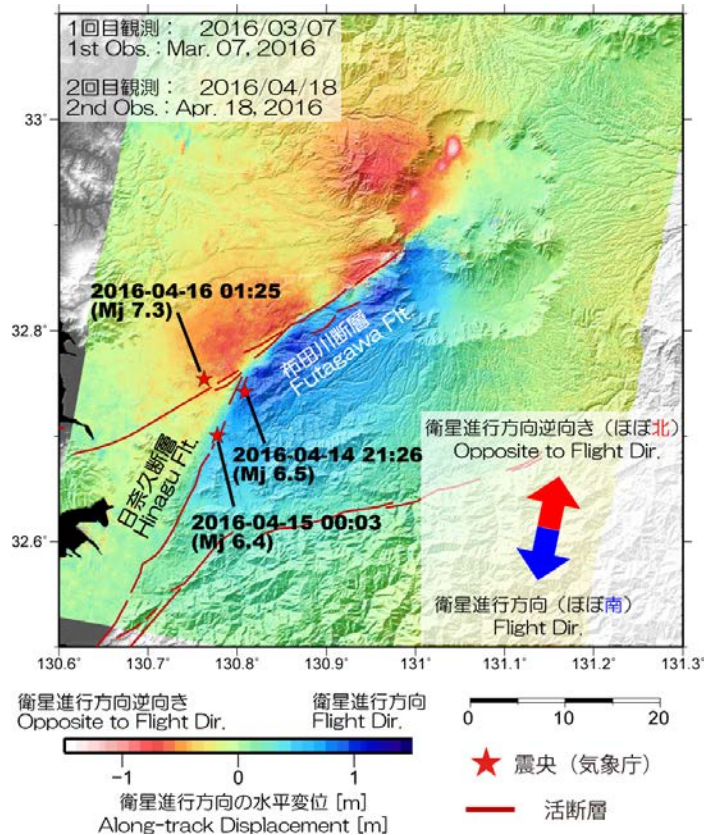
The 2016 Kumamoto mainshock was the strongest earthquake in Kyushu Island in the modern instrumental era. The fault rupture in the foreshocks and mainshock occurred along the Hinagu and Futagawa Faults. The Hinagu Fault is the southernmost fault in this area, just south of Kumamoto, and intersects the Futagawa Fault south of Kumamoto. The Futagawa Fault projects from that intersection point both to the west (the Uto Segment) and to the northeast (the Futagawa Segment). Each of these faults was, in general, previously mapped by the Geological Society of Japan prior to these earthquakes. See (Figure 1, GSJ 2016) for a depiction of the faults.

Fig. 1. Multiple Aperture Interferometry (MAI) processed from ALOS-2 provided by the Geospatial Information Authority of Japan (GSI). The red lines are previously mapped active fault traces.

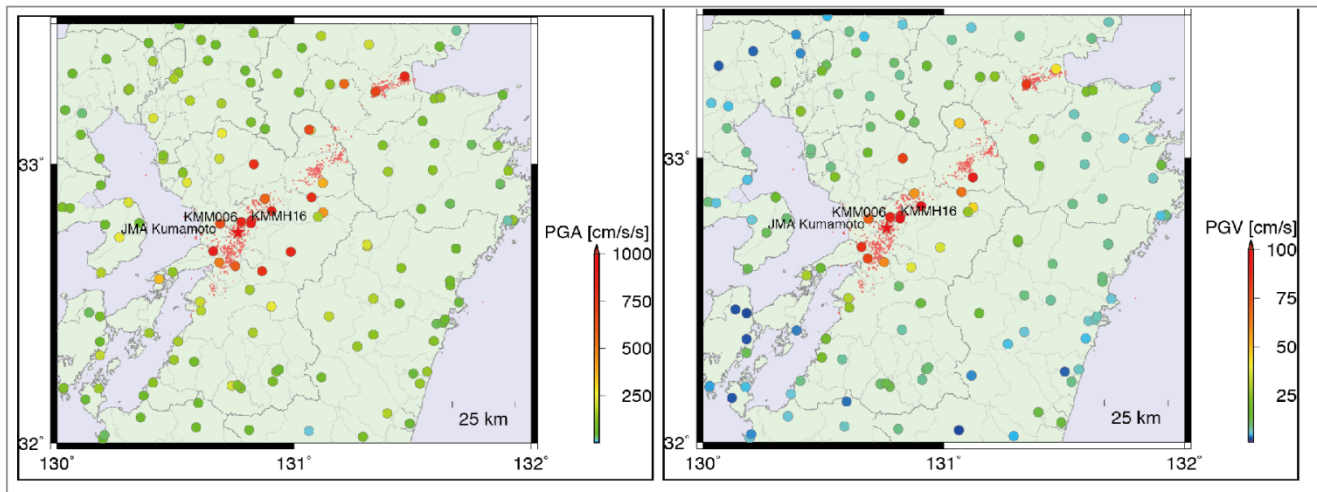
Two strong foreshocks (Moment magnitude M_w 6.0 and 6.2) on April 14th and a mainshock (M_w 7.0) on April 15th, 2016 caused strong levels of shaking in the region, damaging buildings and other infrastructure. During the M6.5 foreshock, the largest recorded ground acceleration of 1.6g was measured at Mashiki Town. During the mainshock, the peak ground accelerations again exceeded 1g at Mashiki Town. These earthquakes were shallow (hypocentral distances of approximately 11 km and 12 km, respectively, according to the Japan Meteorological Agency) under the City of Kumamoto. Building collapse due to strong shaking and landslides as well as damage to roads and lifelines were observed. Figure 2 shows the distribution of PGA and PGVs recorded during the mainshock (Goto 2016).

Fig. 2. Distribution of PGAs and PGVs recorded during the main M 7.0 earthquake (Goto 2016).

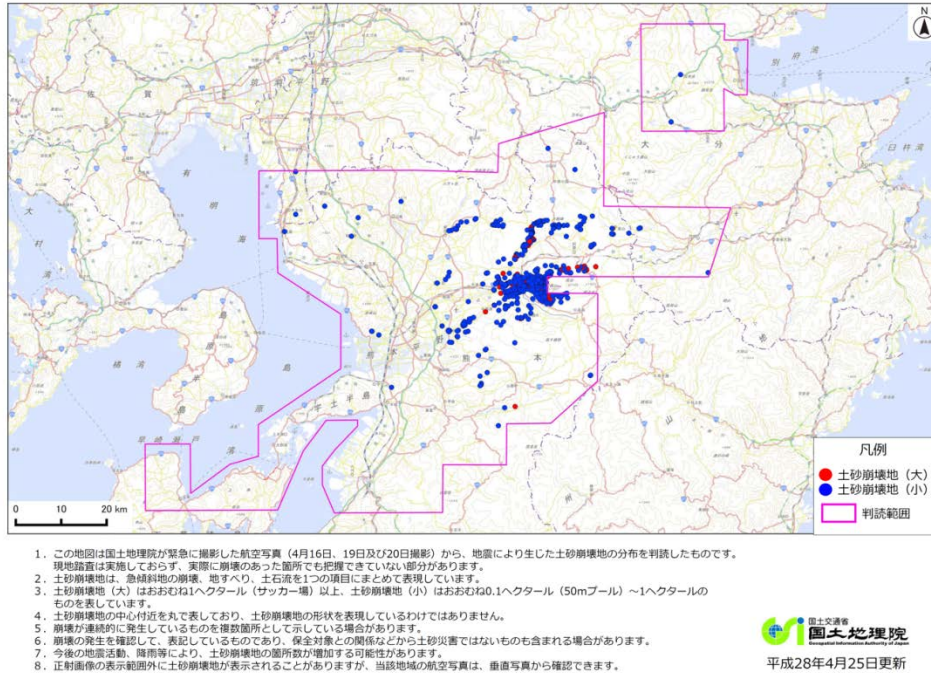
Widespread landsliding was caused by the Kumamoto Earthquakes in the steep volcanic geology of the region. Several hundred landslides are believed to have occurred based on satellite imagery interpretation conducted by the Geospatial Information Authority of Japan (Fig. 3). The GEER reconnaissance team observed numerous landslides while driving through the region.

Fig. 3. Overview of landslides from the Kumamoto Earthquakes produced by the Geospatial Information Authority of Japan (GSI).
