## **Strong Ground Motions and Damage Investigation of Buildings near the Surface Faulting of the 2016 Kumamoto Earthquake in Japan**

### **Abstract**

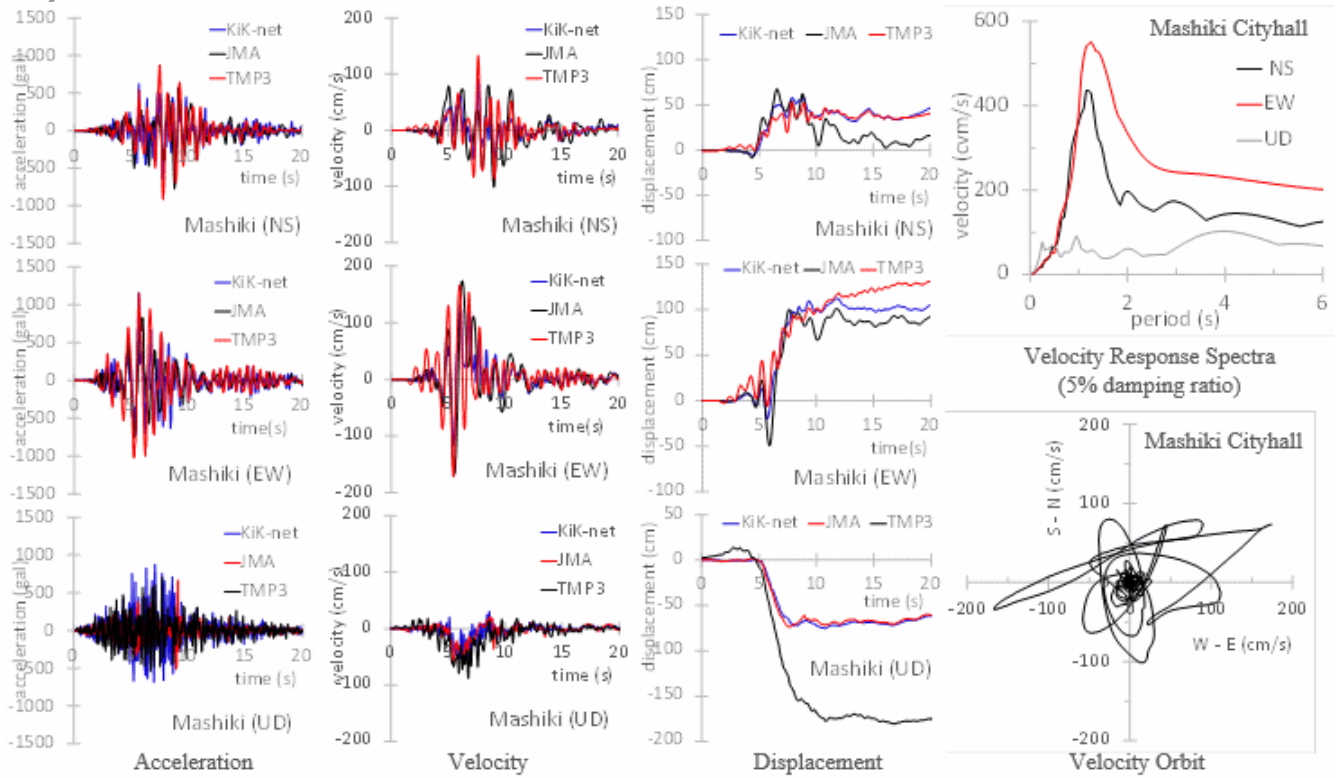
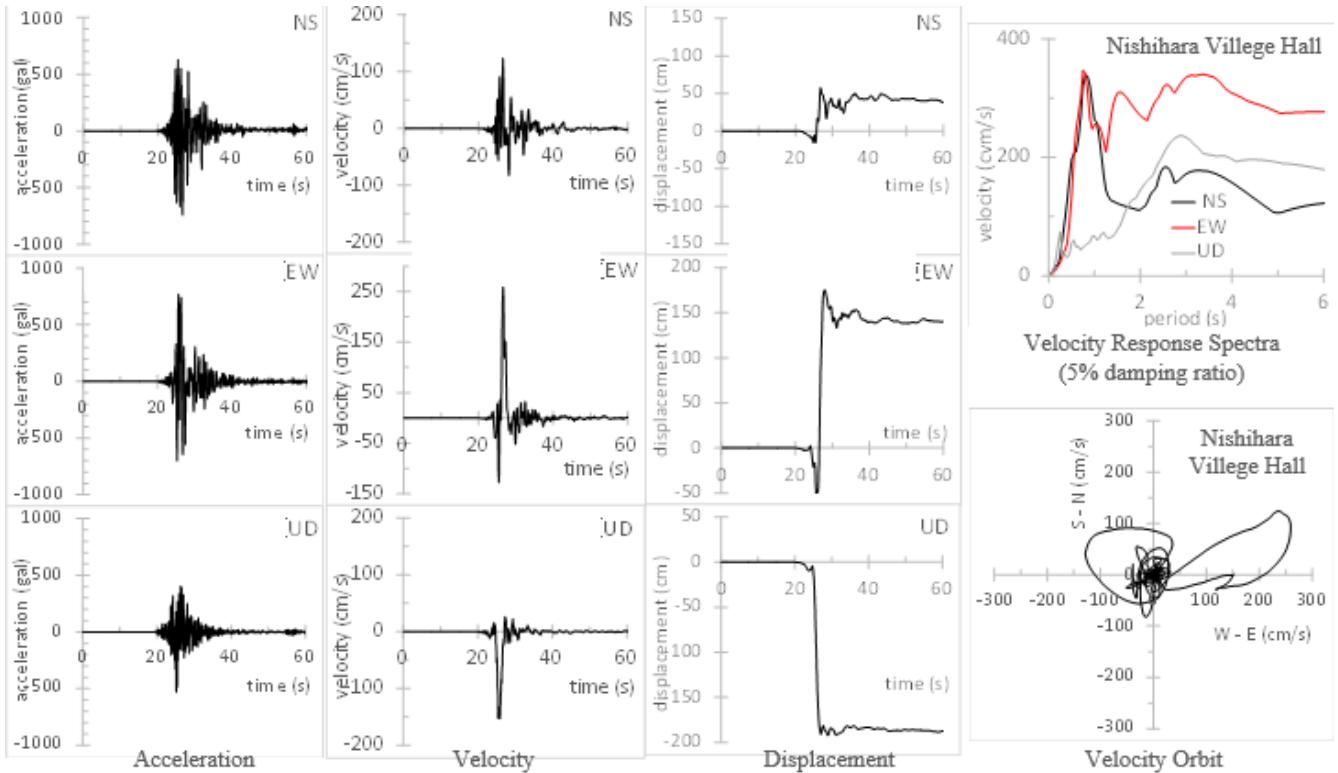
Fig. 2 – The strong motion records near the surface faulting of the main-shock of the Kumamoto earthquake (accelerations, velocities, displacements, velocity response spectra, and velocity orbits on the horizontal plane)

First, we report the characteristic strong ground motions recorded near the surface faults. Fig.2(a) and (b) show the strong ground motion records of the main-shock at the three sites in Mashiki City (KMMH16 of KiK-net Mashiki<sup>2</sup>), Mashiki City hall of JMA<sup>3</sup>), and TMP3 of Hata *et.al.*<sup>4</sup>), and at the Nishihara Village hall (JMA<sup>3</sup>), respectively. They are the original accelerations, velocities (corrected the base lines), displacements, velocity response spectra, and velocity orbits on the horizontal plane. The displacements at all the sites show clearly the fling steps on the hanging wall of the normal and right-lateral faulting<sup>5), 6)</sup>, which are dominant in the EW components at longer periods. In addition, the records at the city hall and TMP3 sites in Mashiki City show the very large amplitudes around 1 sec in the EW direction, which caused the heavy building damage in this area<sup>1)</sup>; this destructive strong motion was probably the forward directivity pulses<sup>7)</sup>.

(a) The strong motion records of the main shock at the three sites in Mashiki City (see the locations in Fig.1)<sup>2-4)</sup>

(b) The strong motion records of the main shock at the Nishihara Village hall (see the locations in Fig.1)<sup>3)</sup>

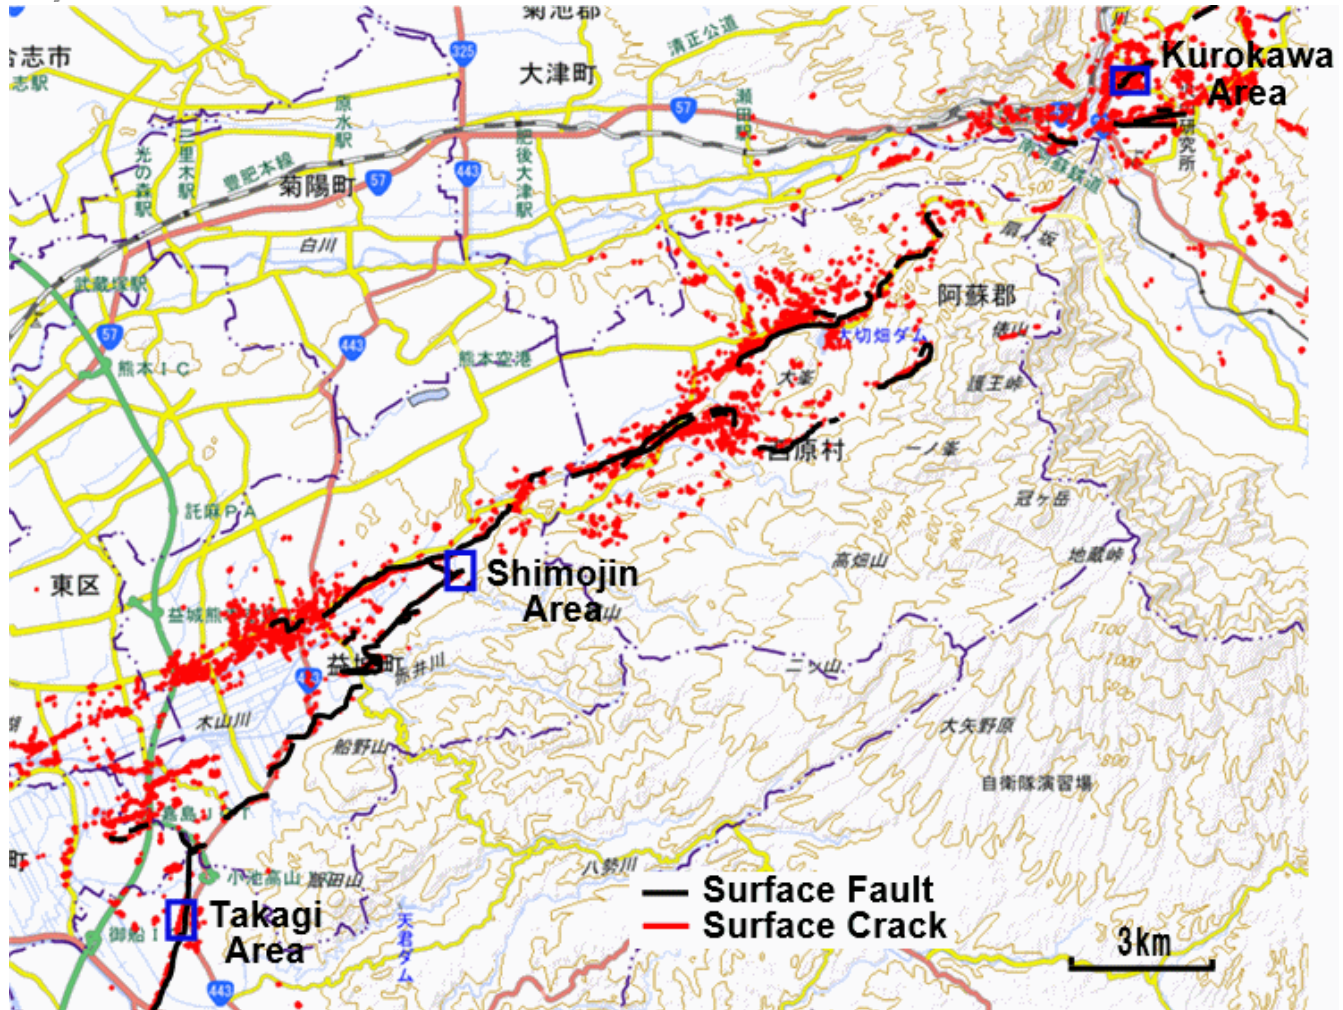
Next, we show the results for investigating building damage near the surface faulting. Fig.3 shows the three investigation areas (Takagi, Shimojin, and Kurokawa), and the locations of the surface faults (black lines) and other surface cracks (red lines)<sup>8)</sup>.
