LESSONS LEARNT FROM BUILDINGS DAMAGED IN THE 2018 HUALIEN EARTHQUAKE, TAIWAN

Y. H. Tu⁽¹⁾, T. Yeh⁽²⁾

Keywords: Building; Damage; Reconnaissance; Reinforced Concrete

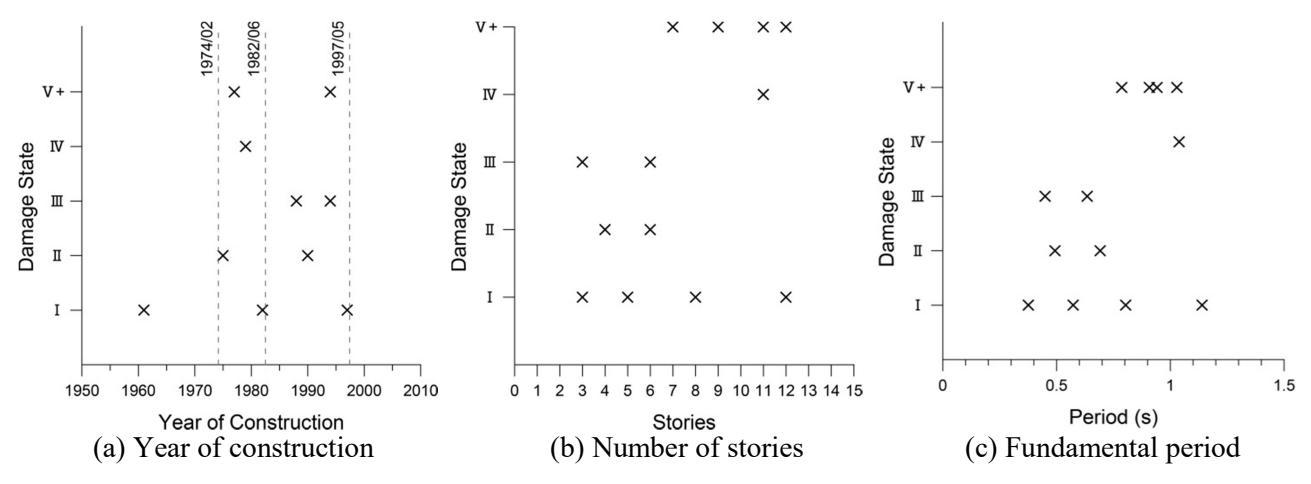
Fig. 4 – The relationships between the damage states and the building parameters

The Seismic Building Codes in Taiwan had been majorly revised three times in 1974, 1982, and 1997, respectively. Fig. 4(a) shows the relationship between the years of construction and the damage states of the thirteen buildings, with the exception of buildings F, I, and M because their exact years of construction were not available. Although the older buildings are believed to have lower seismic resistance, the figure shows no clear relationship between the damage and the age of a building. A possible reason is that most of the old buildings might have been damaged during past earthquakes and demolished or renovated, since the Hualien

area has frequent seismic activities. Fig. 4(a) also shows that none of the damaged building was build after 1997. That means the latest major revision of the Building Codes in 1997 is efficient in seismic resistance.

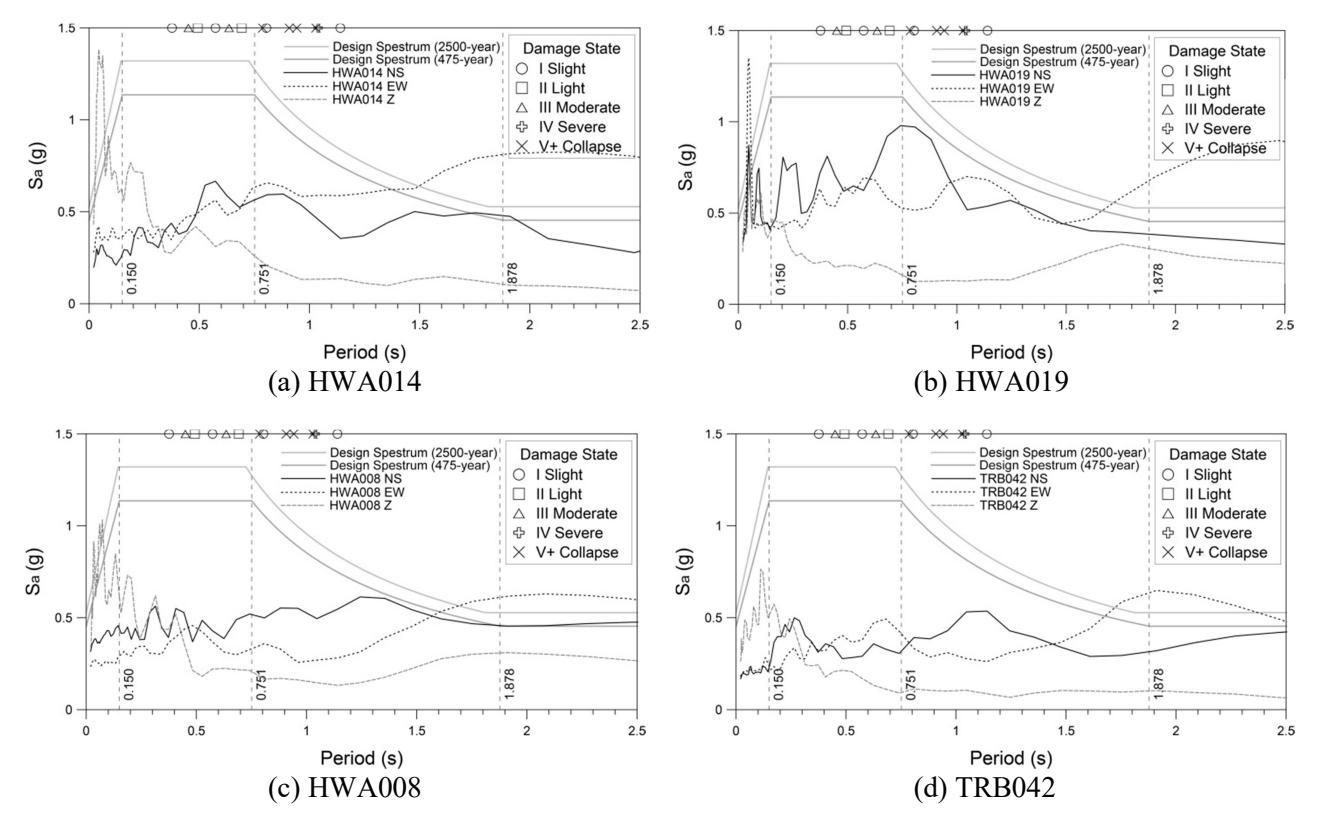
Fig. 5 – The comparisons between the recorded spectra and the design spectra

Fig. 4(c) shows that most of the collapsed and severely damaged buildings had a fundamental period close to 1.0 s. The acceleration spectra of the strong motions recorded by the four closest stations to the buildings were compared with the design spectra, as shown in Fig. 5. In opposition to the design spectra showing a platform for the period between 0.150–0.751 s, most of the recorded spectra showed large spectral acceleration (S_a) for the period higher than 0.751 s. Fig. 5 shows that the NS and EW spectra of HWA014 had a common peak value at about 0.85 s. The NS and EW spectra of HWA019 showed peak values of about 0.75 s and 1.05 s, respectively. The EW spectrum of TRB042 showed a peak of about 1.1 s. These periods corresponded with the fundamental periods of the collapsed and severely damaged buildings plotted at the top of the figures. They also corresponded with predominant frequencies (0.8–1.5 Hz) in downtown Hualien as reported by Kuo et al. [7]. However, both Fig. 4 and Fig. 5 show that there were also buildings (A & G) in

the period region that had only slight damage. Therefore, the building height may be a major reason but not the only factor affecting the building damage.

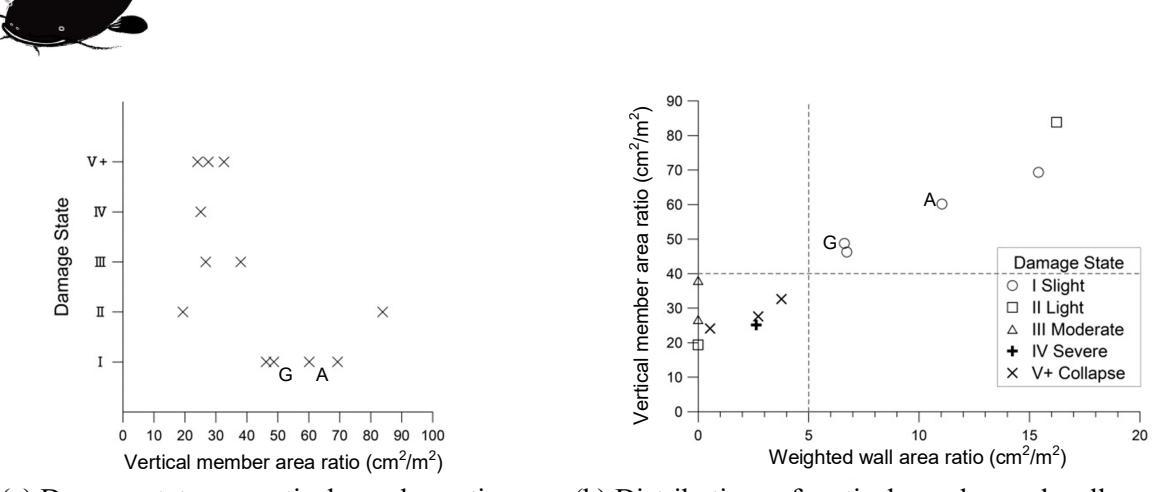
Fig. 6 – The relationships between the damage states and the vertical member areas

Fig. 6(a) shows that the damage state tended to decrease when the vertical member area ratio increased. The R-value calculated from this figure was -0.63, meaning a high negative correlation. Fig. 6(b) shows the distributions of vertical member area ratio and weighted wall area ratio with the damage state of each building represented by different signs. The signs lying on the vertical axis represent the buildings had no wall in their weak direction. This figure shows that all the collapsed and severely damaged buildings had a vertical member area ratio lower than $40 \text{ cm}^2/\text{m}^2$ and a weighted wall area ratio lower than $5 \text{ cm}^2/\text{m}^2$. In contrast, all the buildings that had a vertical member area ratio higher than $40 \text{ cm}^2/\text{m}^2$ and a weighted wall area ratio severely damaged buildings had no the vertical member area ratio lower than $5 \text{ cm}^2/\text{m}^2$. In contrast, all the buildings that had a vertical member area ratio higher than $40 \text{ cm}^2/\text{m}^2$ and a weighted wall area ratio severely damaged earlier area ratio higher than $5 \text{ cm}^2/\text{m}^2$. In contrast, all the buildings that had a vertical member area ratio higher than $40 \text{ cm}^2/\text{m}^2$ and a weighted wall area ratio severely damaged buildings had a vertical member area ratio higher than $5 \text{ cm}^2/\text{m}^2$. In contrast, all the buildings that had a vertical member area ratio higher than $5 \text{ cm}^2/\text{m}^2$. In the thigh the the buildings had only light or slight damage. The buildings A and G discussed earlier are marked in Figs. 6(a) and 6(b). The high vertical member area and wall area ratios might be the reason that they performed better than the other buildings that had similar heights. Although some may debate that the vertical member area can not reflect the effect of reinforcement, such as the hoops related to ductile or non-ductile design, these figures indicate that the column and wall areas obviously affect seismic resistance.
