FIELD OBSERVATIONS IN MEXICO CITY AFTER THE SEPTEMBER 2017 PUEBLA-MORELOS EARTHQUAKE

A. Urich⁽¹⁾

This paper shows the main reconnaissance observations from Mexico City after the September 19th, 2017 Puebla-Morelos Earthquake (7.1 M_w). It presents opinions and photographic illustrations of the seismic culture, the response of society and institutions, and the main factors that affected the structural performance of buildings.

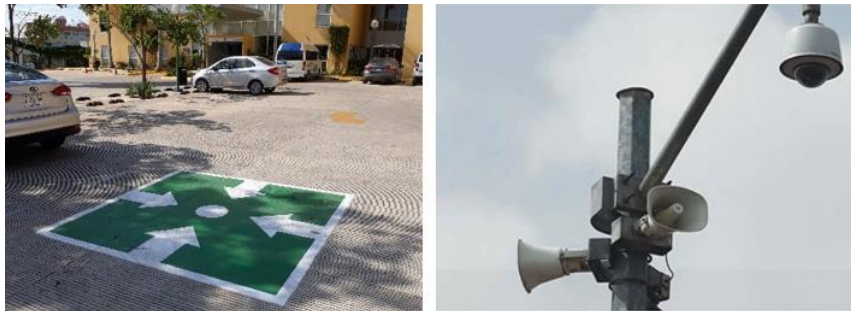
Mexico has a deep-rooted seismic culture; despite the extreme damages and collapses in some sectors, the earthquake did not take them by surprise, since the population has been prepared for these events. It should be pointed out the up-to-date codes; the high academic, professional and institutional proficiency demonstrated by prior preparedness and emergency management; signaling of escape routes and meeting points in case of emergencies, almost in every building; the emergency policies developed by the security committees in condos and companies; the number of buildings that have been retrofitted to increase their capacity against earthquakes, including several with cutting edge technology such as energy dissipation devices, many with local development; finally, the early warning system as an icon of the culture of seismic prevention in Mexico. Fig. 1 shows some of the seismic culture elements that can be found in different spots of the visited areas.

Fig. 1 – Examples of elements of the seismic culture: meeting points and early warning system

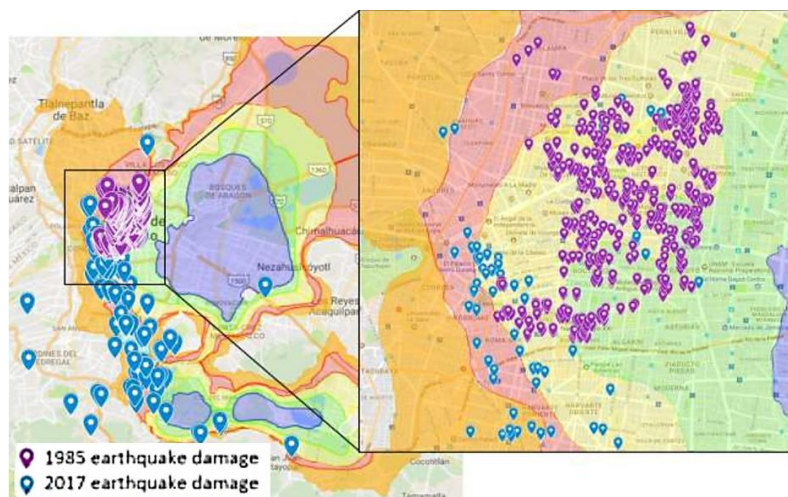
To talk about earthquakes in Mexico City is to talk about the site effects. In fact, this was one of the most commented topics by professionals and academics. It is known that Mexico lies on sediments over an old lagoon, and therefore, the effects of amplification of seismic shaking at certain vibration natural periods are very large. One of the most commented features about the site effects was that this time, the closer intraplate earthquake generated effects different from that of 1985, which epicenter was between the plates of Cocos and North America, much more distant. For the 2017 Earthquake, the named "transition zone" with shallower sediments and a slightly stiffer ground were more affected. Fig. 3 shows the differences in the location of the collapsed buildings on 1985 vs. the new collapses on 2017, warning that previous experiences should not be considered as a recipe.

Fig. 3 – Comparison of the location of collapsed buildings during Sept. 1985 and Sept. 2017 [1]

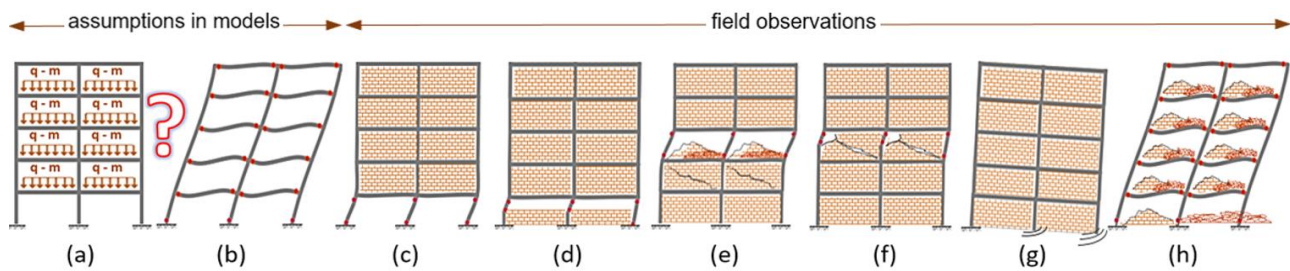
Fig. 10 shows schemes of observed typical performance patterns: a) the common assumptions of walls in models, only weight and mass; b) the expected performance considering free deformation of the structural members without infills; c) Soft Story (open ground story) in the original configuration of the building; d) Captive Column in the original configuration of the building; e) Soft Story induced after infills fail; f) Captive Column induced after infills fail; g) failure of foundations due to increasing base reactions, resulting from the stiffening imposed by the infills; h) generalized damage and collapse of portions or the entire walls, subjected to great deformations if the structure develop the expected drift capacity. These patterns have been widely seen after recent earthquakes in other countries, affecting not only old pre-code buildings but also new buildings. More details have been presented by this paper's author in previous WCEE [2] [3].

Fig. 10 – Schemes of typical performance patterns of MRF with infills

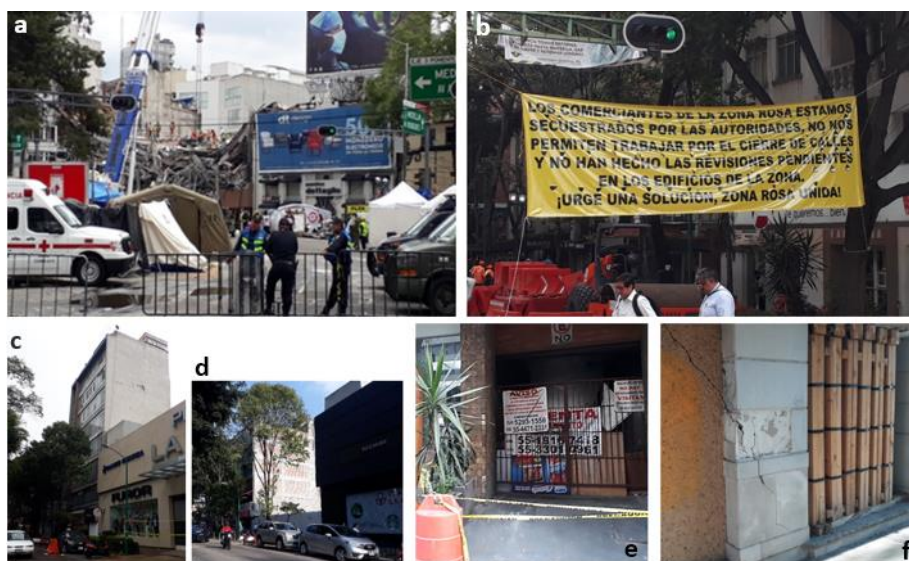
The priority after the earthquake was to rescue people in collapsed buildings; all society and media was thoughtfully following this activity (Fig. 17a). At the end of the third week, another stage was observed: hopes of rescuing people alive cease, and emphasis on restoring the operation of the city is increased. By that time, some people had already begun to despair since whole streets are closed, and many cannot return to their homes, their jobs, their daily lives, realizing that the road to recovery will be a long journey.

Fig. 17 – Images of Mexico City, hours to years after the earthquake

single damaged building can force out of service a whole block of shopping centers, offices, and residential buildings having no damage. Fig. 17b above presents a banner with this message: *The merchants of Zona Rosa are kidnapped by the authorities that do not allow us to work due to the closure of the streets, and have not done the pending revisions in the buildings of the area. A solution is urgent!*

Bit by bit, routine starts getting back and people focuses on recovery. Hopelessly, after the crisis had gone, some of the buildings had to be promptly demolished, as the one in Fig. 5 above. Figures 17 c and d expose the same building, and then, the empty site after it was removed. Then again, many people were unable to afford the great costs of repairing and retrofitting their buildings, specially condos. More than a year after the earthquake, there were still seen restricted safety zones around some buildings, and others with the same emergency shoring installed at that moment (Figs. 17e,f), and the worst part is that some of those buildings had been repaired and retrofitted after previous earthquakes, but they were back out of service. This is an issue requiring more attention because of its social impact.

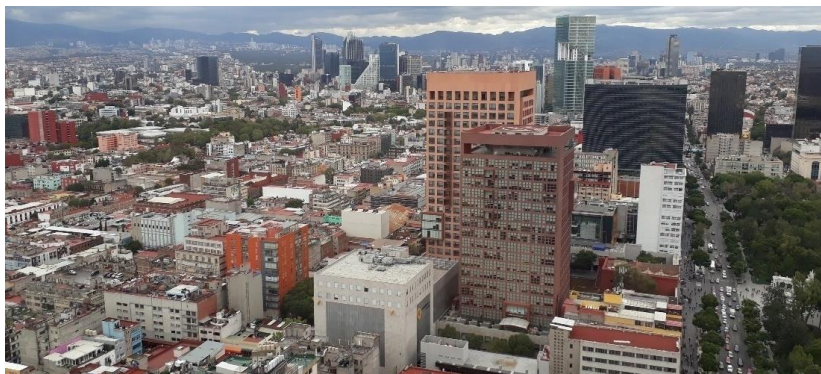
It is important to mention that media, and even this kind of research papers, always emphasize damages and collapses after an earthquake event, but the truth is that the majority of the buildings in the city didn't suffer any damage (Fig. 18). Earthquake failures are selective to vulnerable structures, either because they are located in places where the dynamic response is amplified or because of particular deficiencies in the projects, the construction, the operation and/or the maintenance of the buildings. There is also something related to chance, between the characteristics of the shaking in that specific earthquake and the possibility of activating the weak link of the structural system.

Fig. 18 – A view of Mexico City: not all was damages and collapses
