## CHIMNEY AND MOBILE HOME PERFORMANCE IN RECENT U.S. EARTHQUAKES

### Abstract

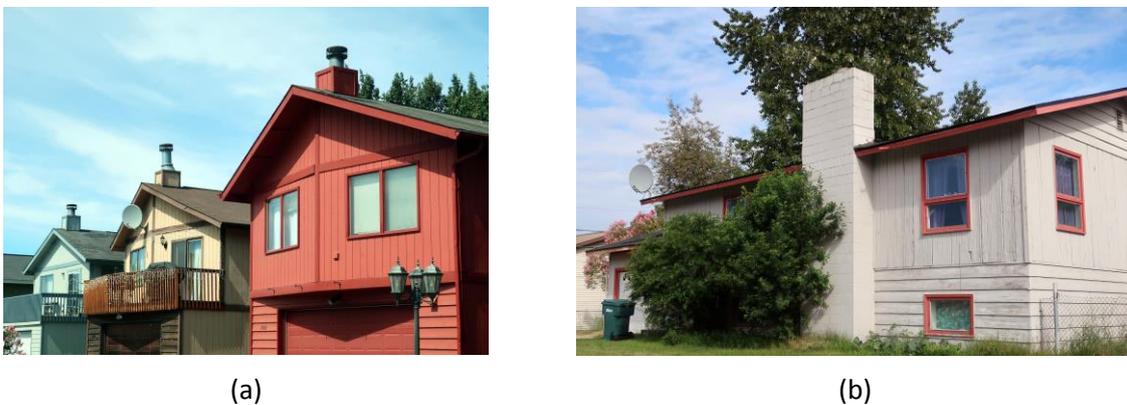
Chimneys on older homes typically consist of concrete block masonry with clay tile flues (Figure 4b). Homes masonry chimneys constructed after 1970 should have steel reinforcement and strapping to the home as required by the building code. However, there are some homes undoubtedly having vulnerable masonry chimneys (i.e., old plain masonry or deficient construction that evaded code).

Fig. 4 – Anchorage chimneys. (a) Metal chimney flue enclosed by wood-framed enclosure (1980s tract homes shown). These are found on newer homes. (b) Concrete block masonry chimney (home built in 1951). These are much fewer and found on older homes.

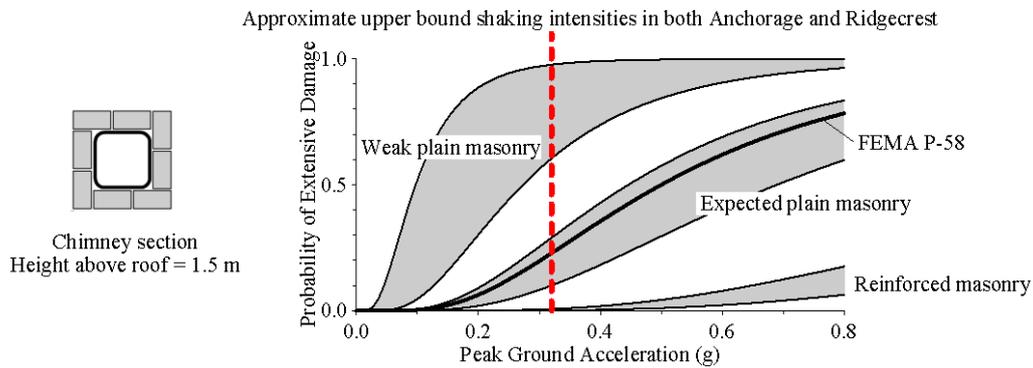
Since PGAs in Anchorage were about 0.32g, the fragility curves indicate that most reinforced chimneys had a negligible chance of extensive damage (Figure 6), consistent with observations. Older plain masonry chimneys of expected quality tensile strengths, which were in fewer numbers, might have been vulnerable by having 10 to 30% chance of extensive damage, where exposed to 0.32g PGA. Indeed, the few damaged chimneys observed seem to fit this situation. Weak masonry chimneys could be from inferior construction and these would have high likelihoods of damage. However, apparently these were rare because of the few incidents of reported damage, which reflects that the inventory of such chimneys was extremely small in Anchorage.

Fig. 6 – Chimney fragility curves for cracking at roof elevation causing extensive damage. Expected and weak plain masonry taken as having masonry tensile strengths, respectively, of 60 psi (0.41 N/mm<sup>2</sup>) and 10 psi (0.069 N/mm<sup>2</sup>) tensile strength. Reinforced masonry taken as having code-conforming four vertical rebar fully grouted into chimney. FEMA P-58 fragility curve with uncertainty parameter beta ( $\beta$ ) of 0.6 intended to reflect uncertainties in ground motions and component capacities [5].

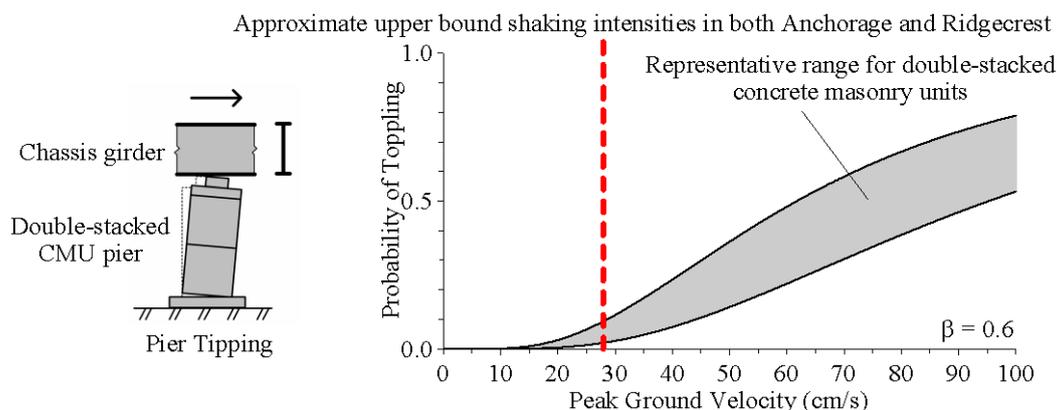
Figure 8 shows fragility curves for mobile homes based on South Napa California earthquake experience [4]. The curves are for unanchored homes supported only on piers (no tie-downs). It relates PGV to the likelihood of the home toppling due to tipping of concrete masonry piers. The function suggests that the PGVs in Anchorage of about 28 cm/s were such that mobile homes were very unlikely to topple *even if they were unanchored* (less than 10% chance). The good performance of mobile homes in Anchorage can be attributed largely to the shaking intensities being relatively low.

Fig. 8 – Fragility curves for mobile home toppling via tipping of piers. Curves are for *unanchored* mobile homes (no tie-downs) supported on stacked concrete masonry units (CMUs).

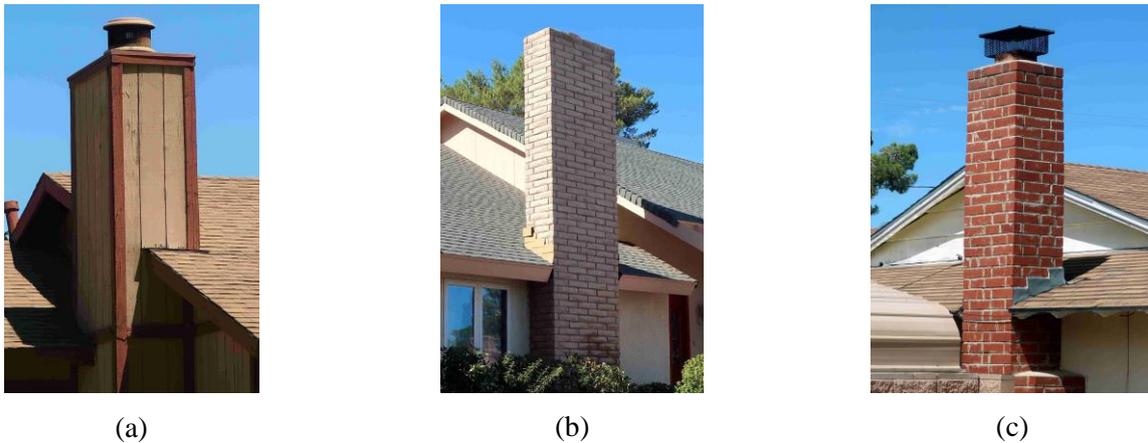
Fig. 10 – Typical Ridgecrest chimneys. (a) Metal chimney flue enclosed by rugged wood-framed enclosure. Home built in circa 1990. (b) Masonry chimney on home built in 1985. (c) Masonry chimney on home built in 1972.

No damage was observed to metal chimneys like the type in Figure 10a, and relatively few masonry chimneys were found to be damaged. A key factor contributing to damage appears to be deficient construction as illustrated by the following examples. Figure 11a shows a damaged chimney in a neighborhood having numerous tract homes built circa 1982. The chimney had the building code-required four vertical rebar, but the grout had voids thereby poor bonding to the bricks allowing them to fall away (Figure 11b). The neighboring homes were ostensibly the same (Figure 11c), yet suffered no damage suggesting that faulty construction played a role in the damaged chimney. Figure 12 shows more Ridgecrest damaged masonry chimneys exhibiting deficient construction. The grout had voids and no rebar was observed at places where the bricks fell away. Figure 13 shows a different type of damage where a masonry chimney pulled away from the home likely from deficient anchoring (strapping) of the chimney to the house floors and roof.
