## SEISMIC DAMAGE AT THE STATE OF MORELOS (MEXICO) DUE TO SEPTEMBER 19/2017 EARTHQUAKE

H. I. Archundia-Aranda<sup>(1)</sup>

### **Abstract**

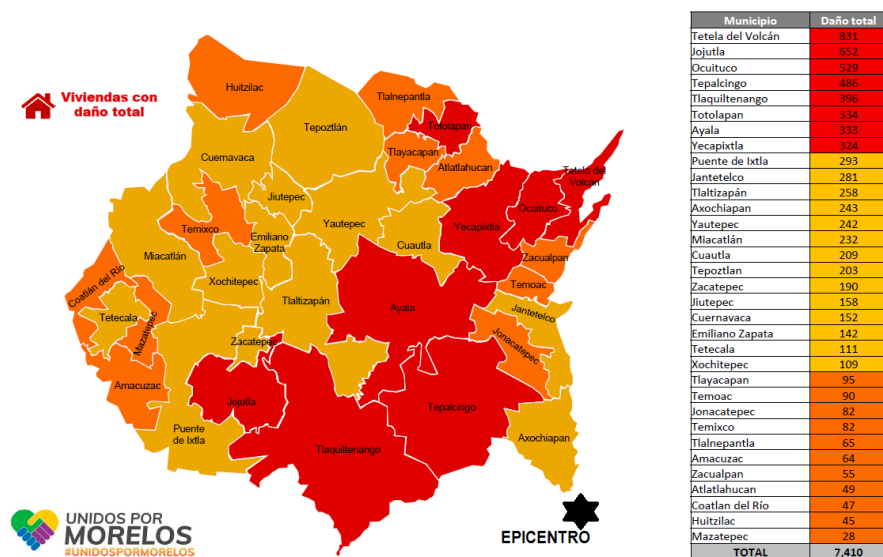
The damage distribution in Morelos caused by S/19/2017/E is presented in Fig. 7 and Fig 8 for housing and schools, respectively. As can be seen in Fig. 7, the major seismic damage in housing was concentrated at the south and east regions (red color in Fig. 7). This can be explained by the fact that both regions are close to the epicenter and they are predominant rural zones in which self-construction with masonry and reinforced concrete are very poor quality in materials and manpower, especially in suburbs (Fig. 9). In Morelos, 84% from the total schools were damaged [7]. The damage distribution in schools (Fig. 8) agrees with the level of urbanism and population. In the municipalities with the major urbanism and population there are the major quantity of schools and therefore more quantity of schools with damage (red color in Fig. 8). It is worth noting that, from decades, in Mexico the schools have to be designed with special seismic considerations. It is evident that something wrong has been happening with the seismic design of schools in Morelos (Fig. 10).

Fig. 7 – Damage distribution of housing (total damage) due to S/19/17/E [6]

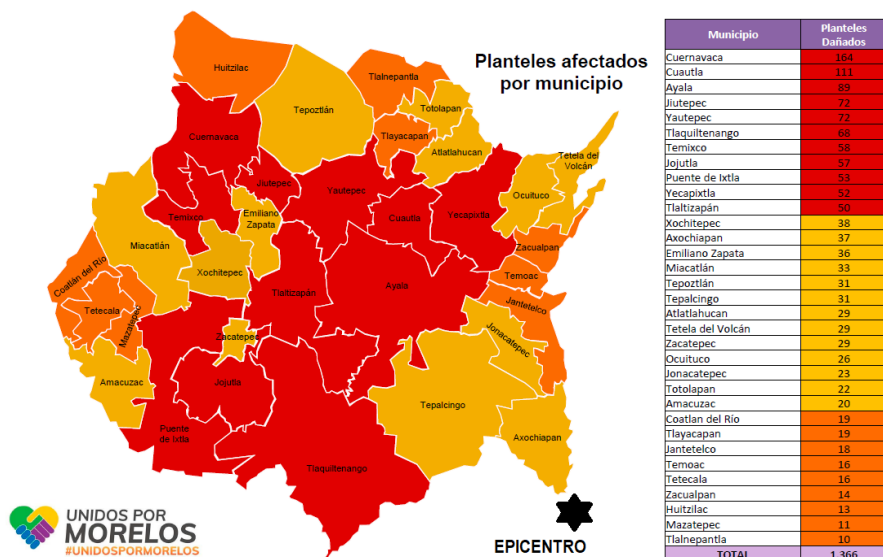
Fig. 8 – Damage distribution of schools (any level of damage) due to S/19/17/E [6]
