Response of school buildings after the September 2017 earthquakes in Mexico

S.M. Alcocer⁽¹⁾, D. Murià⁽²⁾, L. Fernández⁽³⁾, M. Ordaz⁽⁴⁾ J. Arce⁽⁵⁾

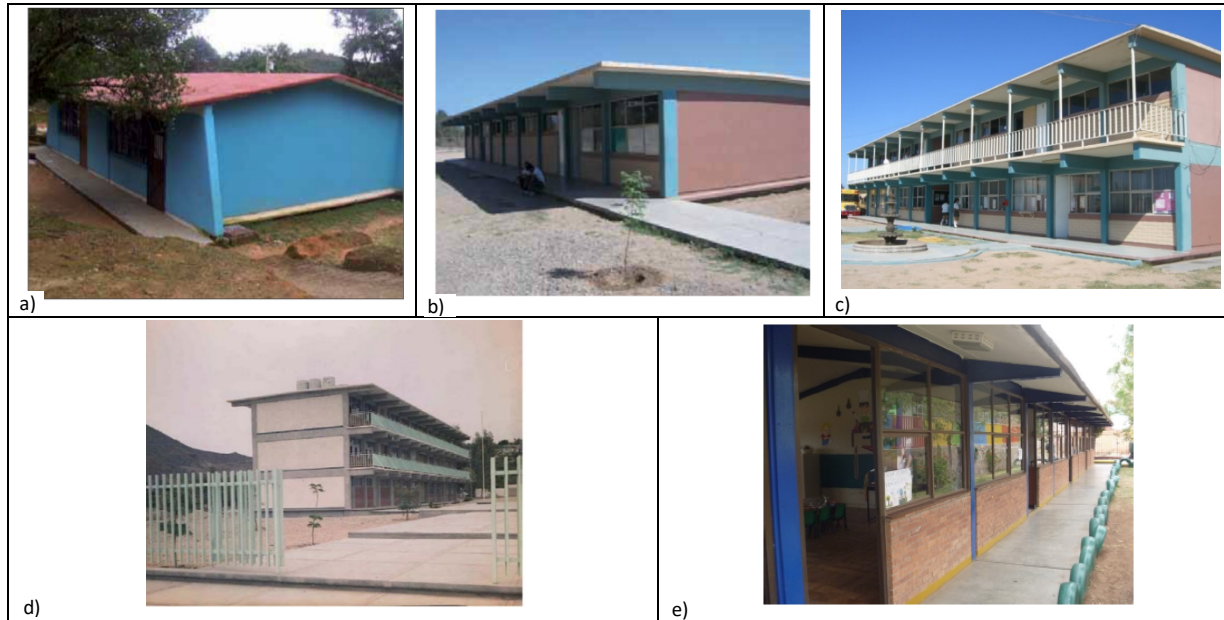
most often affected by the 2017 earthquakes are shown. When a building did not follow a prototype (either because materials or dimensions were distinctly different) or when different materials were used (like adobe or prefabricated walls), school buildings were classified as “atypical” (46% of all buildings were deemed to be “atypical”).

Fig. 1 – INIFED/CAPFCE school buildings prototypes [4]: a) Load-bearing masonry wall buildings - LBMW-, b) One-story concrete frame structure -U1C-, c) Two-story concrete frame structure -U2C-, d) Three-story concrete frame structure -U3C- and e) One-story steel building

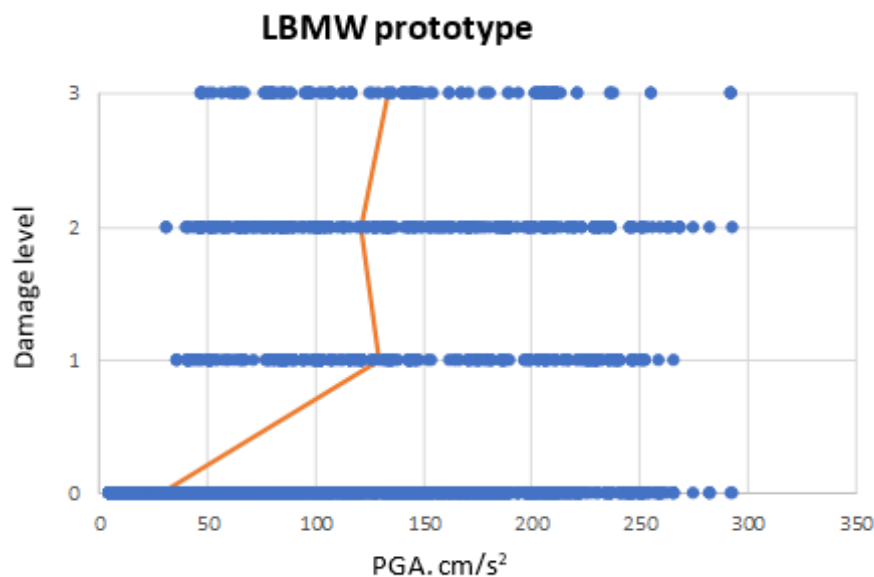
For masonry structures, as expected, the number of structures damaged and damage intensity diminished as epicentral distance increased [4]. The earthquake intensity (PGA) vs. damage level for the LBMW prototype is shown in Fig. 4. The relation between damage and intensity is not very robust. This could be attributed to the deficient quality and limited quantity of information.

Fig. 4 – Earthquake intensity (PGA) vs. Damage level for LBMW prototype for the September 7th, 2017 earthquake. Damage levels: 0=null, 1=low, 2=moderate and 3=severe. The orange line connects the median of the earthquake intensity at each damage level

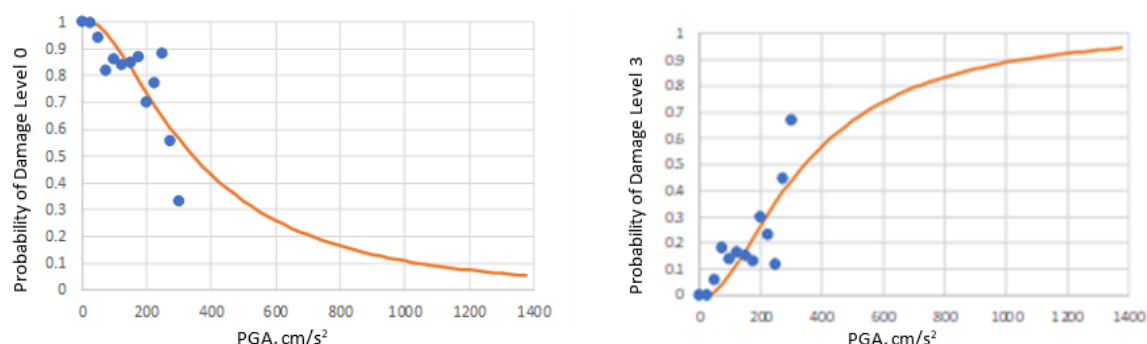
Empirical fragility functions were also developed. Four discrete damage levels (i.e. null, low, moderate, and severe) were used. Functions were calculated for peak ground acceleration (PGA) (Fig. 5) and wall shear stress [4]. In general, trends in empirical fragility functions were consistent with expected behavior: the larger the intensity, the higher the probability of more severe damage.

Fig. 5 – Empirical fragility curves obtained from damage distribution maps for damage level 0 and 3, respectively [4]. The orange line is the log-normal function adjusted to empirical data
