DAMAGE TO REINFORCED CONCRETE SCHOOL BUILDINGS BY 2016 KUMAMOTO EARTHQUAKE

S. Tajiri⁽¹⁾, Toshimi Kabeyasawa⁽²⁾, Toshikazu Kabeyasawa⁽³⁾

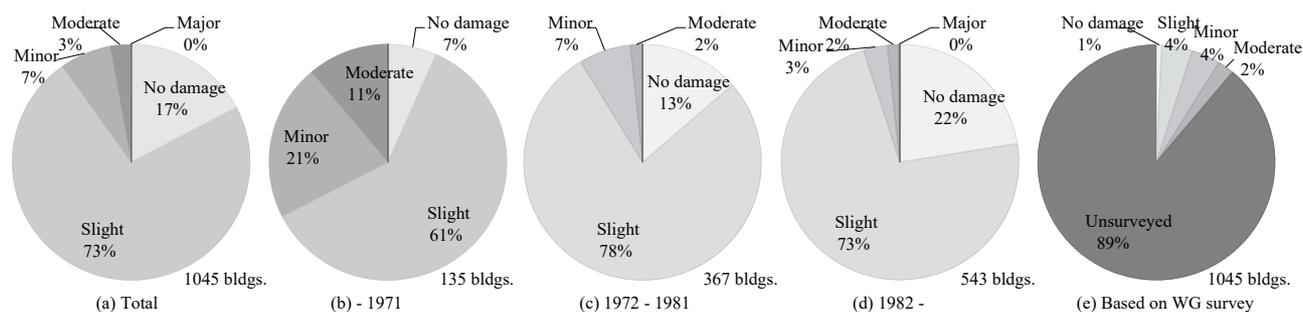
Fig. 2 – Damage rate in Kumamoto city ((a)-(d) are estimated damage rates)

Figure 2 shows the damage rates of the superstructure of the public school in Kumamoto. (a) to (d) show the estimated damage rates by total and construction year, and (e) shows the damage rate by the WG survey. According to (a) and (e), most buildings that were not surveyed in the WG survey were undamaged or minor damaged, and some were minor or moderate damaged. That shows the buildings which were surveyed in the WG survey were relatively severe damaged building. The estimated minor or more damage rate for all the buildings is 10%, but the damage rate varies depending on the construction year. The older the construction year, the higher the damage rate.

As mentioned above, connecting corridors and private school buildings were not included in the damage rate calculation here. In Kumamoto City, there were two corridors and four private school buildings which were major damaged. These are equivalent to about 0.6% of the number of the surveyed buildings.

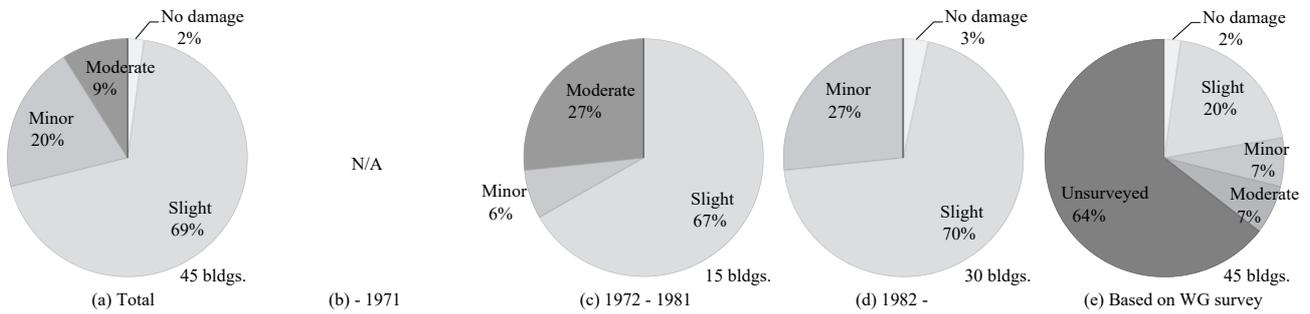
Fig. 3 – Damage rate in Mashiki town ((a)-(d) are estimated damage rates)

Figure 3 shows the damage rate in Mashiki town. The damage rate for minor or more damage is 29%, which is more than Kumamoto City. In Mashiki town, Japanese seismic intensity of 7 was observed, and many wooden houses collapsed, RC school building was relatively damaged as well. In addition, as in Kumamoto City, most of the damages of uninvestigated buildings were slight or less, and the older the building was, the higher the damage rate.

Connecting corridors were not included in the damage rate calculation as in Kumamoto city. In Mashiki town, there were two major damaged corridors, which correspond to about 4% of the number of surveyed buildings.

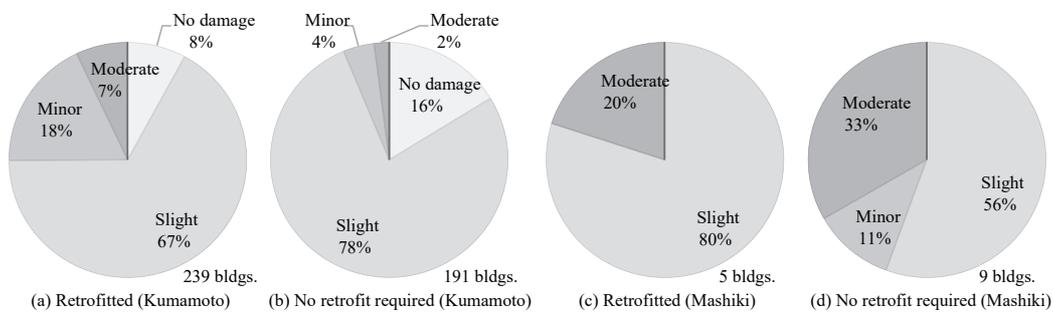
Fig. 4 – Damage rate of retrofitted buildings and buildings that do not require retrofit

Figures 4 and 5 show the damage rates of retrofitted buildings and buildings that had been constructed before 1981 and judged as unnecessary for retrofit by seismic evaluation for Kumamoto City and Mashiki Town, respectively. Although almost all of public schools in Kumamoto City and Mashiki Town was earthquake resistant, the number of buildings constructed before 1981 does not match the number of buildings seismic evaluated in Figs. 2 to 4. This is because Fig.4 includes small buildings that were not subject to seismic evaluation. There is a big difference between the damage rate of retrofitted buildings and those without retrofit. Focusing on Kumamoto city which has much more buildings than Mashiki town, retrofitted buildings has higher damage rate of minor and moderate damage than those without retrofit. Fig.5 is the numbers of public schools in Kumamoto city by seismic performance index and damage level. This figure shows the retrofitted buildings tend to have lower seismic performance than the buildings without retrofit. That may be because most retrofitted buildings are designed to meet barely the criteria for retrofit. That is considered to be one of the causes of the higher damage rate of minor and moderate damage in retrofitted buildings.
