ANALYTICAL STUDY OF RC BUILDING WITH SOFT FIRST STORY DESIGNED AFTER 1981 AND DAMAGED IN THE 2016 KUMAMOTO EARTHQUAKE

R. Wakamatsu⁽¹⁾, T. Mukai⁽²⁾, H. Kinugasa⁽³⁾, Y. Matsuda⁽⁴⁾

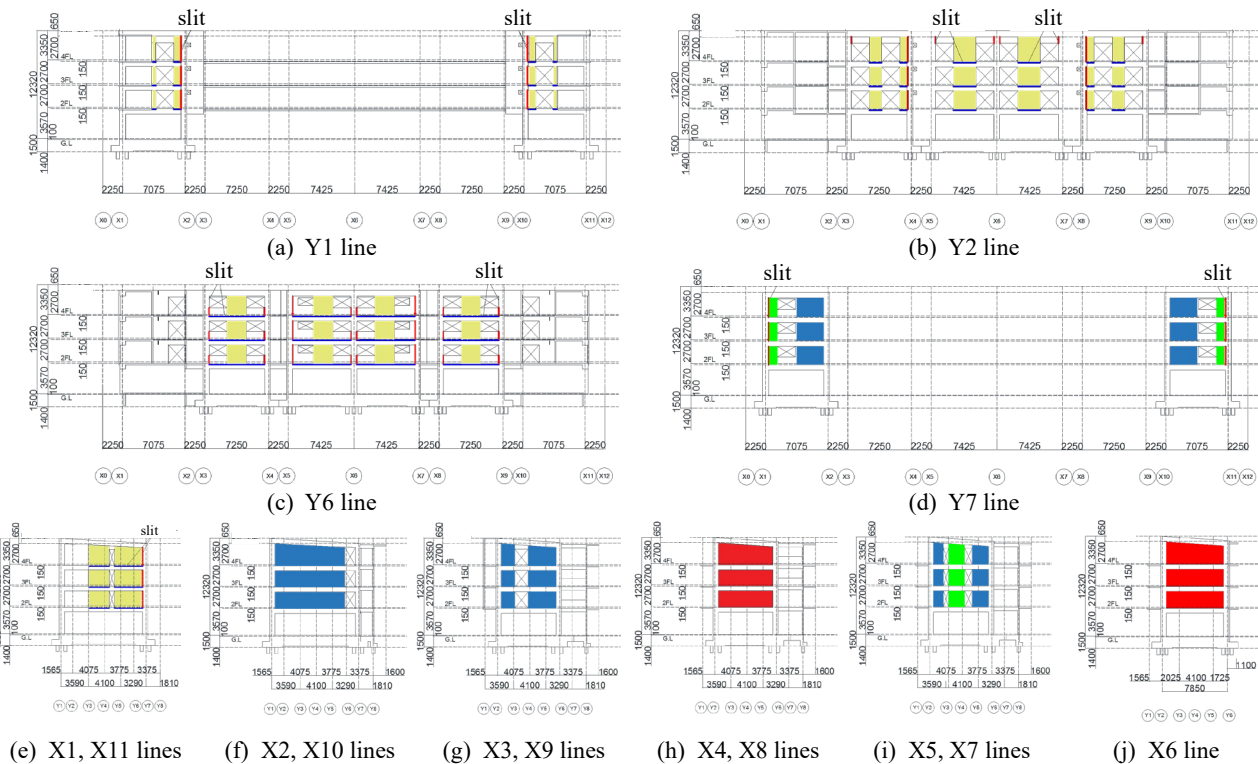
Fig. 2 – Framing drawings including categorization of walls (unit: mm)

The categorization of walls is shown in Fig. 2.

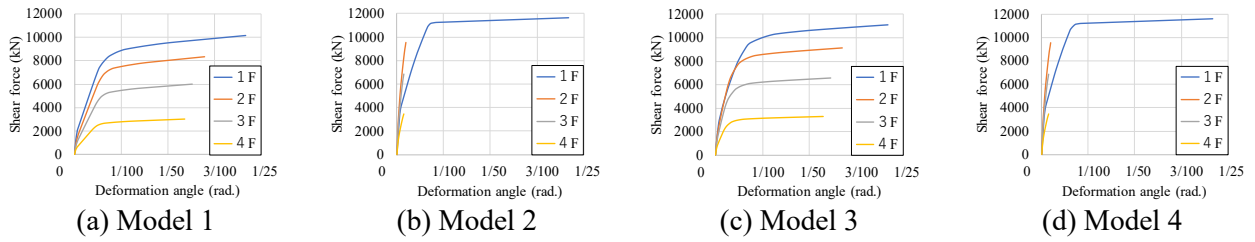
Figs. 5 and 6 show the story shear force deformation angle relationships in the long and short directions, respectively, which were obtained from the static increment analysis of each model. Figs. 7 and 8 provide plots of the maximum inter-story deformation angle in the long and short directions, respectively, for each model obtained from the dynamic response analysis using seismic waves from the foreshock and main shock of the 2016 Kumamoto earthquake. The present study focused mainly on the soft first story because the target building had a soft first story and damage was concentrated on this story.

The story shear force obtained from the static increment analysis on a multi flame model is discussed. Model 1, where the long direction was a pure open frame and the short direction was an open frame with partially sheared walls, and model 3, where the frames in the long direction were walls with slits on three sides, are compared first. The first story shear force in the long direction was 10000 kN and 11000 kN in models 1 and 3, respectively (Fig. 5). The first story shear force of model 3 was 1.1 times larger than that of model 1 and no deformation concentration was found on the first story. Story shear stresses for the other stories of model 3 were approximately 1.1 times larger than those of model 1. The story shear force of model 2, where frames in the long direction were walls with slits on two sides, was 1.15 times larger than that of model 1 for the first story in the long direction (Fig. 5). Here, the deformation concentration on the first story was observed as per the actual damage. Using walls with slits on two sides increased the horizontal stiffness of the second story and higher stories that had walls, resulting in deformation concentration on the first story.

Comparing models 2 and 5 where the five flames were connected by pinned beams and slabs, respectively, there was no great difference in the story shear force in either the long or short directions (Figs. 5 and 6) based on the static increment analysis. The inter-story deformation angle from the dynamic response analysis did not show great differences in either the long or short directions (Figs. 7 and 8); thus, they were almost the same. Therefore, the effect of slabs on the building response was very small and the differences in the multi flame modeling barely affected the response.

Fig. 5 – Comparisons of Q-R curves (The long direction)

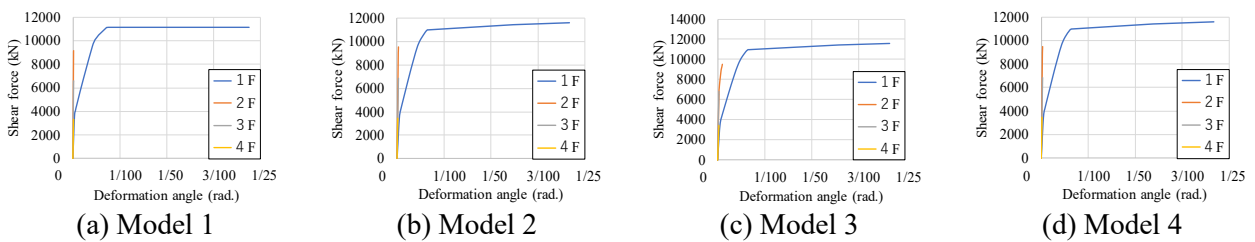
There was no great difference in the short direction first story shear force of models 1, 2, and 3 for the entire building (Fig. 6). However, the end (X1) face damage was intense in its actual damage. The shear and axial forces on the first story end (X1) face were compared. The shear force for model 1 was smaller than

Fig. 6 – Comparisons of Q-R curves (The short direction)

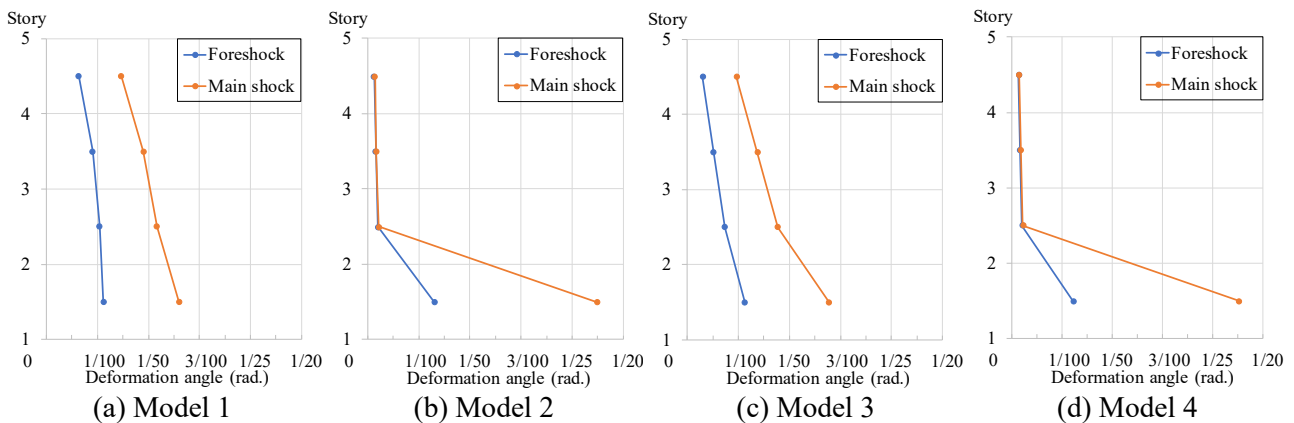
The dynamic response analysis results showed that between model 1, where the long direction was a pure open frame and the short direction was an open frame with partially sheared walls, and model 3, where the frames in the long direction were walls with slits on three sides, the deformation along the long direction was smaller in all stories for model 3 for the foreshock seismic waveform (Fig. 7). However, the deformation for the first story was larger in model 3 than that in model 1 for the main shock seismic waveform. Considering that the walls increased their stiffness in the second and higher stories, the deformation of the first story became larger. The effect of the walls was more profound in model 2, where frames in the long direction were walls with slits on two sides. Here, the stiffness in the second and higher stories was very large and the deformation of the first story was extremely large.

Fig. 7 – Maximum story deformation angle (The long direction)

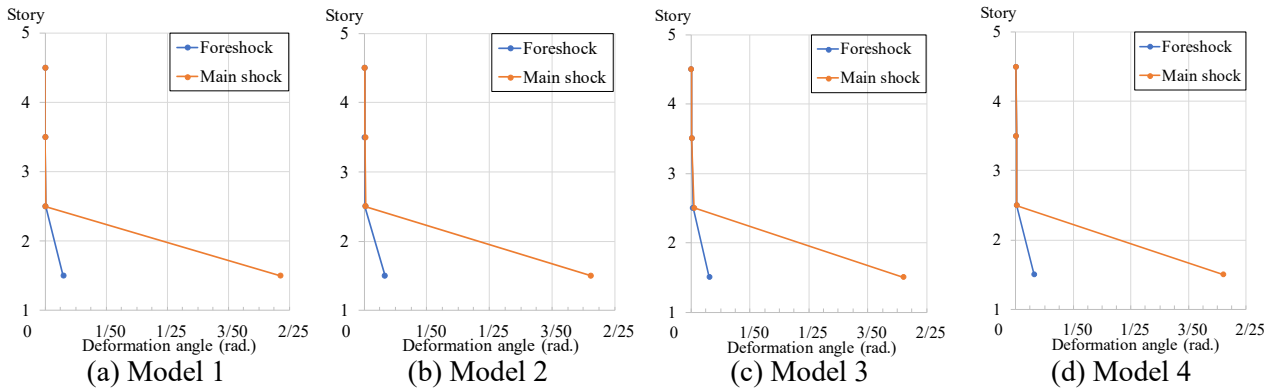
There was no great difference between models 1, 2, and 3 in the inter-story deformation angle in the short direction, even though the first story deformation angle in model 1 was slightly larger (Fig 8). The only difference between models 1, 2, and 3 in the short direction was that of the slit conditions of the end (X1) frame. Model 1 did not consider walls in the end (X1) frames; thus, the increase in deformation was attributed to the increased eccentricity in the X1-2 wing.

Fig. 8 – Maximum story deformation angle (The short direction)

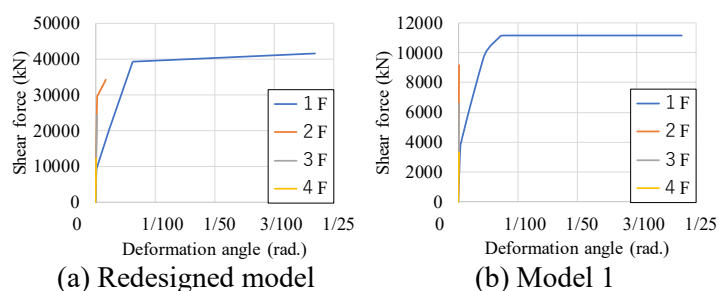
The static increment analysis showed that the base shear coefficient exceeded 0.5 and the bending fracture was the preceding fracture mode. The maximum tensile and compressive axial forces with a positive load in the short direction were 1218 and 1245 kN, respectively. In contrast, with a negative load in the short direction, the maximum tensile and compressive axial forces were 1229 and 1257 kN, respectively, and the tensile maximum pillar top moment was 2365 kN·m. The final bending moment of a pillar calculated using these axial forces was 2516kN·m. The first story shear force with the redesigned pillars was 3.7 times that of model 1, where modeling conditions were the same except for pillars on the first story (Fig. 11). Therefore, the proof stress improved significantly.

Fig. 11 – Comparisons of Q-R curves

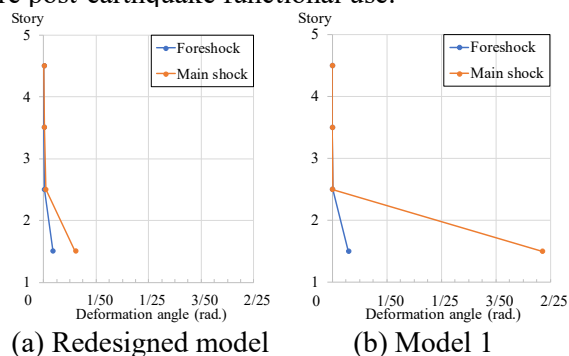
The dynamic response analysis showed that the maximum inter-story deformation angle of the first story was 0.5 and 0.15 times for the foreshock and main shock, respectively, in the redesigned soft first-story pillar mode compared to that of model 1, where modeling conditions were the same except for pillars on the first story. Thus, the deformation in the redesigned pillar model was much smaller than that in model 1.

Fig. 12 – Maximum story deformation angle
