## MEXICO EARTHQUAKE OF SEPTEMBER 19, 2017: CORRELATION BETWEEN SITE EFFECTS AND STRUCTURAL DAMAGE

*Keywords: Mexico City, soft soil, collapsed buildings, seismic intensities, September 19*

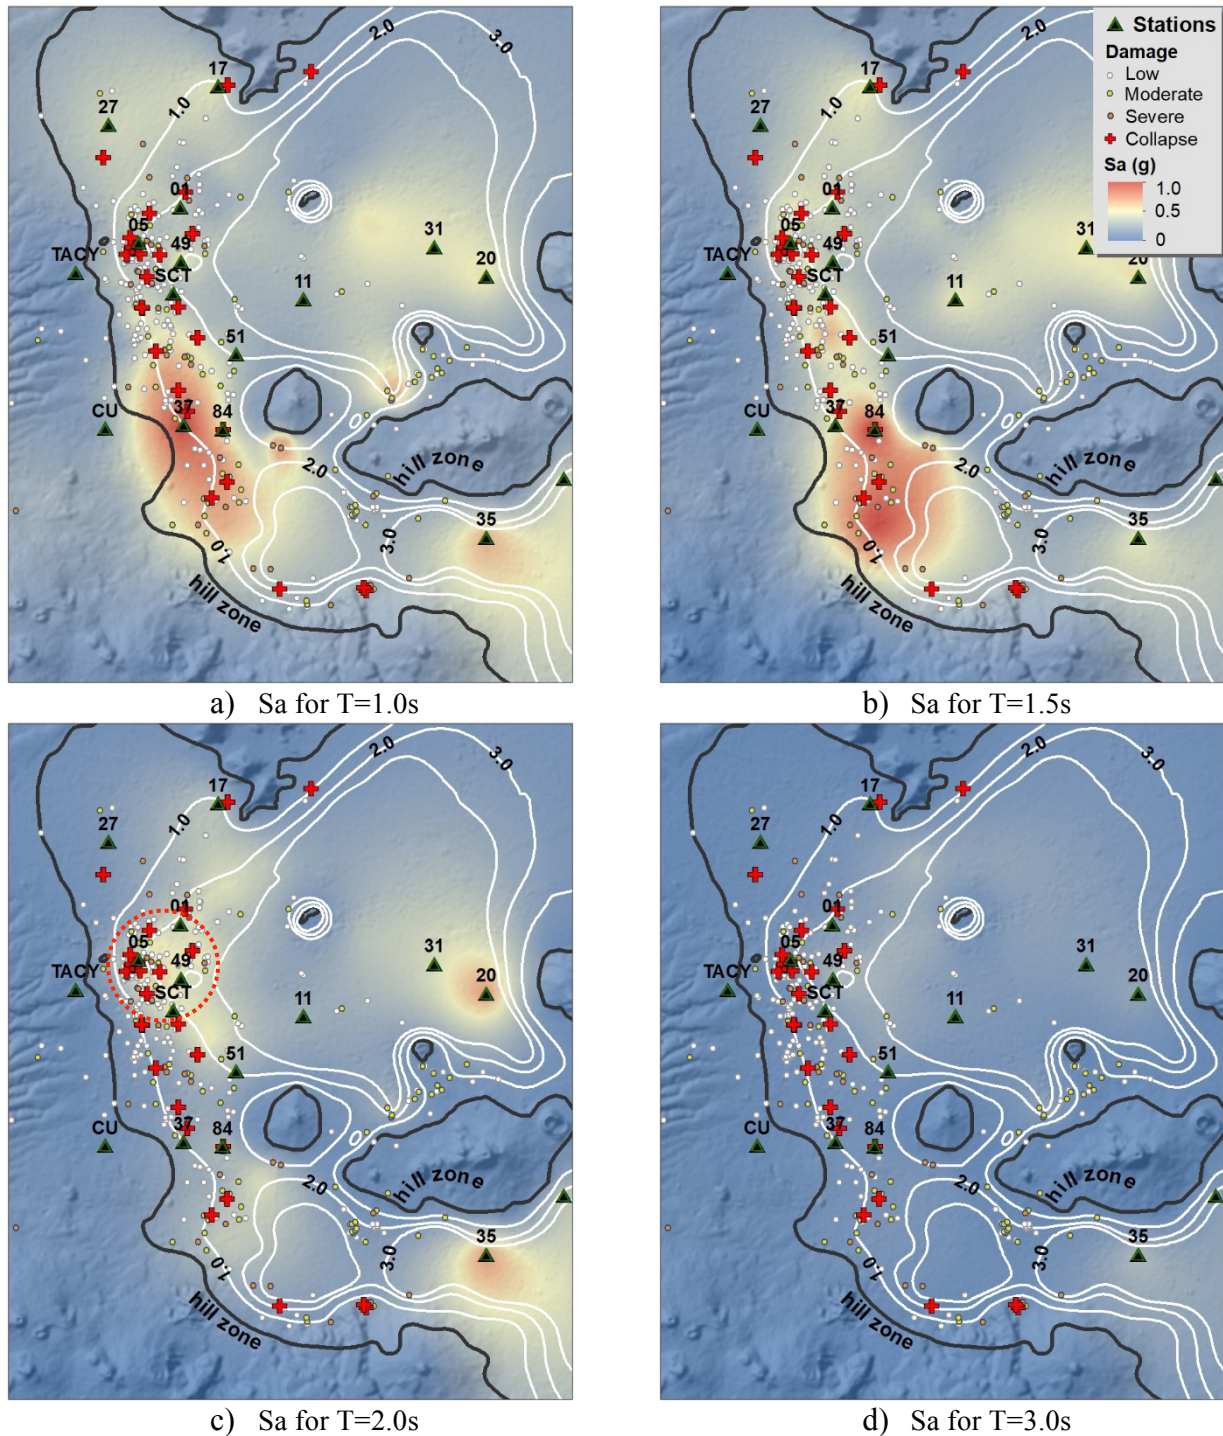
Fig. 1 shows the distributions of pseudoacceleration intensities ( $S_a$ ) for the geometric mean of both orthogonal components recorded for September 19, 2017 earthquake and for single-degree-of-freedom (SDOF) systems with periods  $T=1.0, 1.5, 2.0$  and  $3.0$ s, together with the location of damaged buildings (from moderate damage to total collapse). The charts also include the dominant soil periods for the basin of the Valley of Mexico (contour lines). The soil of Mexico City is very particular and has been studied for several decades. For some frequencies, the amplification can be up to 500 times with respect to the expected amplification at long epicentral sites [3]. A large part of Mexico City is located on the ancient Texcoco lake, therefore in certain areas of the city, the clay deposits depth reaches several tens of meters. Sites at the lakebed zone near the international airport zone (stations 20 and 31) reach dominant periods over 5.0s with very large amplifications with respect to the hill zone.

As shown in Fig. 1, the zones with soil periods between 1.0 and 1.8s had the largest intensities, even reaching values of  $S_a \sim 1.6$ g in station 84 ( $T_g=1.4$ s), coinciding roughly with the zones with reported damage. Although there is a strong correlation between intensities, soil dominant periods (soil amplifications) and damage, for certain zones, such as the downtown ( $T_g \sim 2.0$ s) is not enough to explain the severe structural damage pattern of the area (shown inside the circle in Fig. 1c). Figure 1d exhibit that intensities for periods larger than 3.0s are smaller, and slight damage was to be expected in those areas; however, the second and third vibration modes (with periods between 0.6 – 1.5s), presented relatively high intensities, as shown in Fig. 1b, so the damage was considerable due to the contribution of these modes.

Fig. 1 – Pseudoacceleration maps for the September 19, 2017 earthquake for different periods. a) 1.0s, b) 1.5s, c) 2.0s and d) 3.0s. The damaged buildings are shown with a red cross

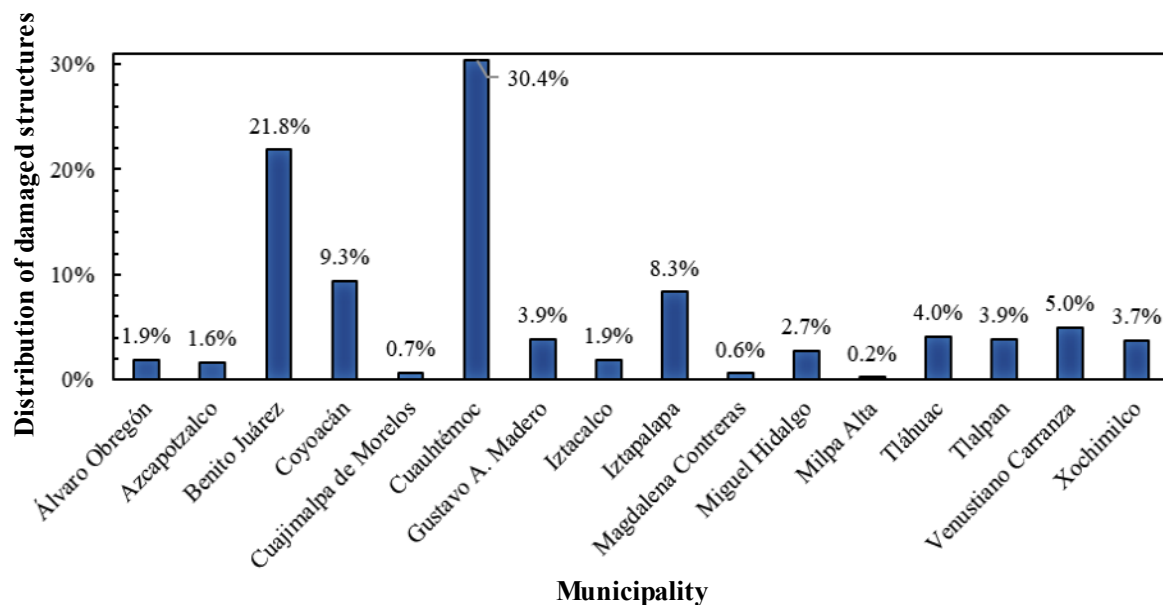
Due to the characteristics of the 2017 earthquake, the damage was mainly concentrated in structures between 1 to 9 stories, which represent about 80% of structures reported with severe damage. The damage is also linked to the zone of the city, since the site effects in the lakebed of the Valley of Mexico change in a few dozens of meters. Figure 2 shows the damage distribution given by the Municipality. As can be seen, the most affected municipalities are Benito Juárez and Cuauhtémoc.

Fig. 2 – Distribution of damage reported in 2017 earthquake according to the municipality

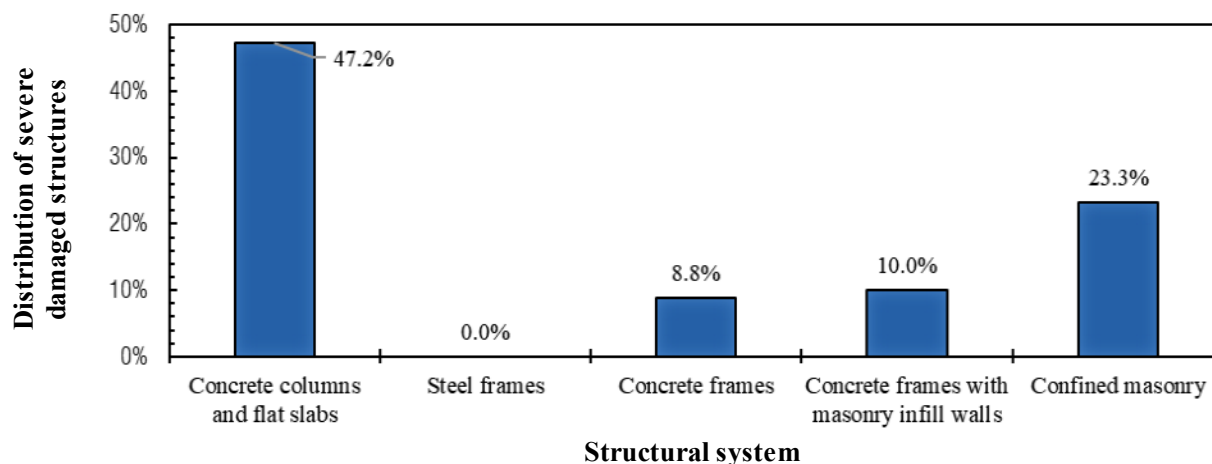
Fig. 3 – Distribution of structures with severe damage according to the structural system

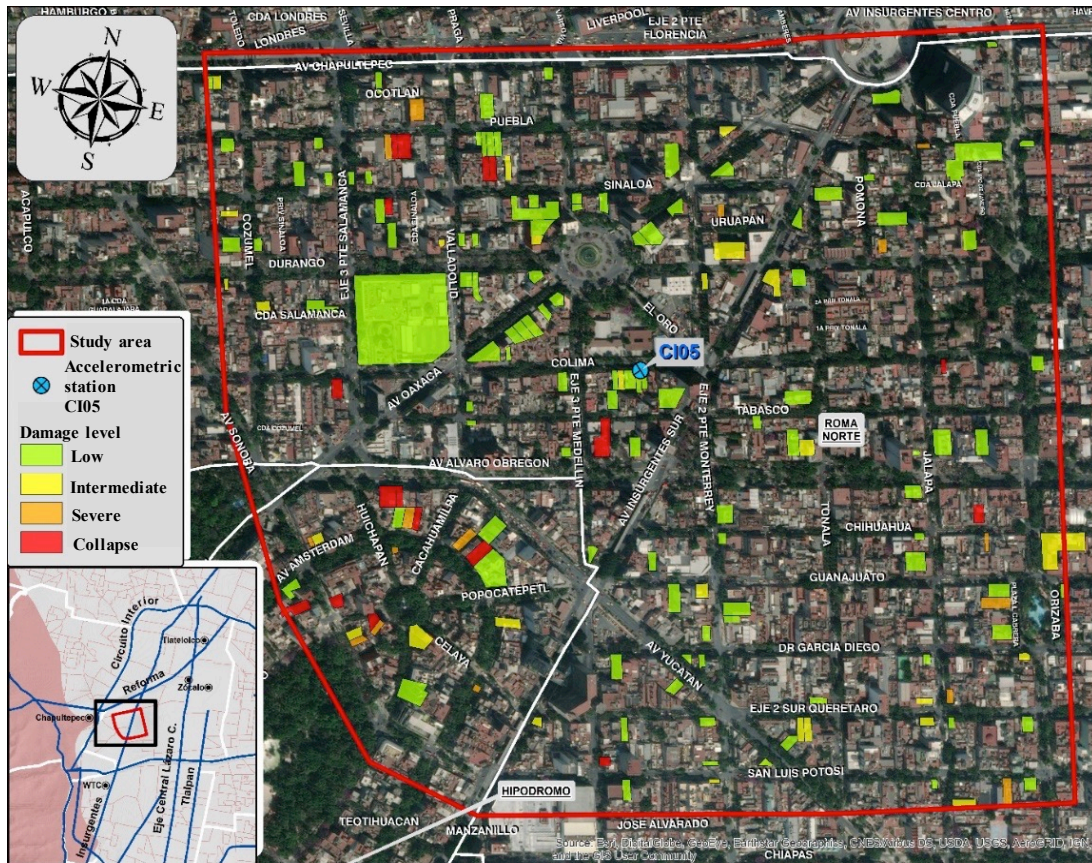
Fig. 4 – Map of the area of study showing the location of the accelerometer station CI05 and buildings with different levels of damage

In the area of study shown in Fig. 4, 1923 buildings were found, 91% of which were not damaged, while less than 1% had partial or total collapse.

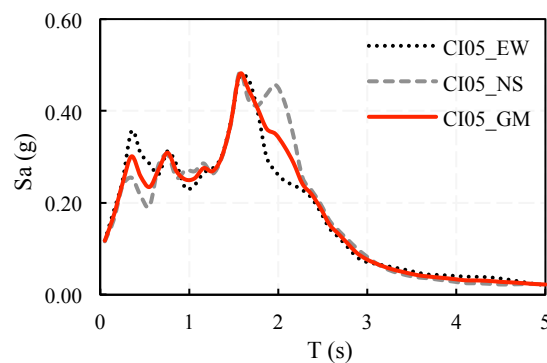
Figure 5 shows the pseudoacceleration demands ( $S_a$ ) for station CI05 for both horizontal components of motion and for the corresponding geometric mean; this geometric mean is the demand used in this work hereafter. As can be seen in Fig. 5, the demands for both orthogonal components are similar for most periods, so using the geometric mean would not exclude directionality effects.

Fig. 5 – Pseudoacceleration spectra for station CI05

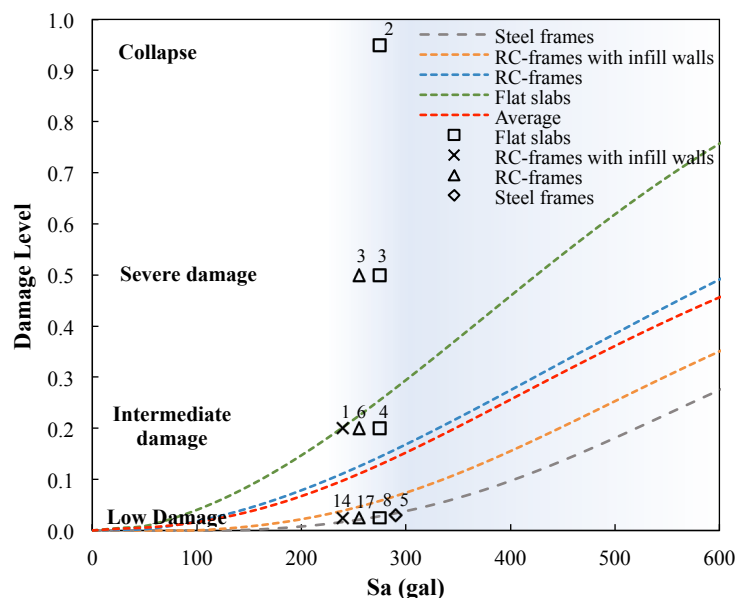
To understand the level of seismic resilience of the structures that were damaged in Mexico City, a statistical analysis of damaged structures was carried out, by identifying different structural pathologies. In the case study area, there was the collapse of the building located in Álvaro Obregón 286, an office building of 7 levels, structured with RC (Reinforced Concrete) columns and flat slabs, built-in 1958. In the same zone, 63 buildings between six to eight were found and analyzed (damage viewer, ERN, 2017 [5]). Those buildings had different damage levels and structural typology. Having structures of similar height, delimited in a small area to reduce differences in the site effects, allowed focusing on the influence of the structural configuration and the pathologies of each building. These 63 buildings were classified into four structural types: 1) flat slabs, 2) Reinforced concrete frames (RC frames), 3) RC frames with masonry walls and, 4) steel frames. Figure 6 shows the comparison of damage between the four structural types. Each symbol corresponds to a structural system and the number above each one corresponds to the number of structures of each structural system, indicating the total number of buildings in each damage level. The blue band corresponds to the accelerations demanded by the structures according to its estimated period (which depends on the structural type) and the spectra of station CI05. Figure 6 also shows typical vulnerability curves for the full range of intensities for the four structural types and the mean curve. These vulnerability curves were constructed with analytical models and calibrated with the statistical data for the acceleration demands of the acceleration band of Figure 6. As can be seen in this figure, most of the structures suffered only minor or intermediate damage (55 structures), six had severe damage and two structures collapsed. The buildings with severe damage were those of RC frames and flat slabs, while the collapses occurred in the flat slab buildings. The most vulnerable structural system was by far flat slabs, while less vulnerable systems were steel frames and dual systems.

Fig. 6 – Comparison of damage levels of the four structural types studied [10]

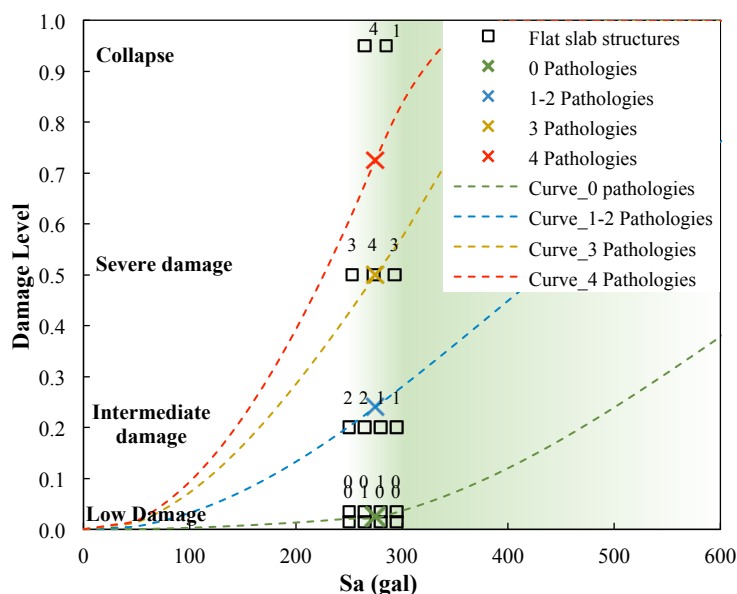
this structural type. In the same figure, each square represents a building, and the number above each one indicates the number of pathologies found in that building. The vulnerability curves, empirically constructed from the observed data, and affected by the influence of the pathologies are presented. As can be seen in this figure, although the flat slab system itself has a high vulnerability, the level of damage increases considerably with the number of structural pathologies. Although the structural system defines the seismic behavior of the structure, it is clear that the structural pathologies may affect this behavior by very large factors. Therefore, to assess correctly the seismic resilience of any building, it must be analyzed comprehensively, considering in a realistic way the pathologies that affect its behavior.

Fig. 7 – Damage levels only for buildings with a flat slab structural system, and the influence of pathologies on the structural performance [10]

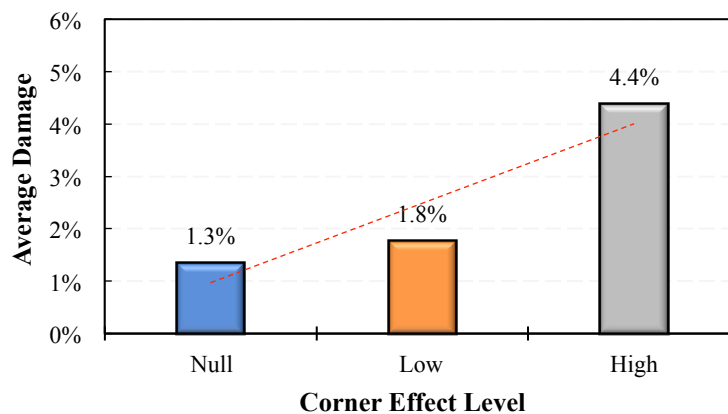
Fig. 8 shows the average damage of buildings according to the assigned level of corner asymmetry. It can be seen that, for the total of buildings in the case study zone, even with null corner asymmetry, there is 1.4% of average damage (this value is very similar to the average loss of all the area of study and it is due to other pathologies and characteristics that caused damage) while buildings with high corner asymmetry represent 4.5% of damage. It is very clear that there is a strong correlation between corner asymmetry and damage: having a strong corner asymmetry increased the observed damage by a factor of 3.2.

Fig. 8 – Statistics of average damage on corner buildings according to the level of corner effect [10]

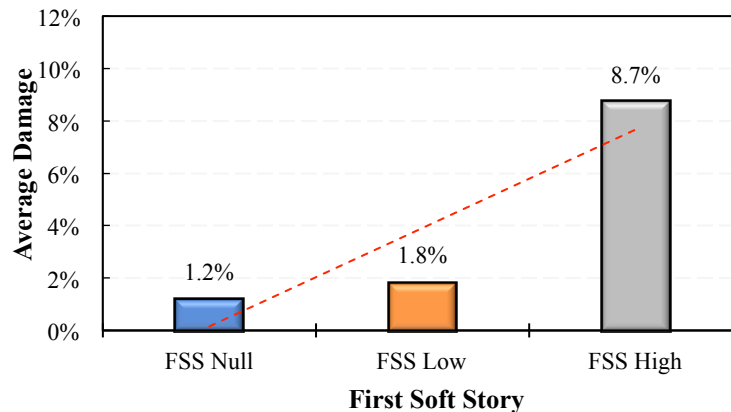
Of all 33 buildings with severe or total damage in the case study zone, 10 (30%) had a soft story pathology. According to the database, 275 buildings had first soft-story (FSS), of which 229 had no damages, 28 suffered minor damages, 8 intermediate damages, and 5 severe damage or total collapse. This pathology had a higher impact in the damage statistics than the corner asymmetry. There is a very strong correlation between FSS and damage: having a high FSS increased the observed damage by a factor of 7.3.

Fig. 9 shows the average damage in buildings according to their level of FSS. As it is observed, there is a considerable increase in the average damage depending on the level of FSS; damage goes from 1.2% when there is no FSS to 8.8% when buildings have an intense FSS effect.

Fig. 9 – Statistics of average damage on buildings damaged by the earthquake according to the assigned level of first soft story [10].

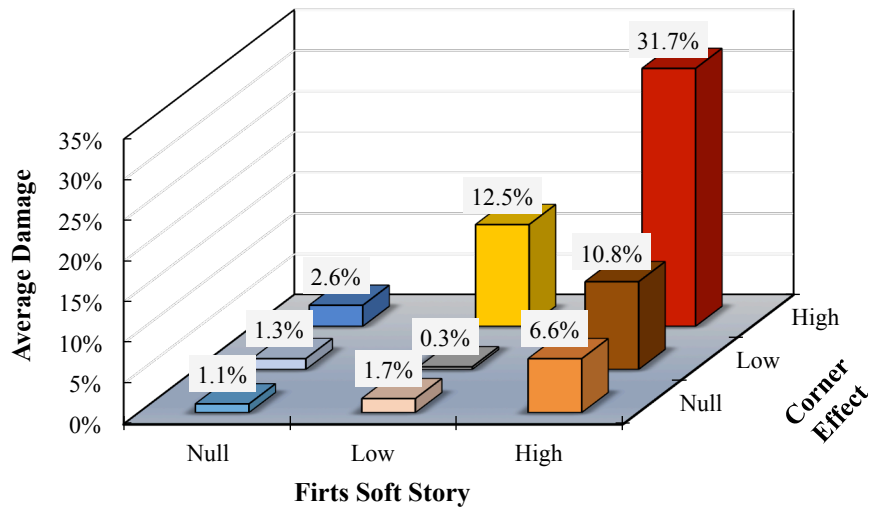
Out of all damaged buildings, 4% presented both pathologies, 10% only have FSS, 13% only corner asymmetry, while the rest (73%), have other or null pathologies. Fig. 11 shows the average damage when the buildings have either one or both pathologies. As can be seen, the most critical condition is the combination where both pathologies are presented with the largest values, reaching an average of 31.7%, this means, total damage for one out of three buildings.

As it is shown in Fig. 11, 31.7% of the actual damage reported is presented in buildings that have high-intensity levels of both pathologies. Likewise, when buildings have a level high of one of each pathology, and low of the other one, the damage is also considerable (between 10.8 and 12.5%).

Fig. 11 – Statistics of buildings, which have either one or both pathologies in the area of zone [10]

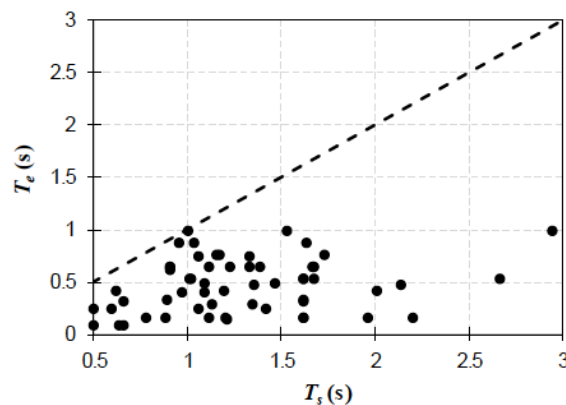
Figure 12 shows the relation between the estimated dominant period of the structure [11] and the dominant period of the site [3]. It can be seen that only one of all collapsed structures was in the line of resonance, but most of all structures were far from this line. It is also clear that no structure had a period larger than the site, which means this condition may put the structure in the safe side.

Fig. 12 – Relation between the dominant period of the site and the dominant period of the structure. The dotted line marks perfect resonance [12].
