A STUDY ON DAMAGE INVESTIGATION OF DAMEGED BUILDING DUE TO THE 2016 KUMAMOTO EARTHQUAKE

Abstract

A reinforced concrete building was damaged by the 2016 Kumamoto earthquake. Functional use of the building was not allowed after the earthquake due to tilt and settlement of the building. The building has deep foundation system with precast concrete piles. Several damage investigations were carried out for the foundation system and structural members of superstructure in the building.

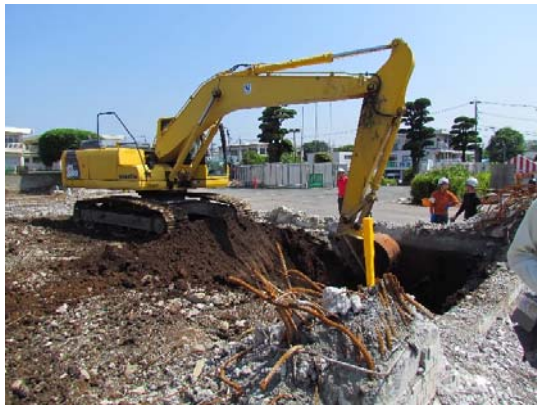
(a) Digging by excavator

1. Demolition of superstructure.
2. Demolition of first floor RC slab, however, foundation beams, footings and piles were not demolished.
3. Digging investigated areas using excavator. (Fig. 4 (a))
4. Digging around the pile to one meter below the level of footing undersurface by manual. (Fig. 4 (b))
5. Observation of foundation beams, footings and piles.
