## SEISMIC PERFORMANCE ESTIMATION BY RESPONSE ANALYSIS OF A BUILDING DAMAGED IN THE 2016 KUMAMOTO EARTHQUAKE

*Keywords: Seismic performance estimation; R/C building; Damage evaluation; Observed record; 2016 Kumamoto EQ*

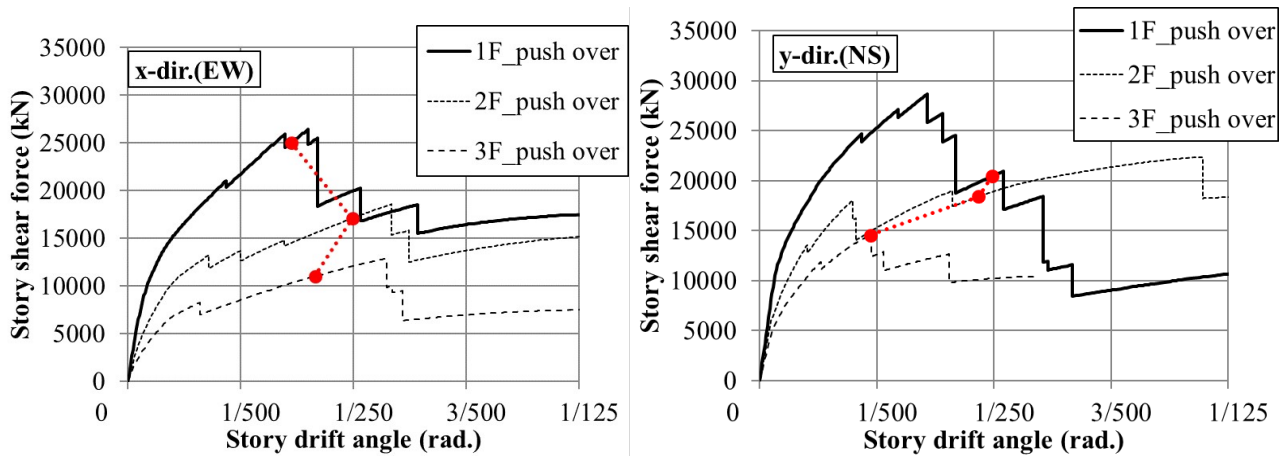
Fig. 5 – Story shear force and drift angle of x and y-direction

The relationship between story shear force and drift angle of x and y-direction is shown in Fig. 5. Further, although the push over analysis was carried out by maintaining the shear strength of the shear failure member, in the figure, the subtracted story shear force is shown. The story deformation angle at 1/250 is also shown because the ultimate lateral load-carrying capacity ( $Q_u$ ) was determined at 1/250 for shear failure.

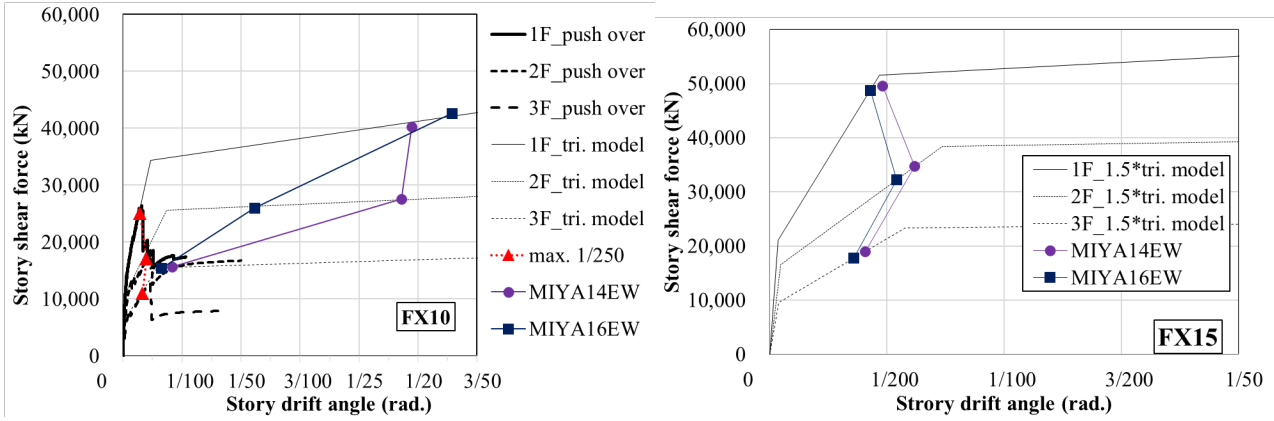
Fig. 8 – Response shear and drift angle in each story of FX10 and FX15 in x-direction (EW)

The maximum response drift angle of each story by the input motion of the 1<sup>st</sup> floor observed record in x-direction (EW) are shown in Fig.8 comparing FX10 to FX15. The 1<sup>st</sup> story drift angle of FX10 exceeded 1/20 though the expectation angle from the damage was 1/250 due to the residual shear crack width and damage level shown in Photo 2, Photo 4, and Fig. 4, but that of FX15 was 1/200 which could explain the damage. That is, structural evaluation by Japanese design standard gives the safer results for the expectation of damage, and in order to expect the real response, in this analysis, almost 1.5 times stiffness and strength of story shear force drift angle relationship from the static push over analysis would be reasonable in consideration of the influence by the force distribution, by the actual higher material strength than the design use, and by the slab effective width and rebar adding to the beams.

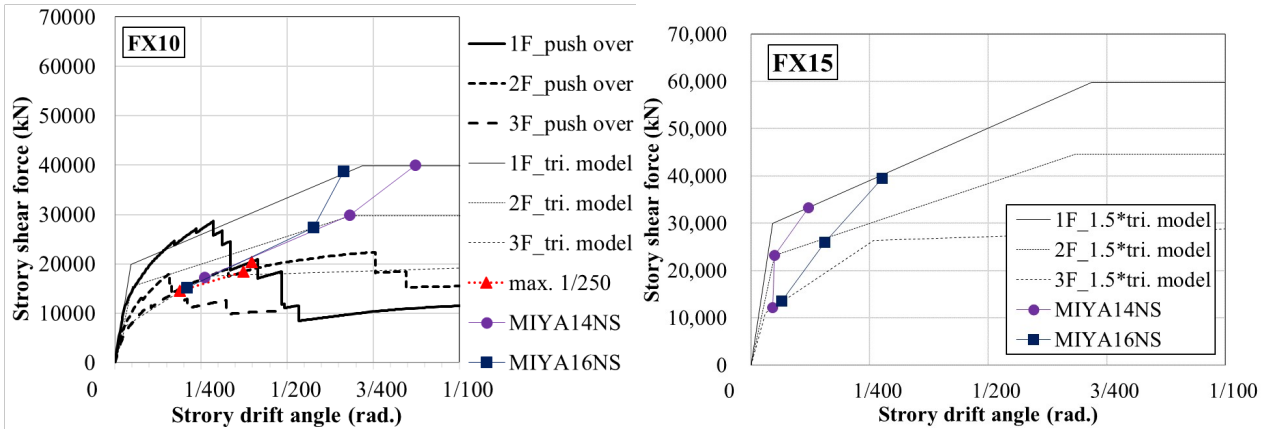
Fig. 9 – Response shear and drift angle in each story of FX10 and FX15 in y-direction (NS)

The maximum response drift angle in y-direction are shown in Fig.9. The same results as x-direction also concluded from the response of y-direction. The maximum drift angle of FX15 responded about 1/400 which damage level showed in y-direction in Photo 3 and Fig. 4.

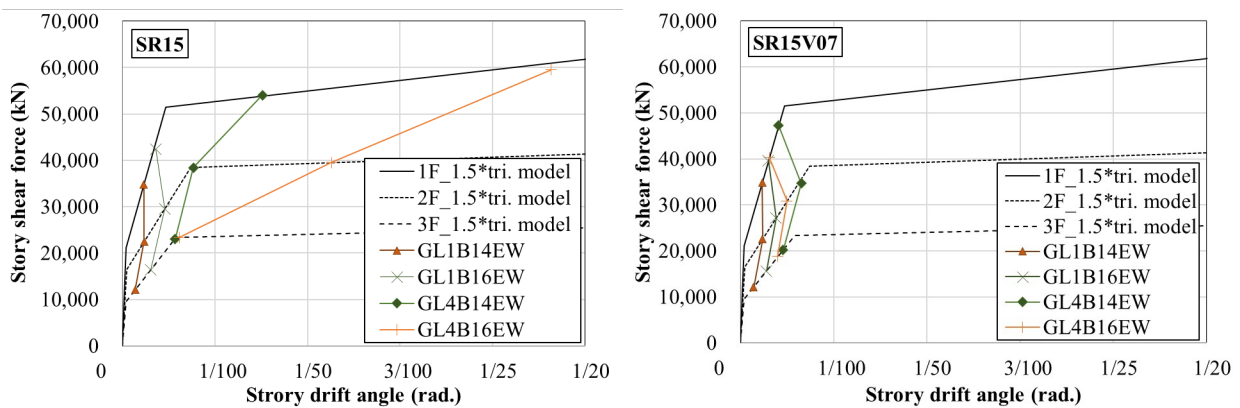
Fig. 10 – Response shear and drift angle in each story of SR15 and SR15V07 in x-direction (EW)

The maximum response drift angle of each story by the input motion of the ground analysis record in x-direction (EW) are shown in Fig. 10 comparing SR15 to SR15V07. The 1<sup>st</sup> story drift angle of SR15 exceeded 1/25 though the expectation angle from the damage was 1/250, and that of SR15V07 was 1/250 which conformed to the damage.

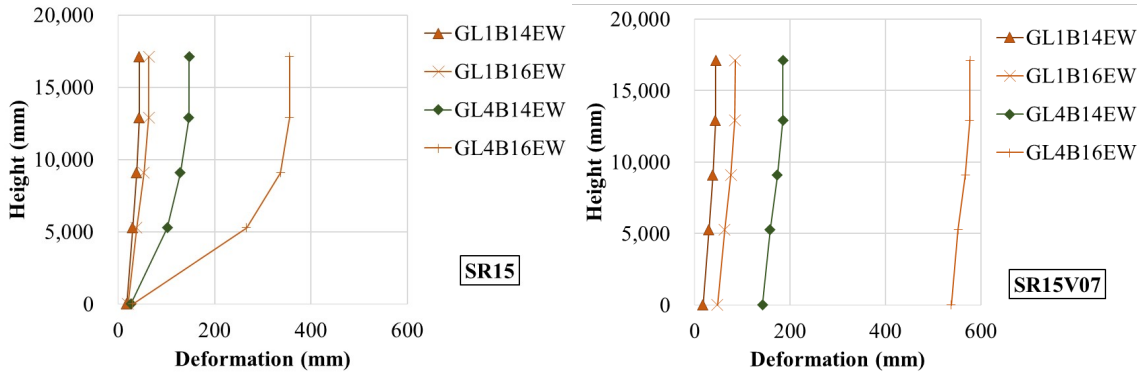
Fig. 11 – Response deformation of SR15 and SR15V07 in x-direction (east to west)

The maximum response deformation of each floor and the basement in x-direction (EW) are shown in Fig. 11 comparing SR15 to SR15V07. The maximum response deformation on the foundation SR15V70 was 500mm which showed reasonable deformation to the pile damage.

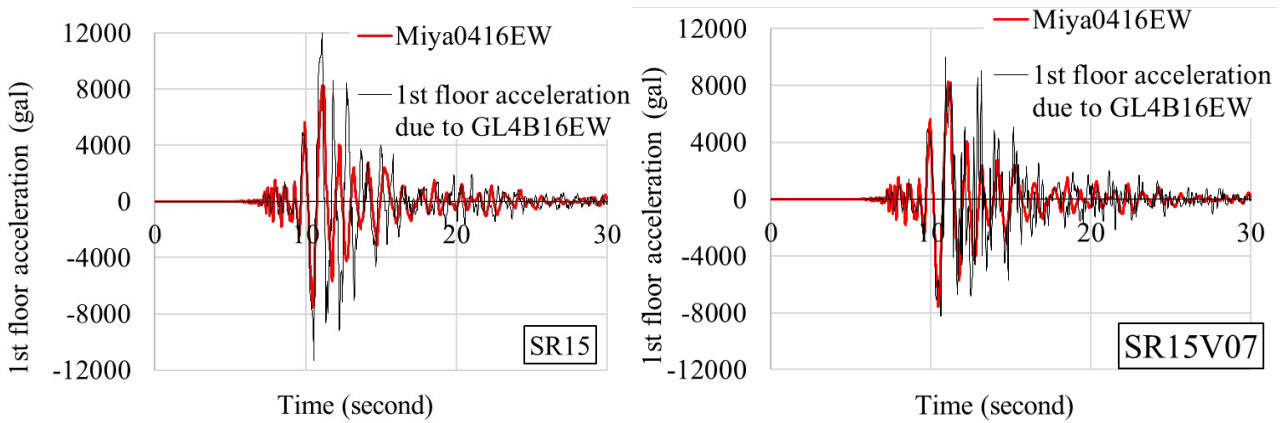
Fig. 12 – 1st floor Response and observed record of SR15 and SR15V07 in x-direction (east to west)

The time history acceleration is shown in Fig. 12 comparing the 1<sup>st</sup> floor analytical response to the observed record on 4/16. The maximum analytical 1<sup>st</sup> floor response acceleration in SR15V07 was consistent with the motion recorded on 4/16. The relationship between the acceleration and displacement response spectrum using 5% damping of the motion recorded on 4/16 and the 1<sup>st</sup> floor analytical motion of SR15 and SR15V07 are shown in Fig. 13. The response spectrum of 1<sup>st</sup> floor analytical motion in SR15V07 was also consistent with the motion recorded on the 1<sup>st</sup> floor in the building on 4/16.
