FACTORS AFFECTING BUILDING DAMAGE INDUCED BY THE SEPTEMBER 2017 MEXICO EARTHQUAKES

E. Lekkas⁽¹⁾, S. Mavroulis⁽²⁾, P. Carydis⁽³⁾

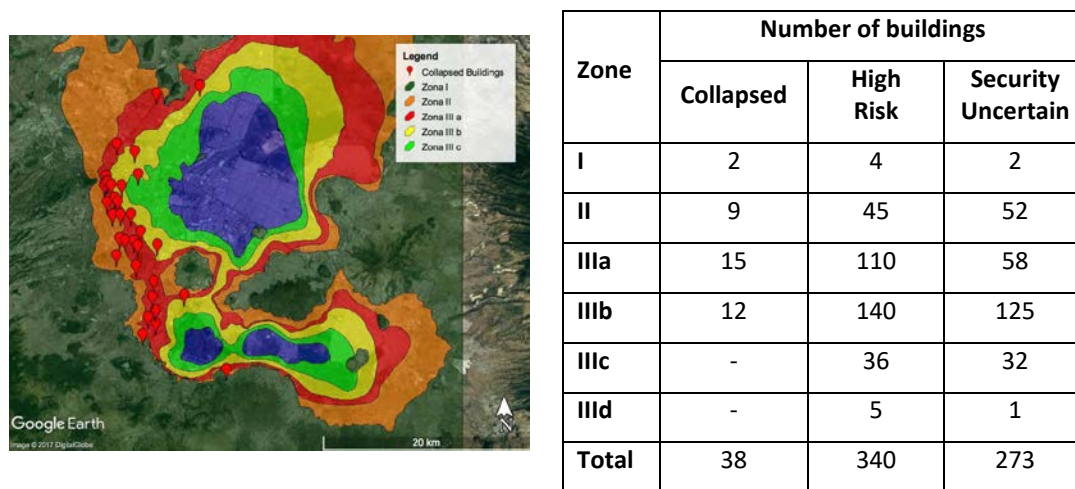
R/C buildings in the Greater Mexico City area and in Puebla and Morelos States suffered structural damage from the second earthquake ranging from light to very heavy. Immediately after the event, the Mexican government reporting to public media indicated 9722 affected buildings with 1632 of them suffering total or partial collapse, 279 schools in need of repairs and 17 hospitals in poor condition. Based on the spatial distribution of the 38 totally collapsed buildings in the city [[14]; based on data from [15]], it is concluded that they were concentrated in the western and southwestern part of the transition zone (zone II, dominant site period ~ 1 s) and in the lake zones (IIIa and IIIb, dominant site period ~ 2 s) (Fig. 10). In comparison with the distribution of damage induced by the 1985 Mw 8.0 Michoacán event, the majority of the collapses occurred in the softest lake bed sediments in the zones IIIb/IIIc (dominant site period ~ 2 s) [2; 3; 4; 5]. Based on the detected distribution, it is concluded that site effects must have played an important role in determining the damaged zones within the Mexico City from the September 19, 2017 earthquake.

Fig. 10 – Collapsed buildings as included in the CICM database as of October 24, 2017 overlaid with geozones in Google Earth [[14]; based on data from [15]].
