DAMAGES IN NON-STRUCTURAL ELEMENTS OF R.C. RESIDENTIAL BUILDINGS CAUSED BY THE 2011 LORCA EARTHQUAKE

Abstract

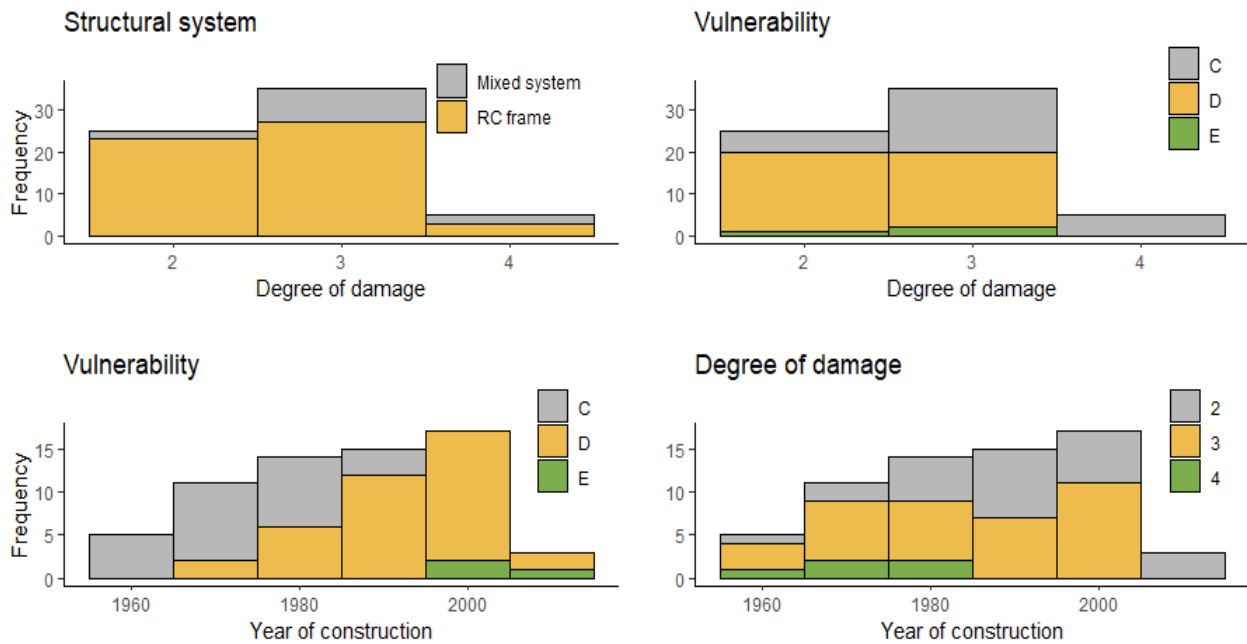
Fig. 2 – Vulnerability and degree of damage of the four to six-storey RC residential buildings

-In relation to the general degree of damage observed, figure 2 shows that the oldest buildings have been classified as more vulnerable to seismic forces (vulnerability types C and D according to EMS-98), and that they have experienced major damages after the event. All the buildings built before the 70s have suffered damages of a degree equal to or greater than 3 and that none of the buildings constructed in the last quarter of the century has suffered grade 4 damage. Furthermore, the buildings of type C vulnerability are the only ones that have reached grade 4 damage. This decrease in the experimental and theoretical vulnerability
