## DIRECTIVITY EVIDENCE FOR THE CONCEPCION CITY DAMAGE IN THE EL MAULE, CHILE 2010 EARTHQUAKE.

R. Ramos (1), G.R. Saragoni (2)

### **Abstract**

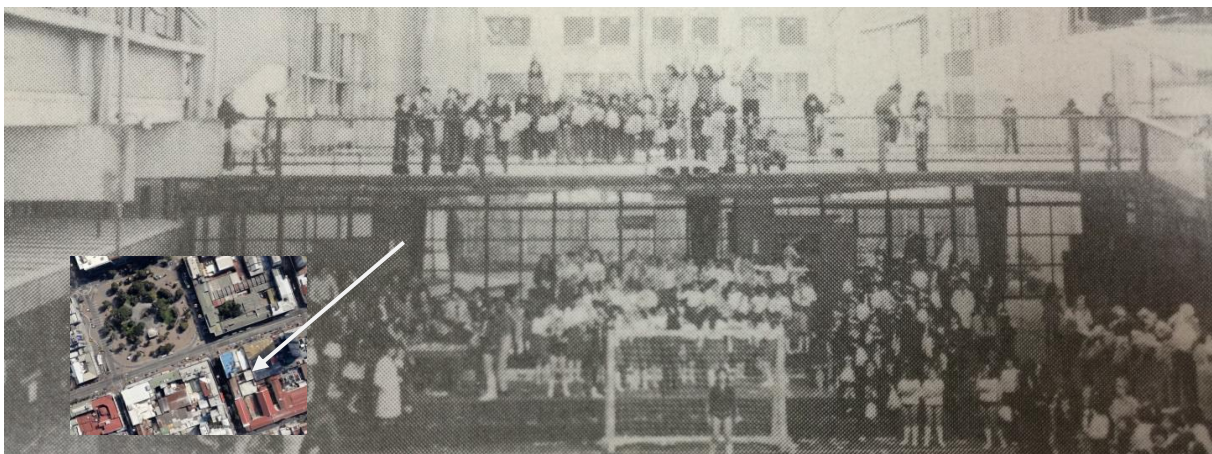
For the earthquake of February 27, 2010 there was a structure that collapsed and remained forgotten for about seven years. This structure is located on Aníbal Pinto 340 Street, next to the “Plaza de Armas” (Main Square) of Concepción and approximately 1.15 km east of the emblematic “Alto Río” building. This structure is very significant, since it is located at the same place of the Immaculate Conception College where the most important epicentral accelerogram of the El Maule 2010 earthquake was recorded,  $M_w = 8.8$  at just 10.0 meters and in the direction  $S30^\circ W$ . west. The main axes of the building coincide exactly with the same directions of the accelerograms. Originally it was built with the purpose of being a covered patio for various activities, and by the date of the earthquake it was used as a casino (dining room) for the students of the College. See Fig. 1.

Fig. 1 - Covered patio (casino) and its context in the Immaculate Concepción College (Enlarged image [3], reduced image Google Maps showing main square).

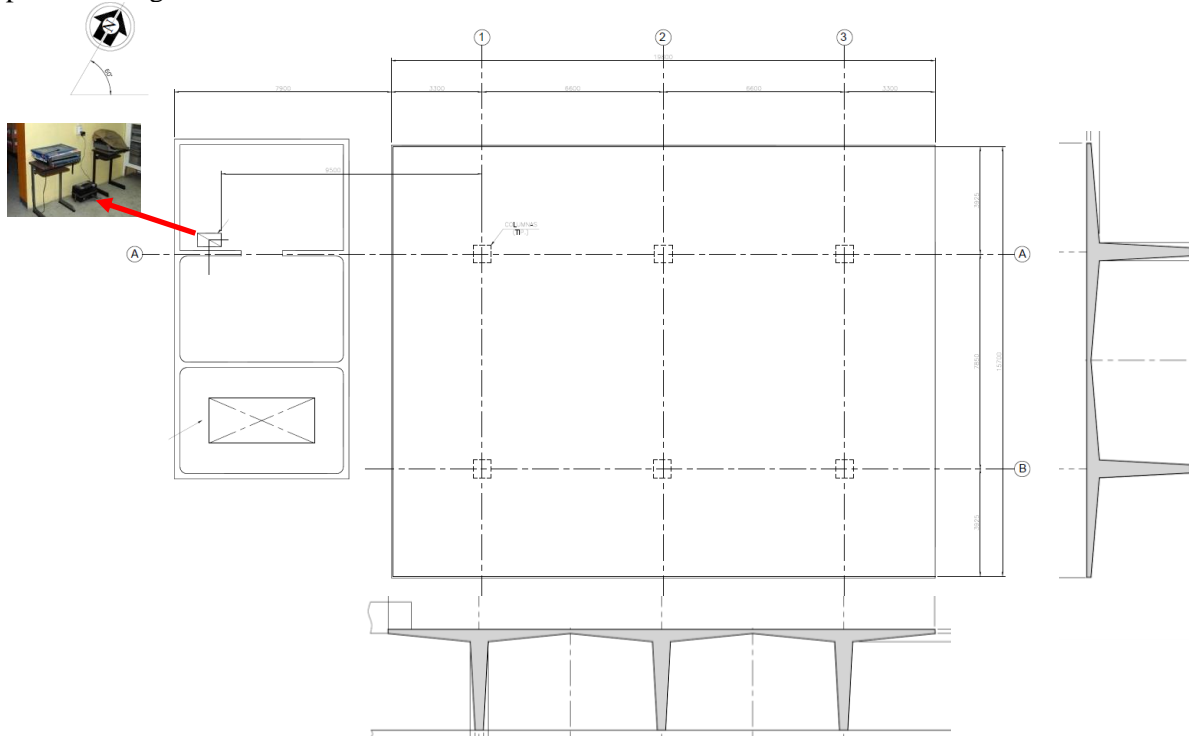
Fig. 2 – Canopy structure. Plan view, Elevations and plant showing accelerometer distance 10 m.

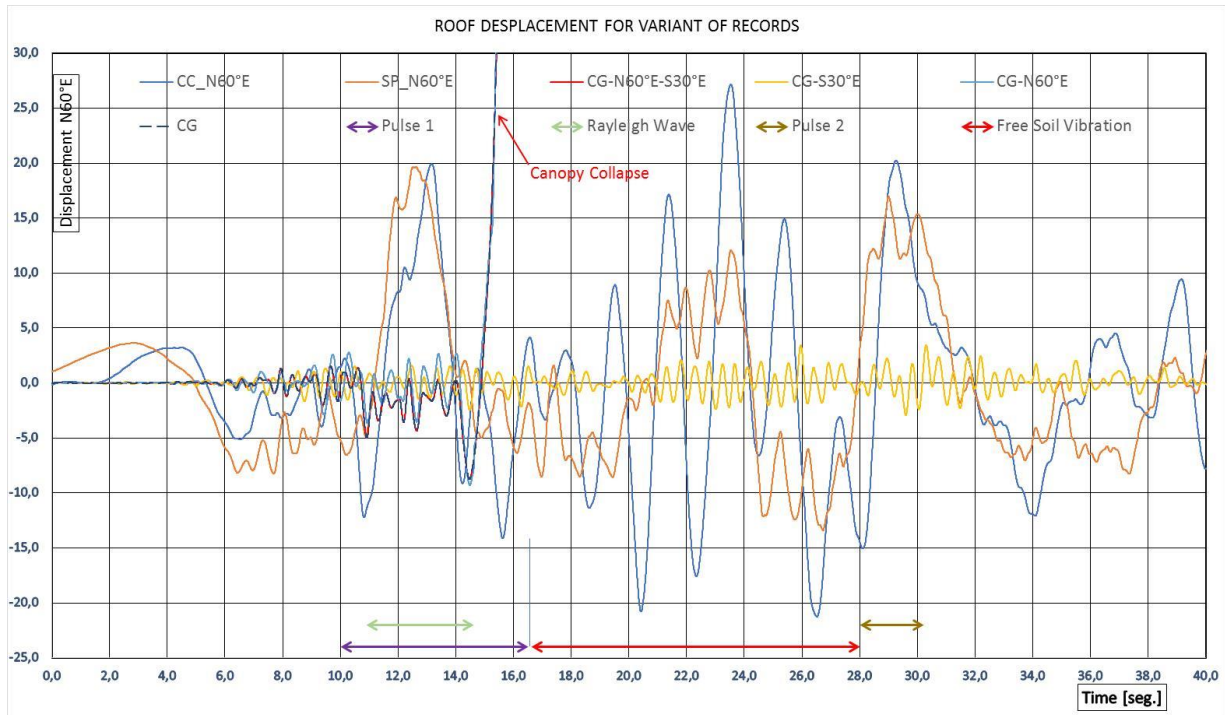
In Fig. 8 the existence of the pulses in the N60 ° E direction for the Concepción stations is plotted for (Rec CC\_N60E) and San Pedro (Rec SP\_N60E), together with the response of the model studied to demand variants. Horizontal arrow and vertical lines are included that indicate start / end of the main events in time: Pulse1, Rayleigh Wave, Free Soil Vibration and Pulse Start 2.

Fig. 8 - The existence of pulses in displacement record N60-E for Concepción Centro and San Pedro de la Paz compared with structure response to different records.

The time intervals with energy to produce damage are the same for the records of Concepción Centro and San Pedro de La Paz, indicating that the fault is initiated and produced by the effect of the earthquake mechanism and not by the soil response of Concepción. The pulse and the Rayleigh wave have a clear directivity, which is reproduced in the existing failure. The implications of the analysis could be extended to other building failure observed in the same direction at the Gran Concepción (Concepción Centro, San Pedro de la Paz, Hualpén, Talcahuano, Coronel).

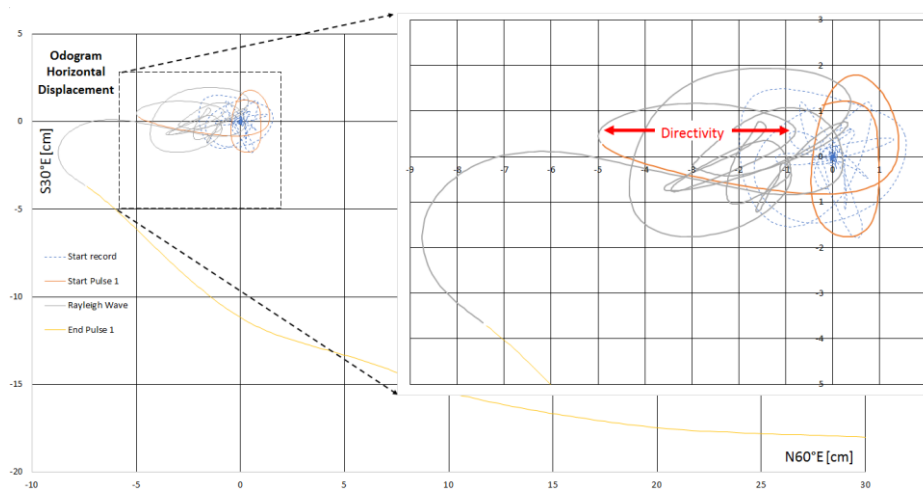
Fig. 9 - Odogram of the structure response to the Concepción N60-E record showing the same polarization from the beginning of seismic source Pulse 1.

In Fig. 9 shows the odogram that relates the horizontal offsets of the model for the full record. This shows a clear polarization with the start from the beginning of Pulse 1, remaining and accentuating during the domination of the Rayleigh wave. 5.3. Horizontal Displacements

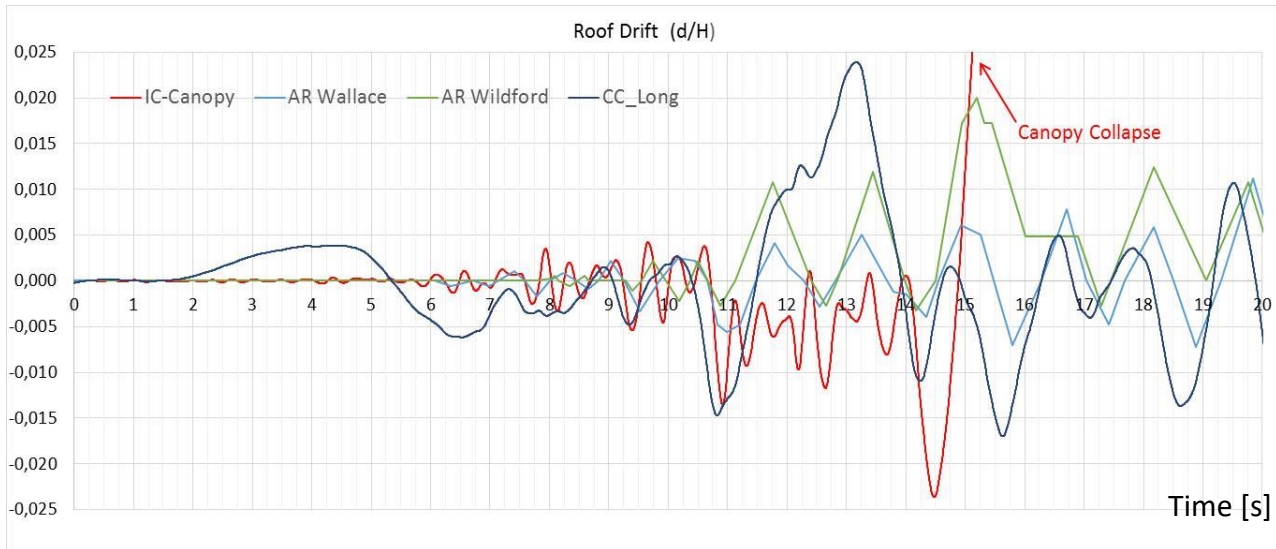
The comparison is shown in Fig. 11, showing a similar response behavior before the arrival of Pulse 1 of the seismic source and associated Rayleigh wave in both structures. Structural degradation or progressive collapse is also seen, manifested as an increase in the vibration period of both structures. This allows to postulate that the energy input of the Rayleigh wave in both structures was similar. The low structural redundancy of the Canopy produces a rapid collapse. On the other hand in the "Alto Río", the energy input causes damage, but its greater redundancy of structural elements allows a slower degradation which would delayed its collapse. The comparison is limited to the collapse time of the first structure.

Finally, it is important to note that collapse in both structures occurs in the same direction and sense, which is approximately N60°E.

Fig. 11. Comparative damage graph for record with three components.
