USE OF VERTICAL UNBONDED POST TENSIONED ON PRECAST CONCRETE WALL TO COUNTERACT VERTICAL EARTHQUAKE

Abstract

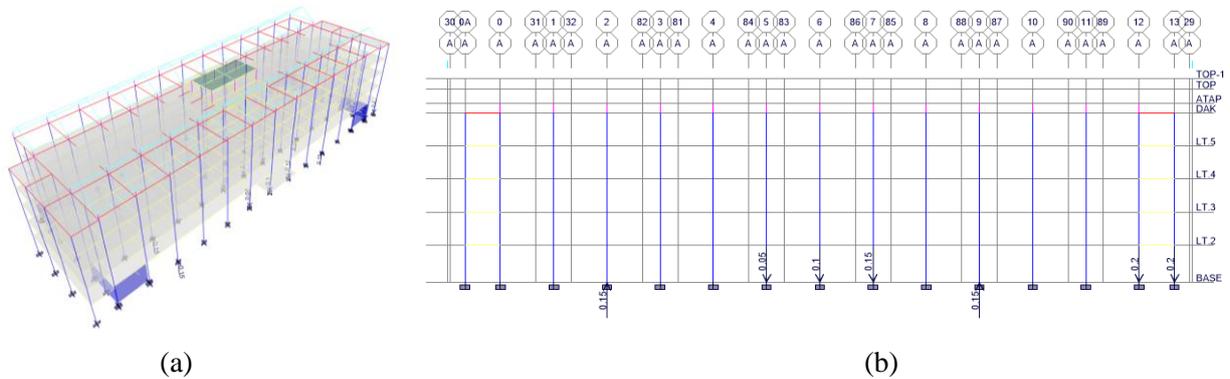
To take into account the effect of vertical earthquake causing damage in building in the form of vertical deformation, structural model including the vertical deformation at the base (ground displacement) based on deformation observed on the field as shown Fig. 3, is developed. The structural model was prepared using structural analysis software ETABS (computer aided design).

Fig. 3 – ETABS Structural model for rental low-cost housing flat Lere with input ground displacement according to measurements from the field: (a) 3D model building, (b) model section along the length of building

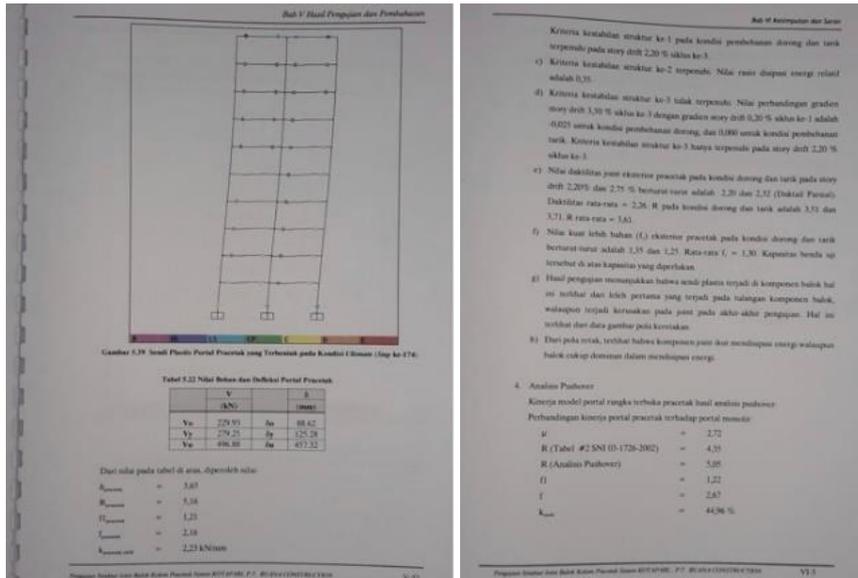
Structural components of rental low-cost housing flat Lere in Palu use precast system that has been tested at structural laboratory of the Research Institute of Human Settlement and Institute of Road Engineering Ministry of Public Works and Housing. Reduction factor R of 4.35 – 5.05 means that this system fall into structural category moderate moment resisting frame as shown in Fig. 6.

Fig. 6 – Lateral resistance system category of precast system which is used

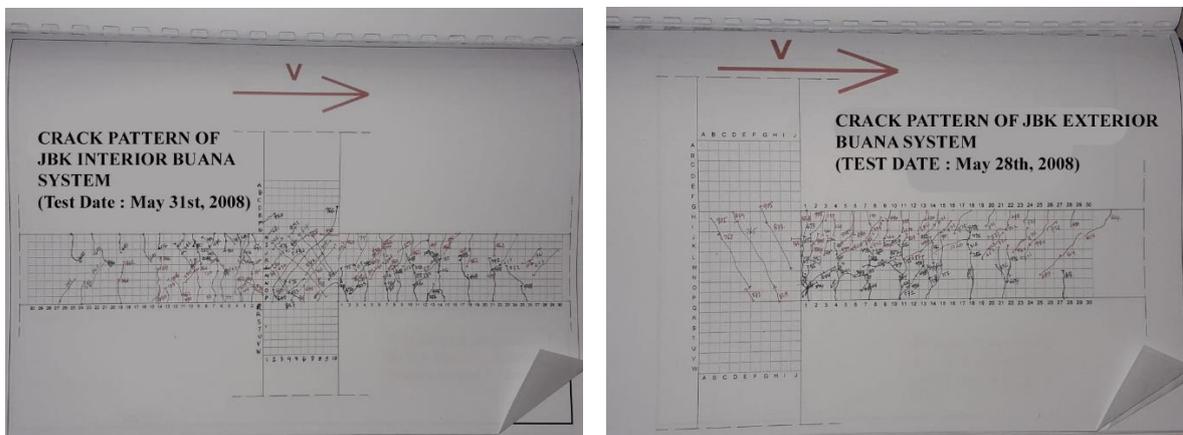
Fig. 7 – Crack pattern at interior and exterior beam-column joints during testing in Laboratory
