Damage analyses on the collapse of Aso-ohashi during the 2016 Kumamoto Earthquake

S. Hosokawa⁽¹⁾, S. Unjoh⁽²⁾

Abstract

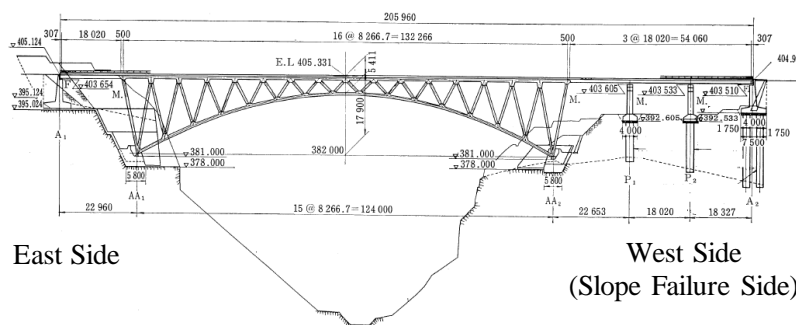
Fig. 2 – Side view of Aso-ohashi (modified from Ref. [2])

During the main shock of the Kumamoto earthquake, superstructures and piers of Aso-ohashi were collapsed and washed away with only its abutments at the both ends and arch abutments left. What was the main reason of this collapse? It was pointed that the possible causes were strong ground motions, heavy mudslide from the adjacent slope on the west side, failure and loss of the arch abutment foundation, and large fault displacement crossing the bridge, as well as the multiple complex effects of these causes. Since there exist several bridges with similar vulnerable conditions in Japan, to consider the possible countermeasures for them, it is important to investigate the damage mechanism and its progress for Aso-ohashi as a typical example of such damage.

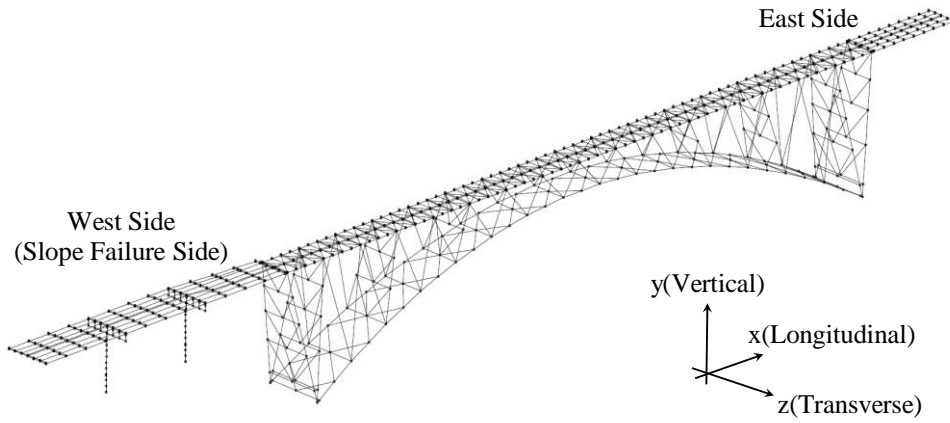
Fig. 3– Simulation model of Aso-ohashi

In this study, the whole of Aso-ohashi was modeled as a frame type structure as shown in Fig.3. For superstructures, decks were modeled as linear beams with lumped masses on nodes giving its weight as shown in Fig.4. Lumped masses were connected with main girder vertically by rigid members based on the JSCE Specifications of Steel Structures [6]. Major parts including main girders, arch members, diagonal members and cross beams, of which material was SM490, were modeled as non-linear beam members with bilinear hysteresis having its material property. Assuming that the lateral and sway bracing members resisted against only axial force, they were modeled as a truss member. Clearance of expansion joints between trussed arch bridge and girder bridge sections was $\Delta W = 0.150\text{m}$ as shown in Fig.5. For simulating the contact effect at the expansion joints, ‘Contact spring model’ was set in this gap. This model had a non-linear force-displacement property in the longitudinal direction as shown in Fig.6. The damping coefficient was assumed as 0.03 for piers and concrete decks, and 0.02 for steel members based on JRA Design Specifications for Highway Bridges [7]. For the numerical simulations, a structural analysis software TDAPIII was used.

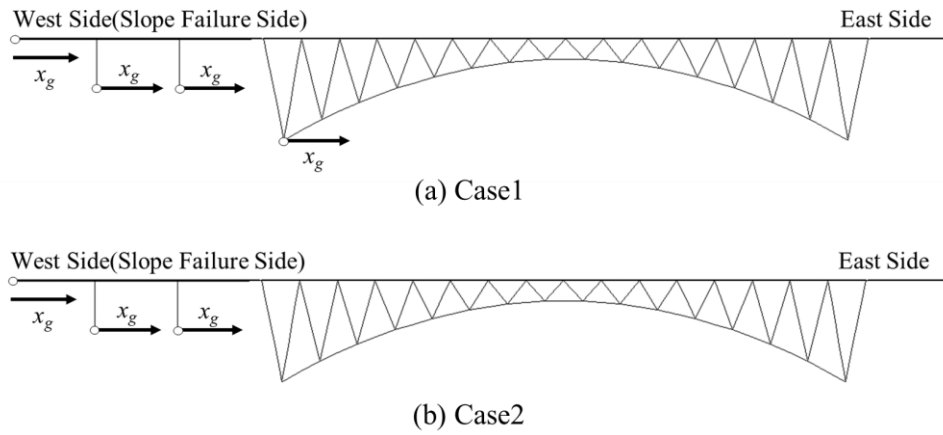
Fig. 7 – Assumed forced ground deformation for the analyses

For the pushover analysis, the forced ground displacement was given to the foundations. Based on the bridge site survey, the forced ground displacement was assumed to increase at the west side (slope failure side) abutments and foundations. The forced ground displacement was gradually increased by the increment of 0.001m up to 2.000m. It was reported in the aerial photo investigation [4] that both side of grounds of the bridge were displaced about 2m relatively toward the direction to compress the bridge. In this study, 2 cases of the pushover analyses in terms of the ground forced displacement was conducted. In Case 1 as shown in Fig.7(a), equivalent amount of displacement, x_g , was given simultaneously to all abutments and piers in the west slope failure side. This case simulated the case assuming that the fault crossed over the trussed arch bridge section acted during the earthquake. In Case 2 as shown in Fig.7(b), the abutment and piers of continuous girder section in the west side were displaced simultaneously but assuming that the abutment of trussed arched bridge section (arch abutment) did not moved. Fig.8 shows the ground condition of the west side section. Since the arch abutment was founded at the andesite while the continuous girder section was piled in the surface soil layer, it was assumed that this surface layer was displaced with the slope failure. According to the bridge site survey, it was confirmed that the arch abutments were left at the original location. In addition, as shown in Fig.9, the expansion joint between the simple girder and the abutment in the east side got into under the pavement on the backfill embankment. From these conditions, it was estimated that the girders contacted each other and moved into the east side.

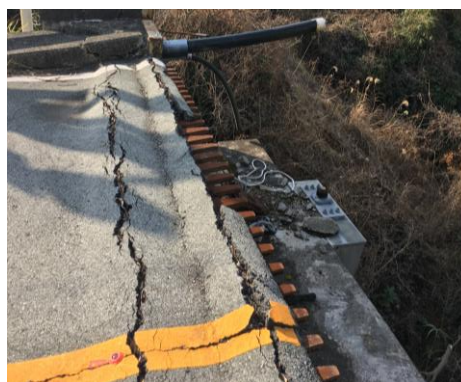
Fig. 9 – Collision or compression of explosion joint at east side abutment
