NUMERICAL STUDY ON DAMAGE OF STEEL CHORD MEMBER IN SPACE TRUSS ROOF UNDER EARTHQUAKE

T.Wada⁽¹⁾, Z.Zhu⁽²⁾, K.Goto⁽³⁾, E.Tomokiyo⁽⁴⁾, M.Yamanari⁽⁵⁾

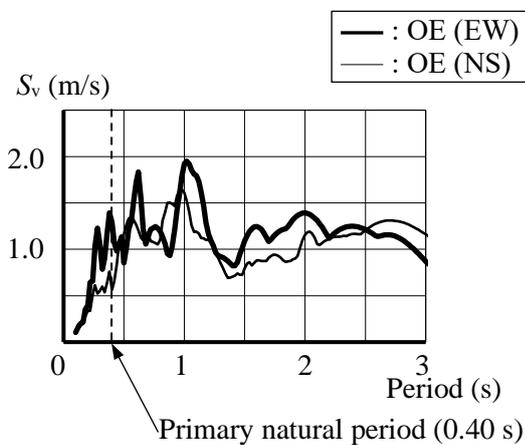
Fig. 6 – Velocity response spectra

Newmark - β method ($\beta = 1/4$) is used as the numerical integration scheme for the dynamic response analysis. Its time increment is 0.002 s in this study. The characteristic of damping is assigned to Rayleigh damping in which the damping factors of the first mode (h_1) and the second mode (h_2) are assumed to be $h_1 = 0.03$ and $h_2 = 0.03$. OE wave was chosen to calculate the seismic response of the real gymnasium. The wave was recorded at the site that is nearest from the place of the analytical gymnasium in the 2016 Kumamoto earthquake. The velocity response spectra of input ground motions and the primary natural period of analytical gymnasium are shown in Fig.6.

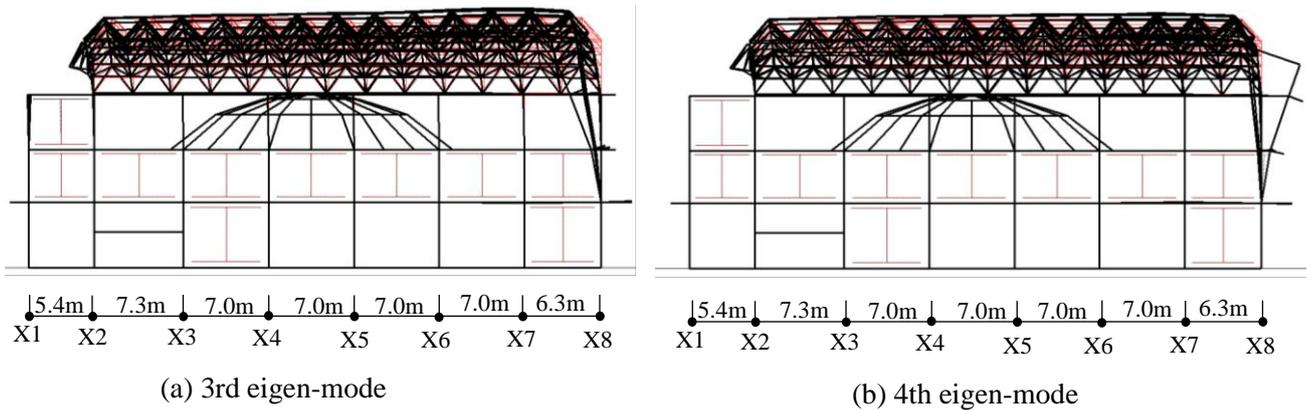
Fig. 8 – Eigen-mode

Fig.7 shows yielded members of the space truss obtained from calculation. The yielded members from the result and the members observed are the same. Consequently, it seems to be reliable that the seismic analysis was well done. Fig.8 shows 3rd and 4th eigen-modes of the frame viewed from Y axis. Also, Fig.9, shows 5th eigen-mode viewed from X axis. The deformed frame was drawn with thick lines. It can be recognized that out-of-plane deformation of the walls at on X2-line and X8-line occurs under the earthquake. It suggests that those modes derive the yielding of the truss members around X8-line. In addition, it can be also seen that there is out-of-plane deformation of wall on Y1-line as shown in Fig.9. The out-of-plane deformation on Y1-line was smaller than that on Y7-line. The fact that there was a low RC frame on Y7-line only, made the difference. From those eigen-modes, those modes have caused the yielding or buckling of the members in the space truss around Y1-line and Y7-line.

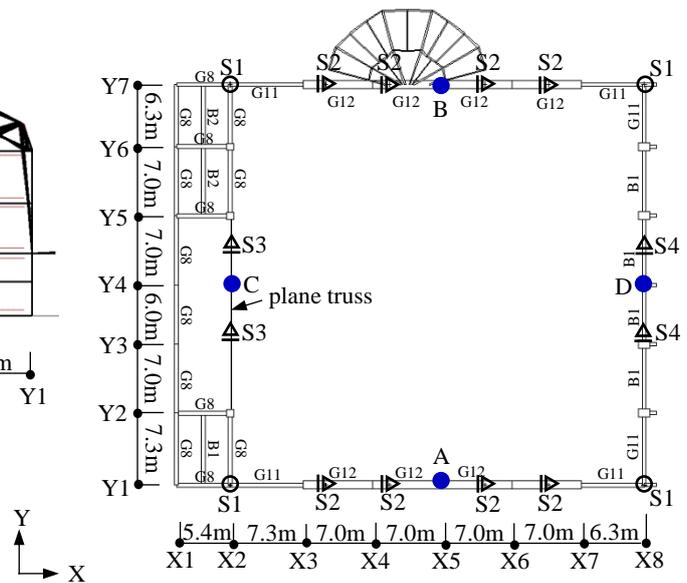
Fig. 10 – Beam framing plan of top story substructure

Fig.10 shows the representative positions of A, B, C and D in the space truss for examining the out-of-plane displacement under the earthquake. Fig.11 shows for recognizing the relative lateral displacement between A and B as well as C and D along the time line. A and B are the truss nodes that exist opposite point mutually in the plan. The history of the displacements of the opposite points insists that the truss chord members were under tensile or compressive stress. Eventually, some chord members broke or buckled because of exceeding their loading capacity.
