PERFORMANCE OF LOW-RISE BUILDINGS WITH NO SEISMIC DESIGN IN UNANTICIPATED EARTHQUAKES

2c-0197

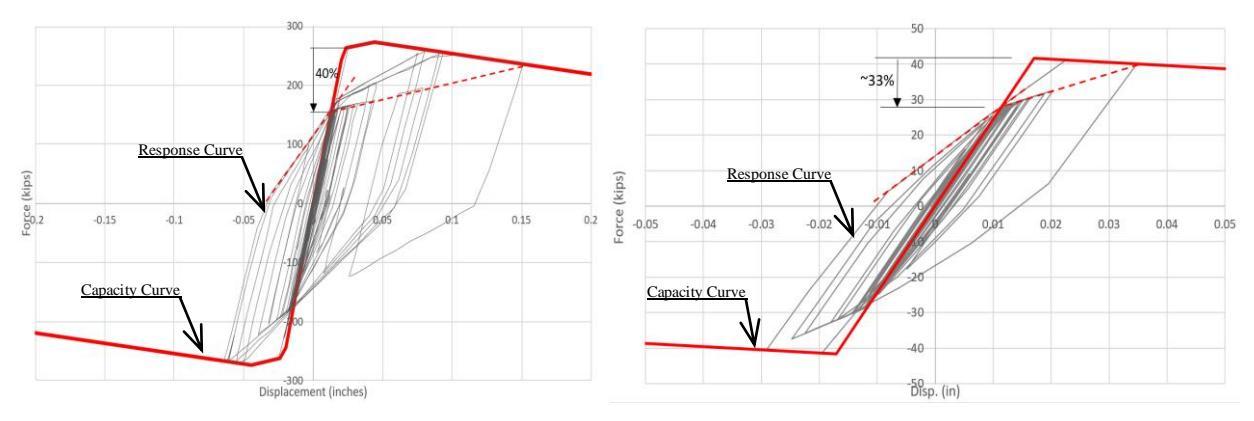
Fig.14 shows the in-plane response to ground acceleration history of masonry walls in the direction of the applied seismic load which is parallel to the plane of the walls. These results indicate a significant drop in the lateral strength of the walls, both in the pre-peak and the post-peak ranges of the capacity curves, accompanied with a drop in the lateral stiffness of the walls, as illustrated with dashed lines in Fig.14. The deviation from the capacity curve and associated strength loss is up to 40% for some masonry walls. The inelastic response of the masonry walls during cyclic earthquake loading results in energy dissipation in each cyclic loop (excursion). These loops are evident in Fig.14 and correlate to the damage sustained by these building components such as cracking and spalling of the masonry.

Fig. 14 - In-plane wall response to acceleration history record

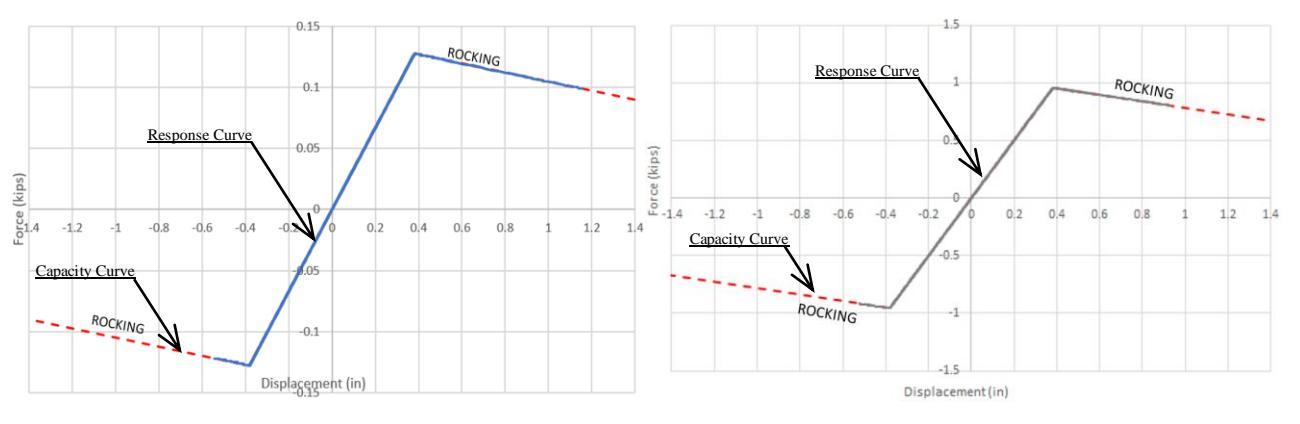
Fig.15 shows the results from the computer analysis runs for a load-bearing and a non-load bearing masonry wall response to ground acceleration history (shown with solid lines). In particular, Fig.15 illustrates the out-of-plane response of two masonry walls in the direction of the applied seismic load which is perpendicular to the plane of each wall. The results of the analyses show that the masonry walls cracked and rocked in the out-of-plane direction during the ground shaking.

Fig. 15 - Out-of-plane wall response to acceleration history record

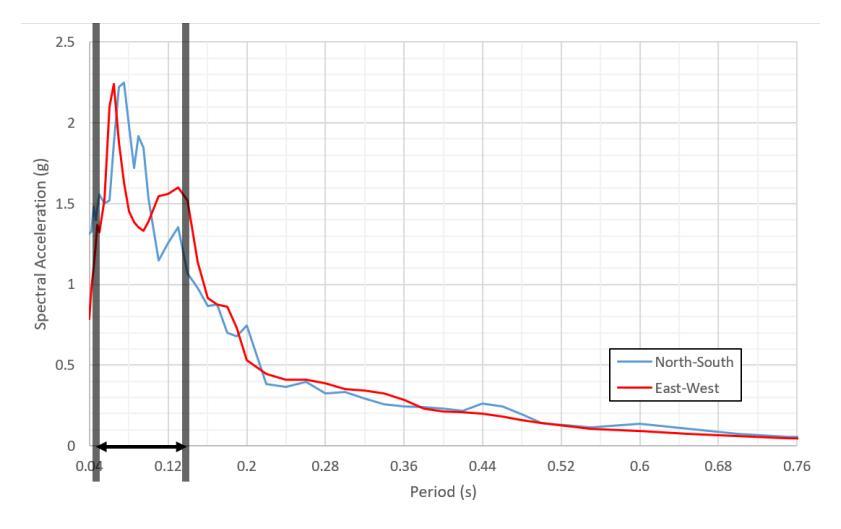
Fig.16 shows the acceleration response spectra as obtained from one of the stations for the Cushing Earthquake. The ground accelerations were amplified by the dynamic characteristics of the low-rise buildings with one-story stiff walls and short periods. The structural engineering analyses described earlier computed a natural period of vibration in the range of approximately 0.04 seconds to 0.12 seconds for the individual masonry walls and the building structures. Spectral accelerations of over 2g in the range of the dominant periods of the earthquake ground motion (between 0.04 and 0.15-seconds) coincided with the natural period of vibration of the masonry walls and the building structures. For instance, a comparison between the spectral acceleration of approximately 1.5g at 0.1-second from Fig.16 and the peak ground acceleration of 0.58g shows that the subject walls experienced about 2.6 times the ground acceleration during the Cushing Earthquake. This striking feature of the Cushing Earthquake with spectral amplification near the 0.1-second period was also illustrated in literature [4].

Fig. 16 - Acceleration response spectra (5% damped) at seismic recording station OK914

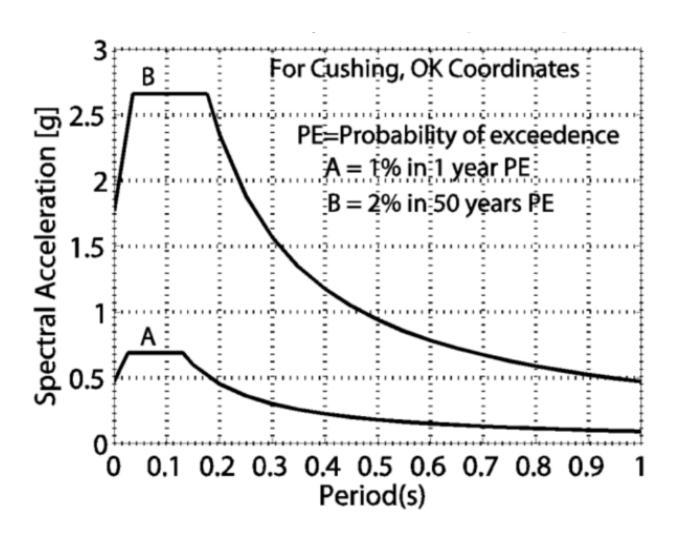
In the last 10 years, rates of earthquakes increased rapidly in Oklahoma; consequently, the USGS updated the short-term seismic hazard maps for the region in the last three years to account for induced earthquakes [1]. Therefore, the authors recommend that the strengthening design also consider this updated induced earthquake hazard in addition to the IBC 2015 [11] natural earthquake hazard. The strengthening design spectral acceleration may be taken as 75% of two-thirds of the curve B in Fig.17 [1, 4]. This corresponds to approximately 1.4g at the fundamental period of the buildings (or roughly a repeat of the Cushing Earthquake for existing buildings when compared to Fig.16 at the 0.1-second period).

Fig. 17 – Induced earthquake hazard response spectra for Cushing, USGS [1, 4]

The strengthening work for the lateral force system with substantial damage would typically include, along with the repairs, strengthening of the connections between the masonry walls and the roof framing to provide improved load path continuity to support and transfer seismic load demands for roof diaphragm action. Strengthening for the induced earthquake hazard would include, in addition to the above, installation of reinforced concrete overlay or carbon fiber reinforced polymer (CFRP) fabric sheets on some of the masonry walls.
