DAMAGE MECHANISM OF OHKIRIHATA BRIDGE DUE TO KUMAMOTO EARTHQUAKE

H. Nakao⁽¹⁾, K. Eguchi⁽²⁾, T. Yono⁽³⁾ and M. Ohsumi⁽⁴⁾

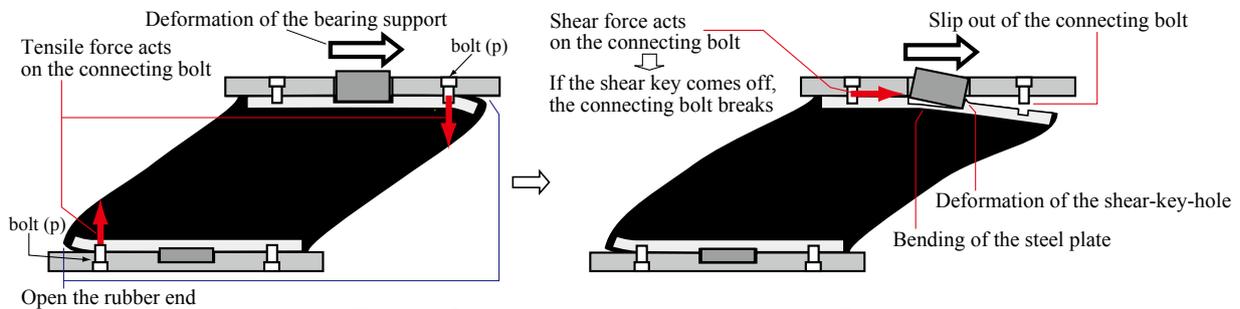
Fig. 4 – Loading test of bearing support [7]

From these analyses, it is estimated that the bearing support installed at the G1 girder was broken by the behavior of the deformation to the G1 girder side and the rotation around the shear-key-hole. Next, we presume which one was damaged first. If the upper connecting bolt was broken before the failure of the lower connecting bolt, the rotation force did not generate at the rubber bearing. Therefore, it is not presumed that the upper connecting bolt was broken before the failure of the lower connecting bolt. On the other hand, in case of the lower connecting bolt was broken before the failure of the upper connecting bolt, the external force from the upper shoe can be transmitted to the lower shoe if the lower shear key was not removed. So the bearing support may be deformed such as Fig. 4.

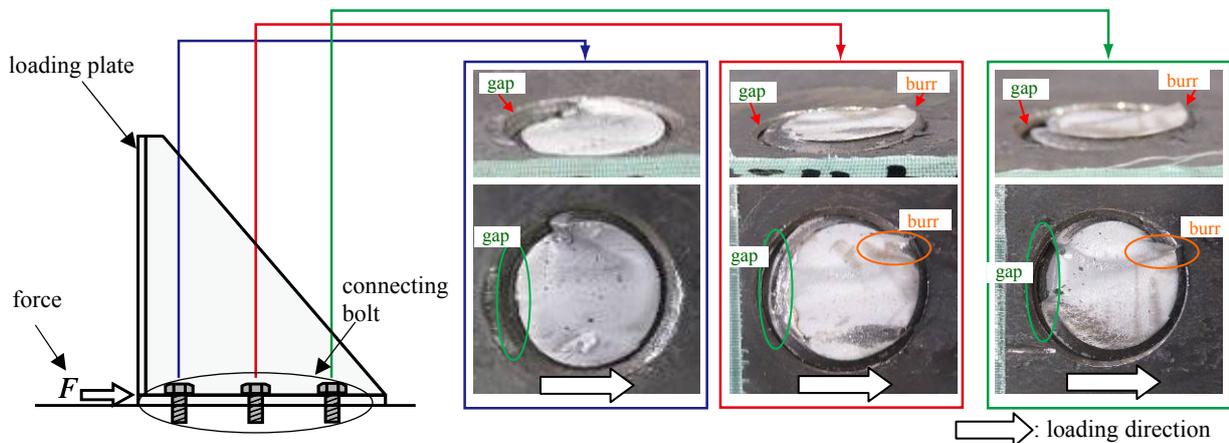
Fig. 5 – Loading test of connecting bolts [8]

The bottom surface of the rubber bearing is shown in Photo 3(c). The all lower connecting bolts were broken at the rubber bearing surface. Looking at the broken-bolt marks, there are the gap and the burr. According to the loading test of connecting bolts conducted by authors [8], it is confirmed that the gap and the burr are generated in the direction of the force when the connecting bolt was broken by the external shear force as shown in Fig. 5. From this knowledge, it is presumed that the lower connecting bolts were deformed in the direction of the arrow shown in Photo 3(c), and were broken at the rubber bearing surface. Looking at the lower shoe in Photo 4, there are scratch traces by the broken-out-bolt beside the bolt hole. And thus, it is presumed that lower connecting bolts were broken because the bearing support was excessive rotated around the shear-key-hole. In addition, the direction of the scratch trace was matched with the rotated direction found from the broken-out section of the connection bolt described above.
