## DAMAGE MECHANISM OF TAWARAYAMA BRIDGE DUE TO KUMAMOTO EARTHQUAKE

K. Eguchi<sup>(1)</sup>, N. Nakao<sup>(2)</sup>, T. Yono<sup>(3)</sup>, M. Ohsumi<sup>(4)</sup>

<sup>(1)</sup> Researcher, Public Works Research Institute, [eguchi-k573bt@pwri.go.jp](mailto:eguchi-k573bt@pwri.go.jp)

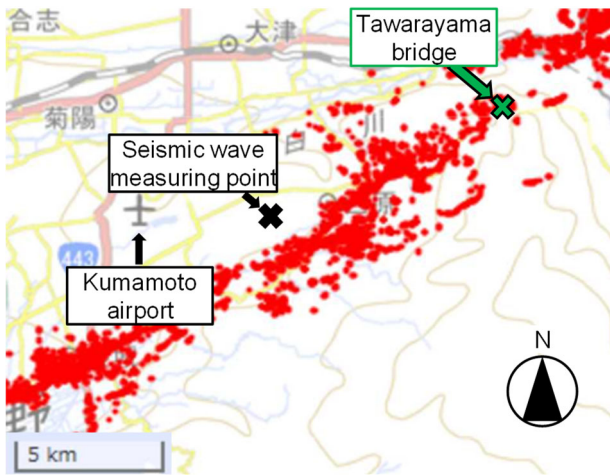
Fig.2 – Ground displacement point by aerial photography (red circle)

On April 16, 2016, magnitude 7.3 earthquakes occurred in Kumamoto Prefecture, located in the southwestern part of the Japan. The earthquake caused serious damage not only for houses but also for infrastructure. In addition, large residual displacement was surveyed on the ground surface. Figure 2 shows the distribution of cracks on the ground surface near the target bridge, based on the aerial photo interpretation surveyed by the Geographical Survey Institute [4].

Tawarayama bridge is in the area where the ground surface displacement was surveyed, and it is expected that ground displacement also affected. Fig.3 shows the analysis results of the displacement due to the earthquake observed near Tawarayama Bridge [5].

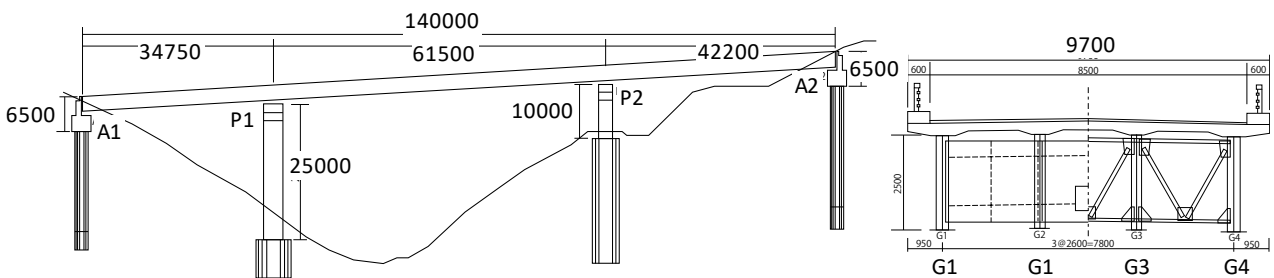
Fig.4 – General plan of Tawarayama bridge

In this study, Tawarayama bridge was investigated whose the function was greatly damaged by the Kumamoto earthquake. Fig.4 shows a general view of the bridge. Tawarayama Bridge was constructed in 2001. This bridge has a continuous non-composite three spans steel girder with bridge length of 140m,

rubber bearings, inverted T-type abutment and an overhang type bridge piers and deep foundations. In addition, side block was installed on the bearing on the abutment, and unseating prevention cables connecting the girder and the abutment was installed.

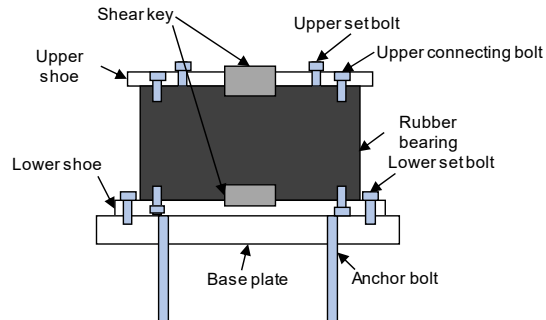
Fig.9 – Members of the rubber bearing

Names of members of rubber bearing are shown in Fig.9. Fig.10 shows the state of the bearings right after the earthquake. Looking at the A1 bearing, all bearings showed residual deformation to the A1 side, but obvious damage such as rupture of the bearing was not found. Looking at the P1 bearing, there were residual deformation to the northeast direction, but the damage of rubber bearing was not observed same as A1 bearing.

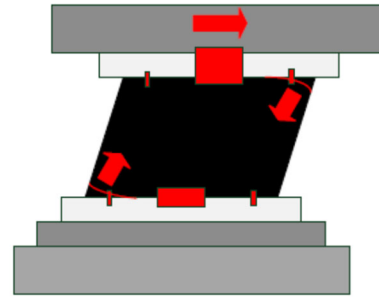
Fig.14 Image of force acted in rubber bearing

It is known that a tensile force acts while deforming as shown in Fig.14 when the horizontal force acts on rubber bearing. Shear force acts on one side connecting bolts and tensile force acts on the opposite connecting bolts. Therefore, it is presumed that most connecting bolts fractured due to shear force and the other connecting bolts were pulled off due to tensile force. Also, looking at the upper side of bearing, there are the scratch marks toward one direction, it is presumed that the girder dropped off from the bearing right after connecting bolts fractured.
