OBSERVED DAMAGE AT SCHOOLS AFTER THE ILLAPEL EARTHQUAKE (CHILE, 2015)

F. López-Almansa⁽¹⁾, G. Valdebenito⁽²⁾, S. Bustos⁽³⁾

Most of the damage caused by the Illapel earthquake concentrated in poorly designed school and hospital buildings; this paper presents a study of the observed damage in the school buildings. Four representative schools are particularly discussed: “El Ingenio” school in Ovalle, children school in Coquimbo, “Maritima” school in Tongoy, and, mainly, “San Rafael de Rozas” school in Illapel. Their damage is comprehensively described; it is understood in terms of poor design, site effects and other relevant issues. Regarding the seismic design, the role of short columns is thoroughly investigated, among other structural deficiencies. Concerning the site effects, the soil fundamental period is identified after by two types of ambient vibration field tests: Nakamura, and soil profile analysis by using geophones. The natural periods of the damaged buildings were identified after operational modal analysis using triaxial seismometers. Then, the proximity between and the soil and the structure fundamental period is investigated as a main potential source of response amp

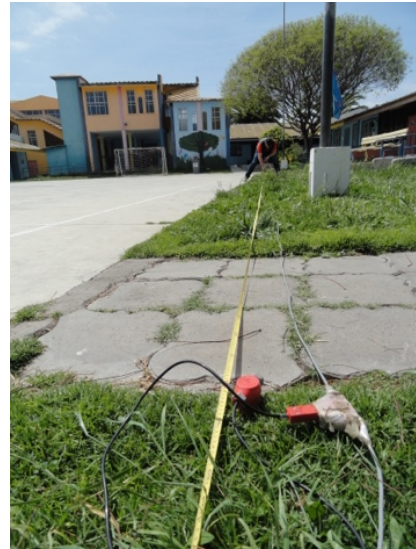
(b) ReMi seismic survey

Although very slight damage was observed in this 2-story building, it is interesting to expose a typical masonry Chilean school building being located in an area where the Illapel earthquake notably affected masonry housing buildings. Figure 4.a shows the damage on a wall originated by bending rotation of the beam-wall connection; as well, probably, the slab experienced also some pounding. Additionally, Figure 4.b describes part of the performed geophysical surveys.

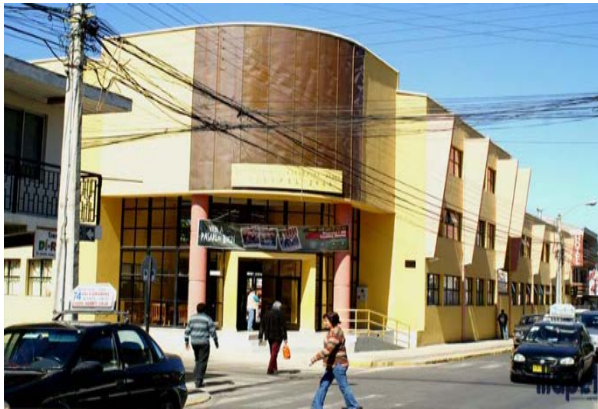
(a) General view

Figure 7.a displays the main building entrance, being located in the corner of the central wing. Figure 7.b represents the first floor plan layout. This paper focusses in the central wing, having been the most damaged part during the quake.

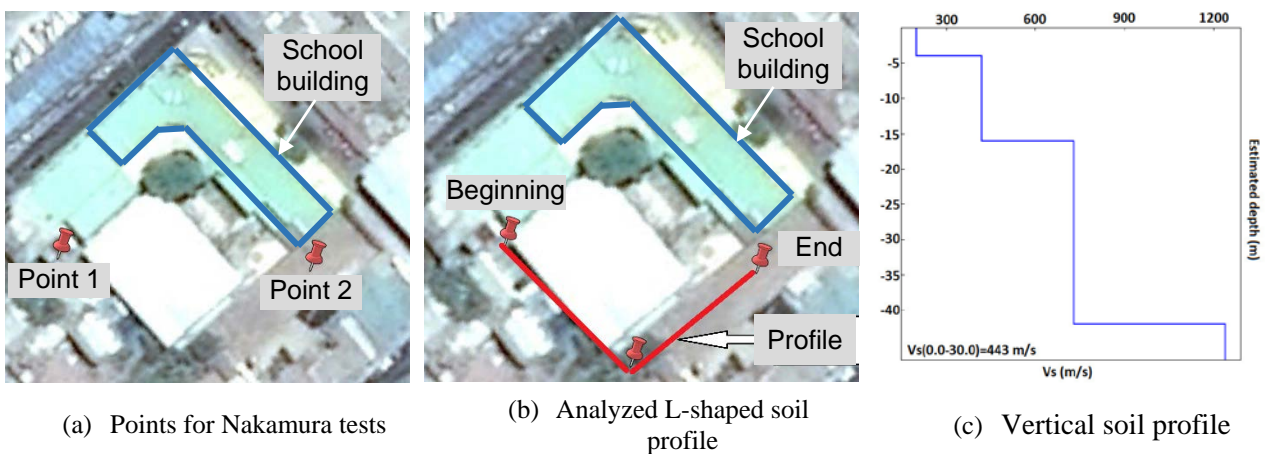
Figure 10. Soil field tests in the San Rafael de Rozas School, Illapel

Nakamura. Two ambient vibration measurements using the Micromed TROMINO seismograph were carried out in the points marked as 1 and 2 in Figure 10.a.

Figure 10.c represents the shear wave velocity vs. soil depth. The harmonic weighted average for the top 30 m is $v_{s,30} = 443$ m/s. According to the Chilean regulation [14] the soil type is C; however, given the absence of more conclusive information (such as boreholes), the soil is conservatively classified as D. This type corresponds to soil B according the European regulations [15] and soil C according the American specifications [16]. In any case, broadly speaking, the soil is rather stiff; moreover, Figure 10.c shows that, below 16 m, the soil is almost rock. These circumstances seem to indicate that no relevant site effects (seismic waves amplification) are expected.

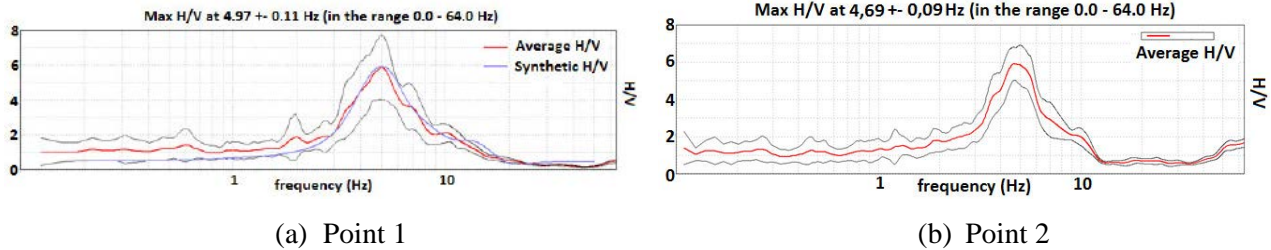
Figure 11. H / V spectra in Illapel

Figure 11 shows a peak for a frequency approximately equal to 5 Hz; hence, the soil fundamental period should be near to 0.2 s. Comparison between the spectra in Figure 11.a and Figure 11.b shows high similarity; therefore, the soil appears to be rather uniform.

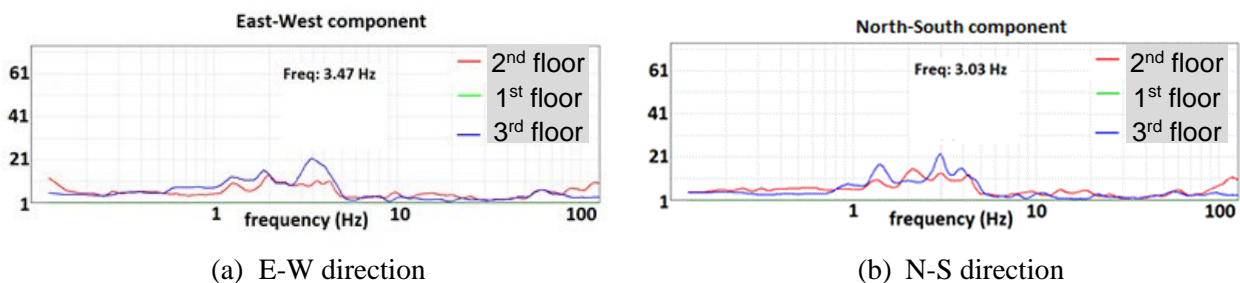
Figure 12. Spectra in Illapel obtained after Operational Modal Analysis

Figure 12 shows that the spectra in both directions exhibit a peak near 0.3 s (0.288 s in Figure 12.a and 0.330 s in Figure 12.b); thus, the periods of the first translational modes in x and y directions should be close to that
