VERIFICATION OF THE FRACTURE MECHANISM OF A WOODEN BRACING BEARING WALL WITH CROSS-SECTIONAL DEFECTS

H. Funatsu⁽¹⁾, Y. Wakabayashi⁽²⁾, X. Chen⁽³⁾, N. Takiyama⁽⁴⁾

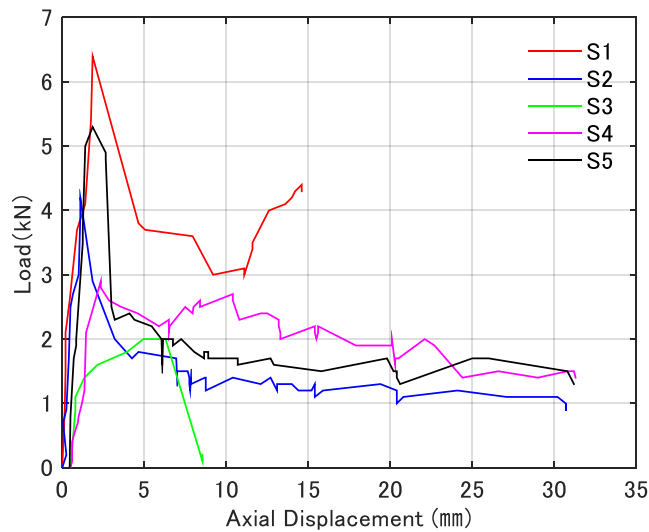
Fig. 4 – Skeleton curve

[S1] After exhibiting a maximum load of 6.4 kN on the compression side of 10.1 mm (1/150 rad), the material buckled and its resistance dropped rapidly. The maximum out-of-plane displacement was 128.7 mm on the W-side and 123.3 mm on the E-side. The bending moment in the out-of-plane direction was a maximum at the center of the bracing when compressed. When a tensile force of 12.6 mm (1/120 rad) was applied, the edge was ‘cut off’, but no other noticeable damage was observed.

[S3] After exhibiting a maximum load of 1.3 kN on the compression side of 6.0 mm (1/250 rad), the material broke immediately after buckling. The maximum out-of-plane displacement was 188.9 mm on the W-side and 213.6 mm on the E-side. It buckled to the notched S-side, referred to as S-side buckling, and was damaged in the notch at 6.0 mm (1/250 rad) on the compression side.

[S5] After exhibiting a maximum load of 5.8 kN on the compression side of 6.0 mm (1/250 rad), the material buckled and its resistance dropped rapidly. The maximum out-of-plane displacement was 189.0 mm on the W-side and 184.4 mm on the E-side. The bending moment in the out-of-plane direction was a maximum around the notch when compressed. Buckling occurred on the N-side, cracks occurred in the notch at 12.6 mm (1/120 rad) on the compression side, and a relatively small amount of peeling occurred on the N-surface of the notch at 30.4 mm (1/50 rad) on the compression side.

The bracing without a notch was not damaged by buckling, and the bracing with a notch generally resulted in damage to the notch. Regarding the buckling load, the bracing S1 without a notch exhibited the largest buckling load, followed by the bracing S5 with a notch. The bending moment in the out-of-plane direction of the compression side of the bracing showed a maximum at the center of the bracing (around the notch for the bracing with a notch).

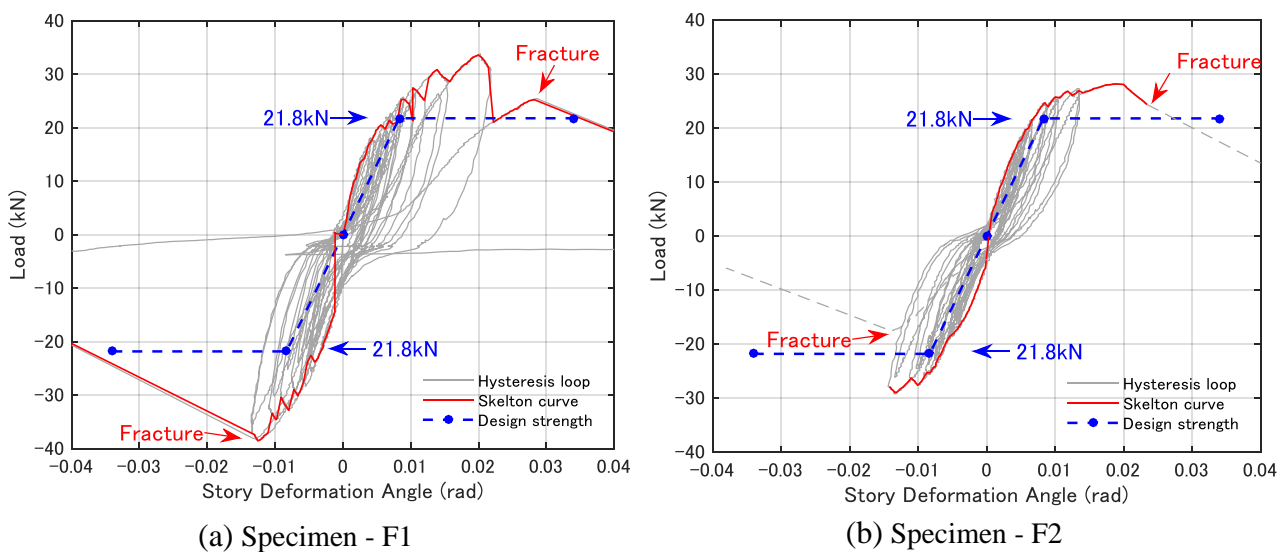
Fig. 8 – Restoring force characteristics

The horizontal load–story deformation angle relationship is shown in Fig. 8 where it is compared to the design value⁶. The maximum load for specimen F1 was 33.8 kN on the positive side (at 0.020 rad) and 38.5 kN on the negative side (at 0.013 rad), and for specimen F2 it was 28.2 kN on the positive side (at 0.019 rad), and 29.2 kN on the negative side (at 0.013 rad). The designed value was 21.8 kN at 1/120 rad and reaches the deformation limit at 1/30 rad. Comparing the design values with the experimental values, both the frame specimens exceeded the maximum strength but exhibited low deformation performance. A comparison of the two specimens showed that the provision of the notch in the bracing reduced its maximum strength. In both cases, the bracing buckled at a story deformation angle of 1/50 rad, and broke the gypsum board causing a decrease in the restoring force. However, in the case of a bracing with a notch, the bracing was broken as inferred by the difference in maximum strength.
